## **Sport and Recreation Reference Group**

**Report SR05 - 15 March 2021**

**SUBJECT:** Tunks Park Eastern Amenities Block

# North Sydney Council Amenities Condition Report

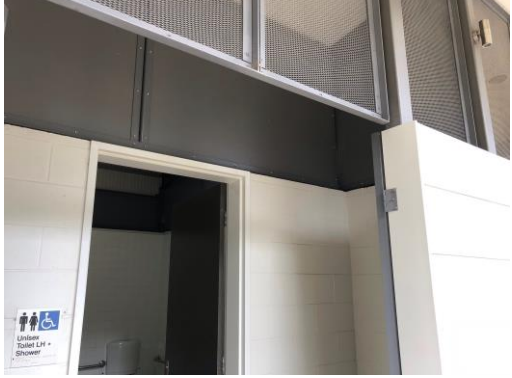
<p>Unisex/Accessible amenities require some permanent ventilation. Upon entering this area it was evident there was a lack of continuous ventilation as the mechanical fan only activates by sensor upon entry. Consider modifying the front high panels above entry door with mesh panels to match the remaining building.</p>

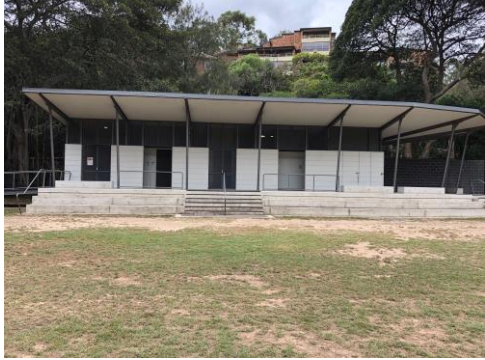
<p>External painting including minor repairs such as fixing back trims, easing and adjusting doors, removing redundant fixtures and minor patching of surfaces.</p>

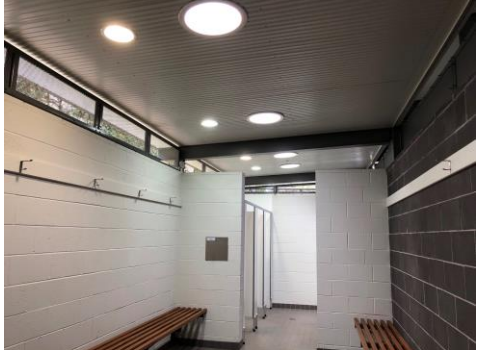
<p>Internal painting including minor repairs such as fixing back trims, easing and adjusting doors, removing redundant fixtures and minor patching of surfaces..</p>

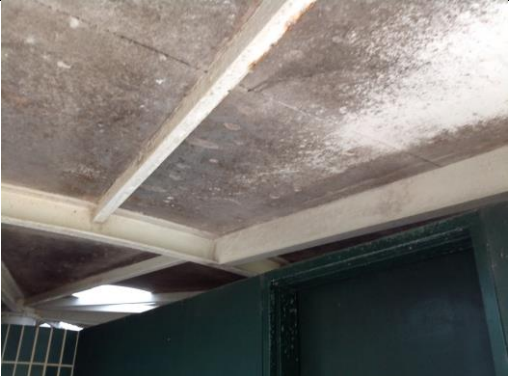
<p>External and Internal painting including minor repairs such as fixing back trims, easing and adjusting doors, removing redundant fixtures and minor patching of surfaces.</p>

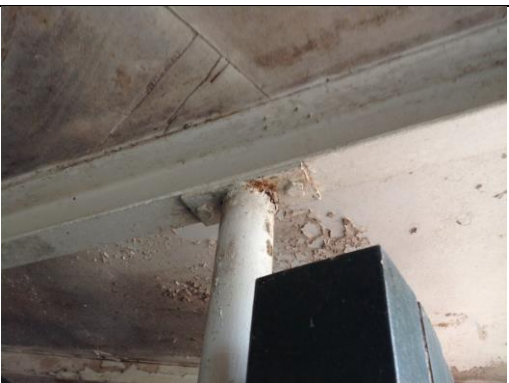
<p>Treat rusted surfaces such as doors and jambs to service rooms, structural steelwork.</p>

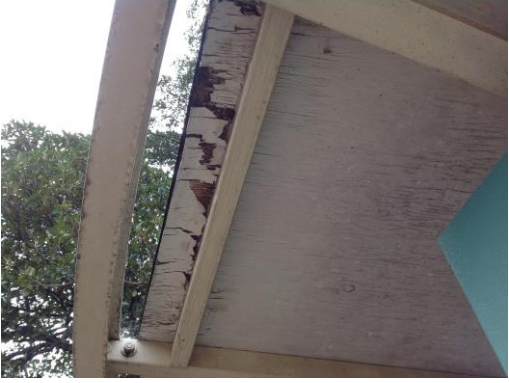
External and Internal painting including minor repairs such as fixing back trims, easing and adjusting doors, removing redundant fixtures and minor patching of surfaces.

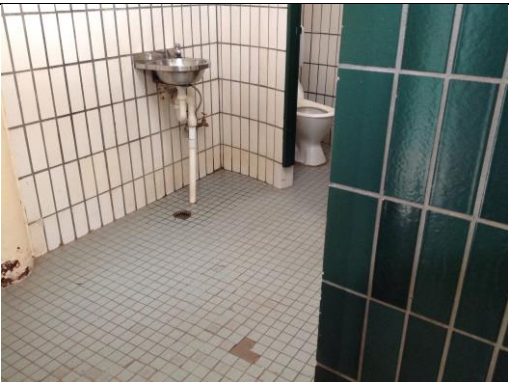
Repair floor tiles where missing.

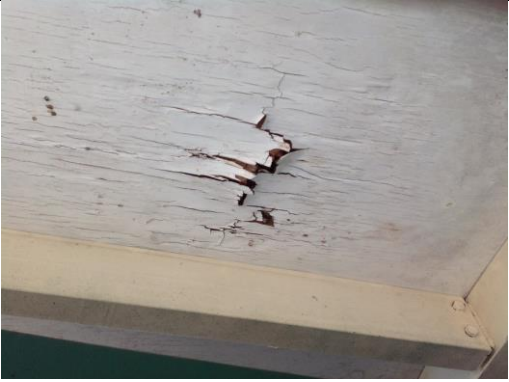
Re-roof complete building. Plywood soffit linings also need replacing, consider an alternative material such as a prefinished material to reduce future maintenance cost.

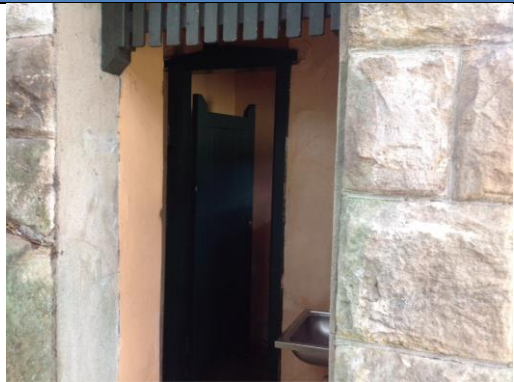
External and Internal painting including minor repairs such as fixing back trims, easing and adjusting doors, removing redundant fixtures and minor patching of surfaces.
 	Consider applying an epoxy coating to men's toilet floor and lower walls for hygiene.

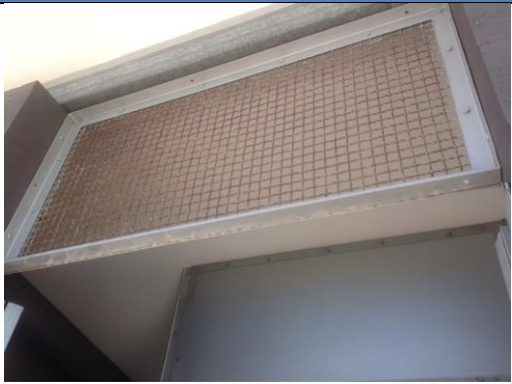
<p>Mesh to gates is showing evidence of corrosion. Gates require treatment to remove corrosion and treat with an epoxy coating suitable for use near a salt environment.</p>

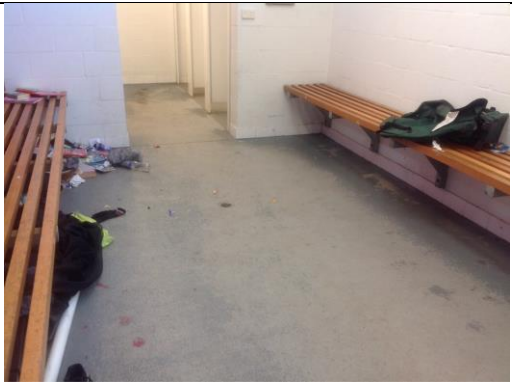
<p>Apply epoxy coating to toilet and change room floors for hygiene.</p>

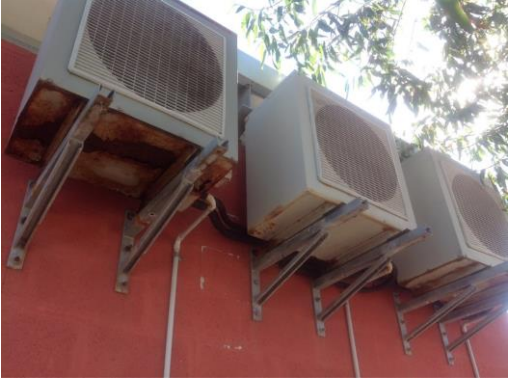
<p>Treat rust on elevated heat pump units.</p>

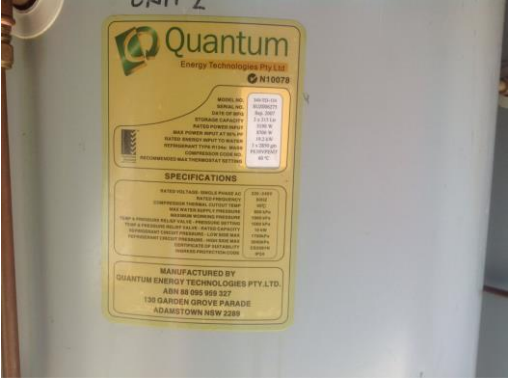
<p>HWS storage tanks, life expectancy of 10 to 15 years. These units are dated 2007.</p>

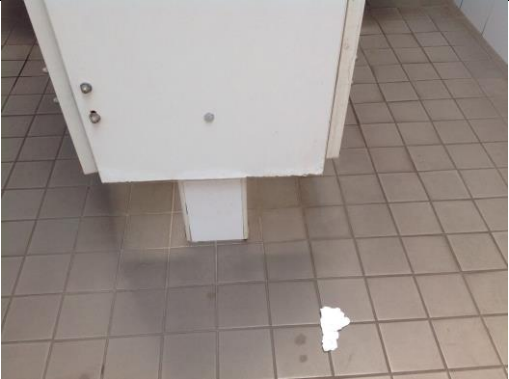
<p>Repair toilet partitions. Assumed damaged due to cleaner hosing out building.</p>

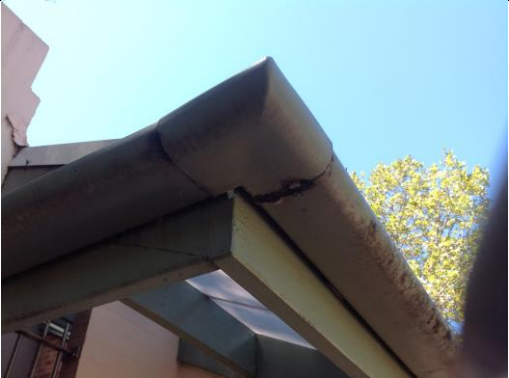
<p>Renew eaves and gutters. Roof water is used to flush toilets in this building.</p>

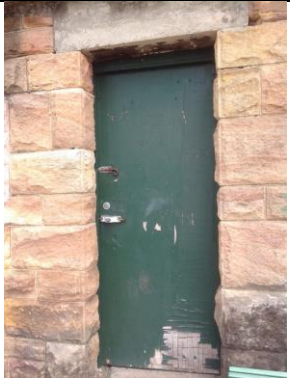
<p>Renew door.</p>

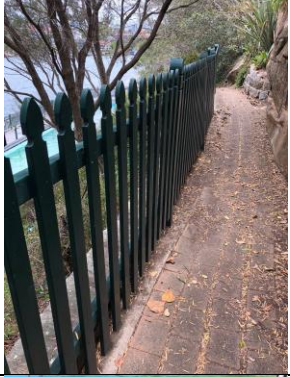
Paint handrails cliff side of pool including minor repairs.

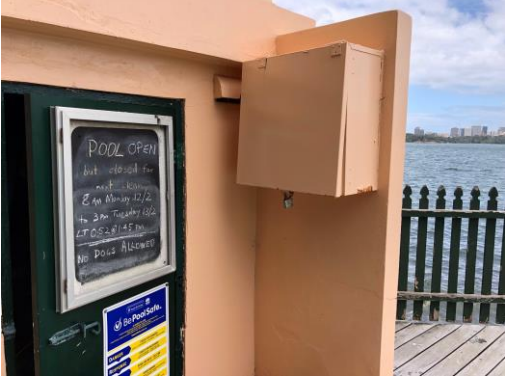
Treat rusted surfaces.

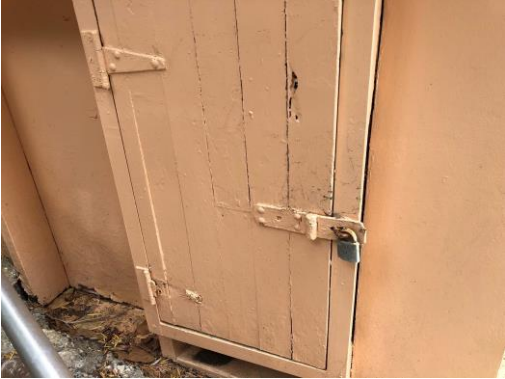
Renew timber access door and adjoining wall panel on side wall of pump shed.

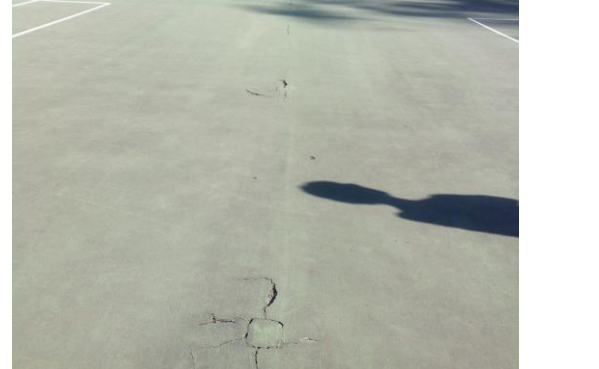
<p>Repairs to sub base of courts.</p>

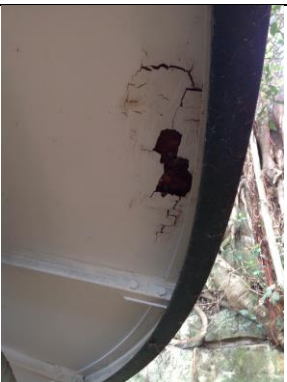
<p>Re-roof complete building. Plywood soffit linings also need replacing. Consider an alternative material such as a prefinished material to reduce future maintenance cost.</p>

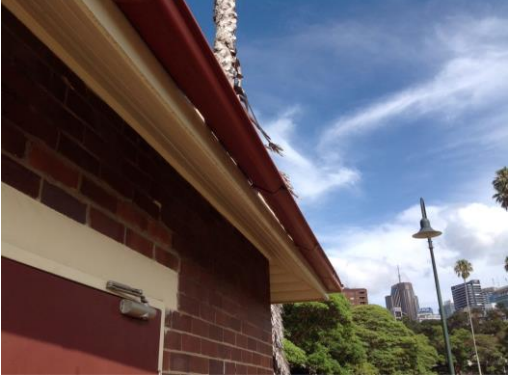
<p>Renew gutters and downpipes. Consider installing overstraps to gutters.</p>

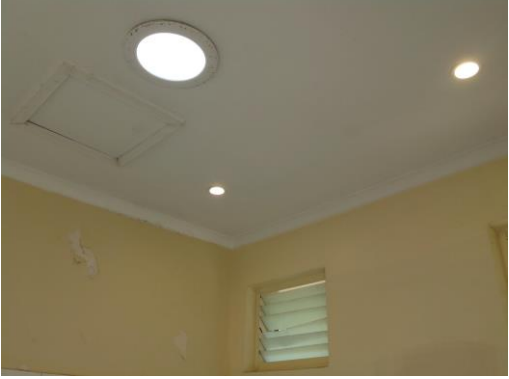
<p>External and Internal painting including minor repairs such as fixing back trims, easing and adjusting doors, removing redundant fixtures and minor patching of surfaces. Treat failed internal wall coatings.</p>

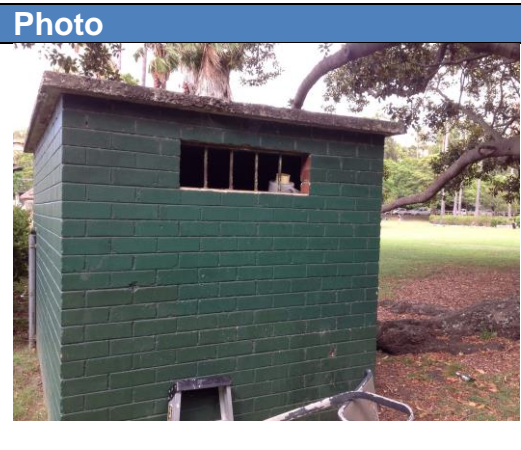
<p>External painting including minor repairs such as fixing back trims, easing and adjusting doors, removing redundant fixtures and minor patching of surfaces.</p>

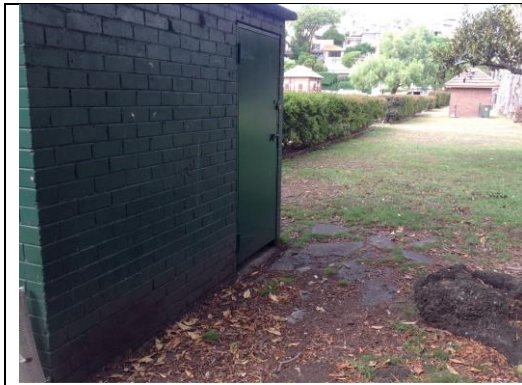
Address trip hazard leading to entrance and provide falls to divert stormwater away from doorway.

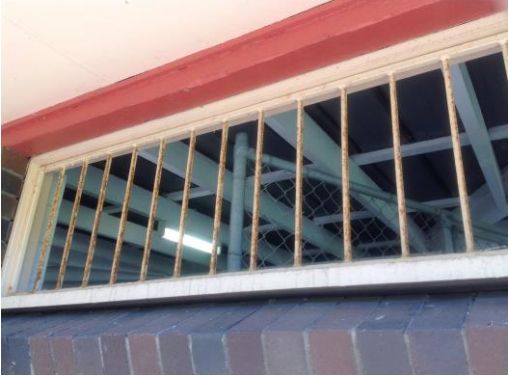
<p>Treat rusted building elements.</p>

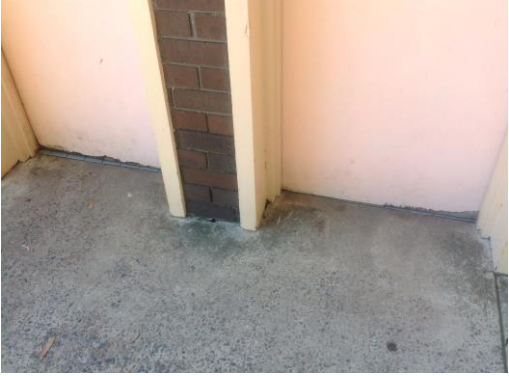
<p>Trim bottoms of doors, seal and install stainless steel kick plates to prevent future damage.</p>

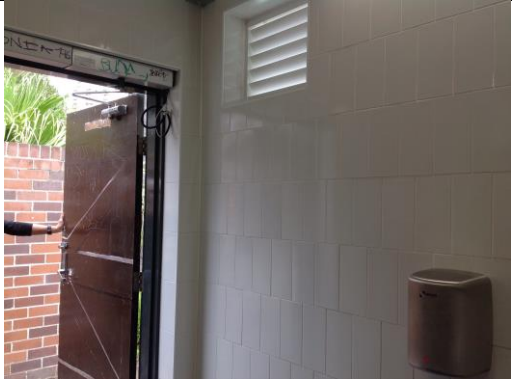
<p>Repair automatic door opening mechanism.</p>

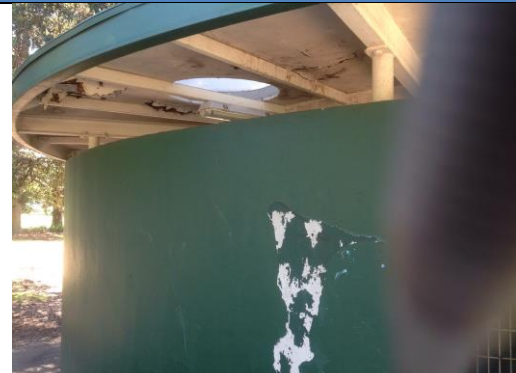
External and internal painting including minor repairs such as fixing back trims, easing and adjusting doors, removing redundant fixtures and minor patching of surfaces.

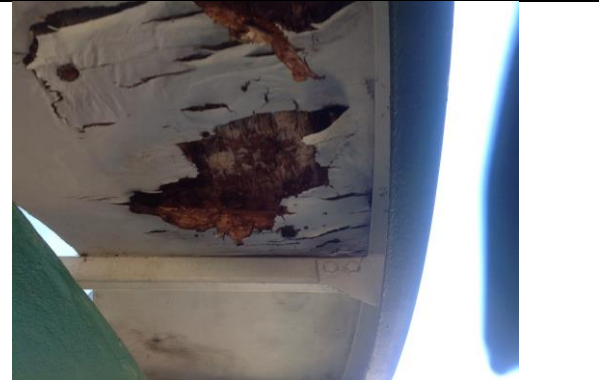
<p>Re-roof complete building. Plywood soffit linings also need replacing. Consider an alternative material such as a prefinished material to reduce future maintenance cost.</p>
---	--

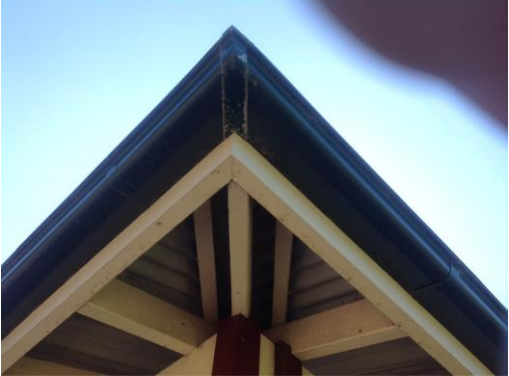
<p>Replace quad gutters to brick section of pavilion.</p>

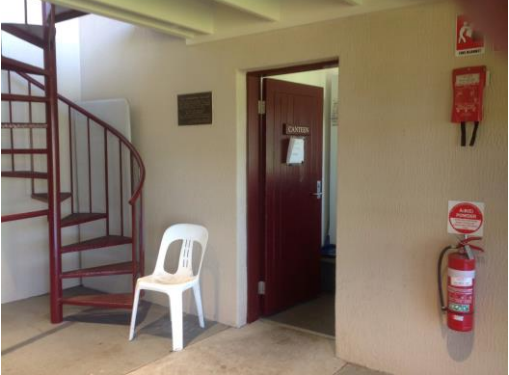
<p>Maintain epoxy coating to floors.</p>

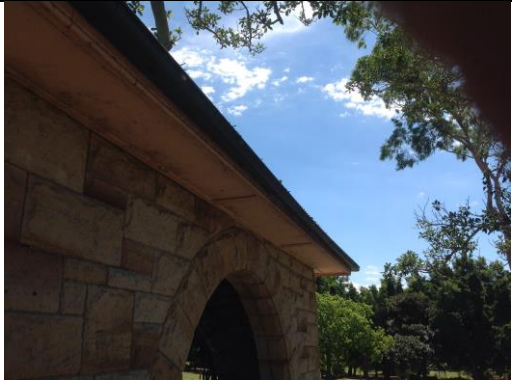
External and Internal painting including minor repairs such as fixing back trims, removing redundant fixtures and minor patching of surfaces.

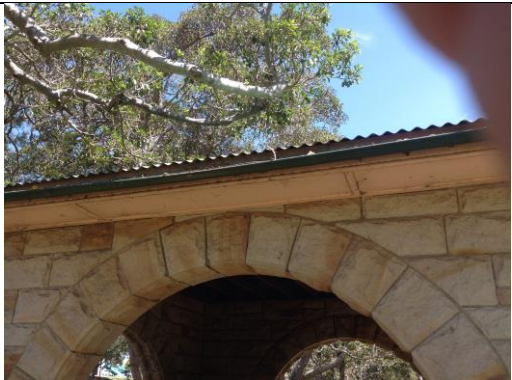
Straighten, realign and overstrap existing eaves and gutters.

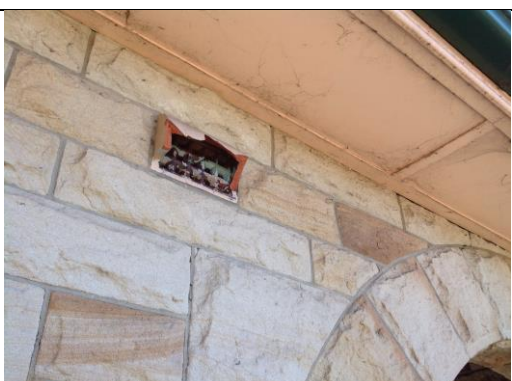
Replace damaged terra cotta wall vents.

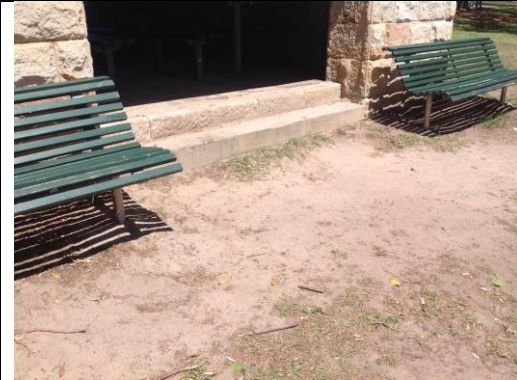
Address trip hazard leading to entrance. Provide a concrete landing the width of the opening. This will maintain even ground and correct riser height at stairs.

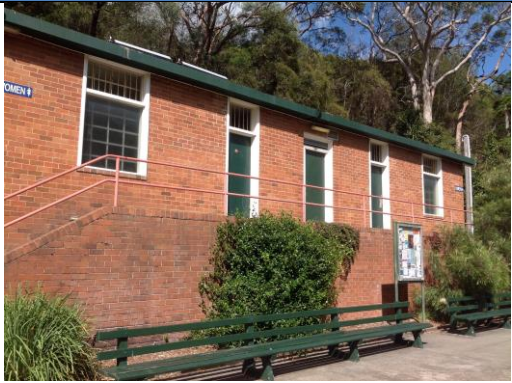
<p>External painting including minor repairs such as fixing back trims, easing and adjusting doors, removing redundant fixtures and minor patching of surfaces.</p>

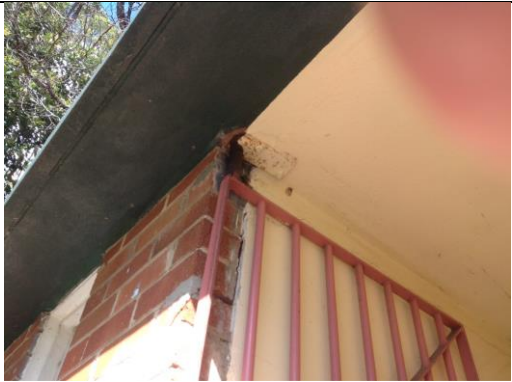
<p>Treat rusted surfaces such as handrails, gates and gate hinges.</p>

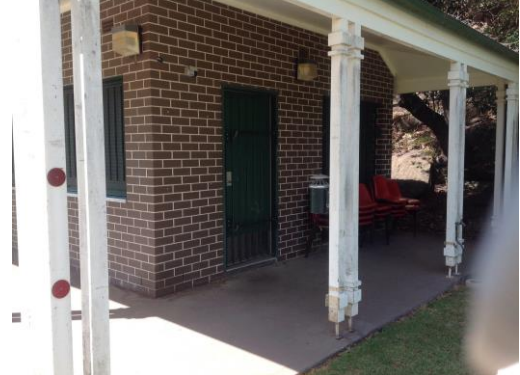
Repairs to timbers such as trims to veranda post.

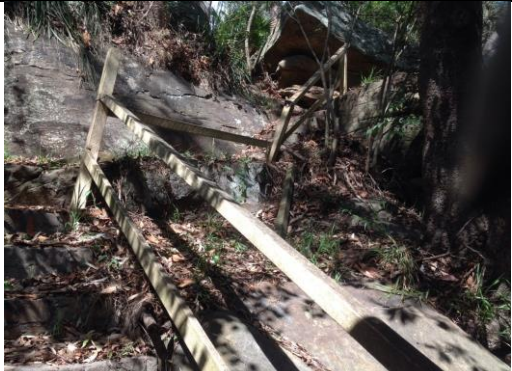
Renew handrail to stairs at rear of building.

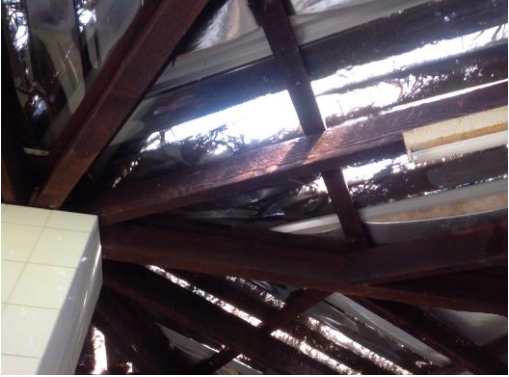
<p>Skylights, install safety mesh to the underside.</p>

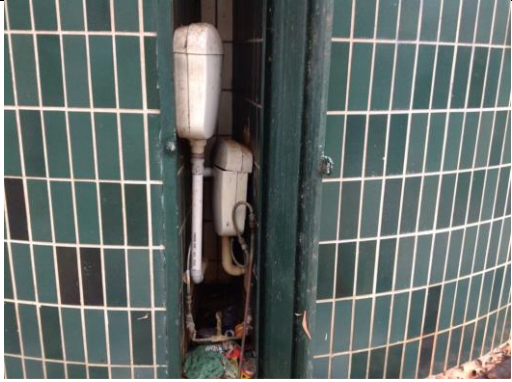
<p>Treat rusted surfaces such as doors and jambs to service rooms, structural steelwork.</p>

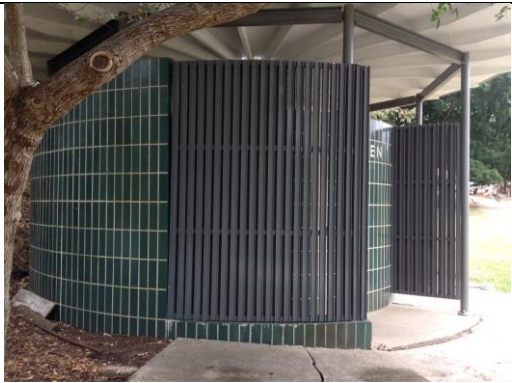
<p>Address trip hazard by constructing a new path at the entrance of building.</p>

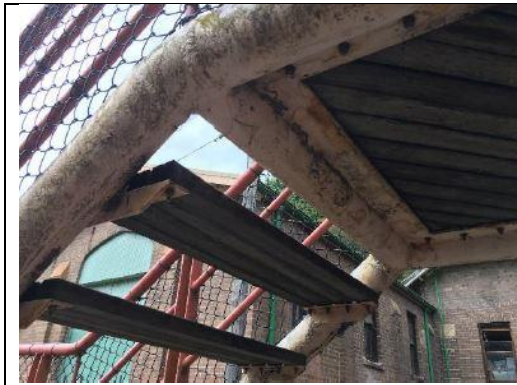
Photo	Issue
 	There is plywood on the top of the stair.
 	The ply is covering a missing decking timber.
 	Timber decking in poor condition.

Corroded timber beam fixings incl. stair stringer and support column.

It is recommended that all the timber treads and decking be replaced with 35 x 130 F27 kiln dried hardwood. The fixings should be grade 316 stainless steel bolts with neoprene washers to provide metal separation.

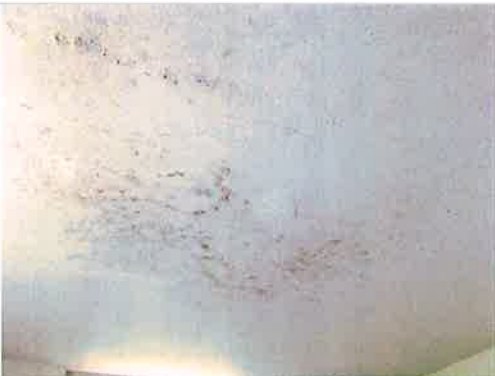
Item	Description	Photograph
1	Moisture entry through concrete roof

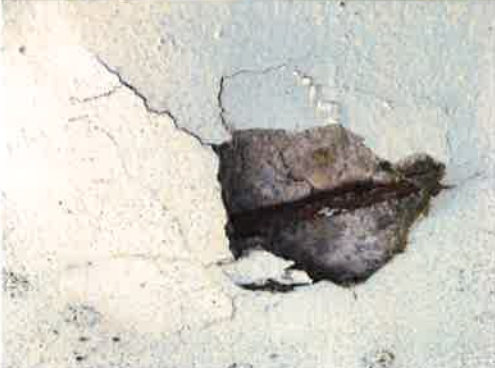
2	Corroded reinforcement in concrete roof

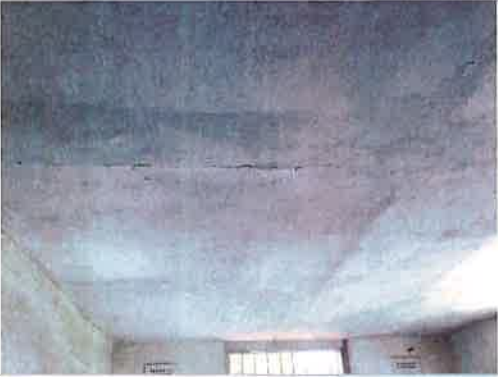
Item	Description	Photograph
3	Further moisture entry through concrete roof and potential corroded reinforcement

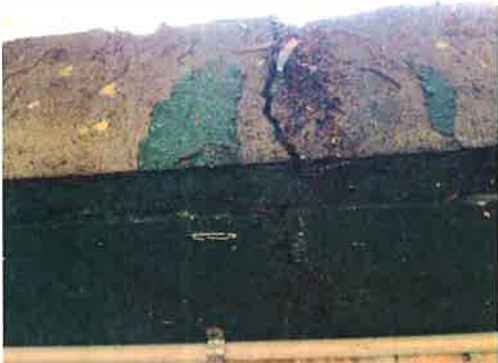
5	Cracked roof slab

1	External painting including minor repairs such as fixing back trims, easing, and adjusting doors, removing redundant fixtures and minor patching of surfaces.
2	Internal painting including minor repairs such as fixing back trims, easing, and adjusting doors, removing redundant fixtures and minor patching of surfaces.
3	Renew 2 external doors.
4	Treat rusted surfaces such as handrails, gates, and gate hinges.
5	Repair corroded reinforcement.
6	Repair brick and render cracking.
7	Repair cracked roof slab. Repairs and grout injection. (Engineers Report #5)

8	Repair cracked roof slab and new membrane for roof. Approx. 115m2 (Engineers Report #5a)
9	Replace missing brickwork and repair cracked brickwork rear wall. (Engineers Report #6&7)
10	Repair displaced brickwork over groundsman's entry door and cracked brickwork to side of groundsman's entry door. Repair cracked concrete stairs. (Engineers Report #8, 13, 15, 16)
11	Repair displaced brickwork to veranda, cracked brickwork to stair stringer, and cracked brickwork to wall at side of stairs. Separate slab from brickwork with slip joint. Works incl. Geotech report and underpinning (Engineers Report # 9-12a)
12	Repair cracked topping to stairs. (Engineers Report #14)
13	Replace cracked foundation rock to rear steel stair. (Engineers Report #17)

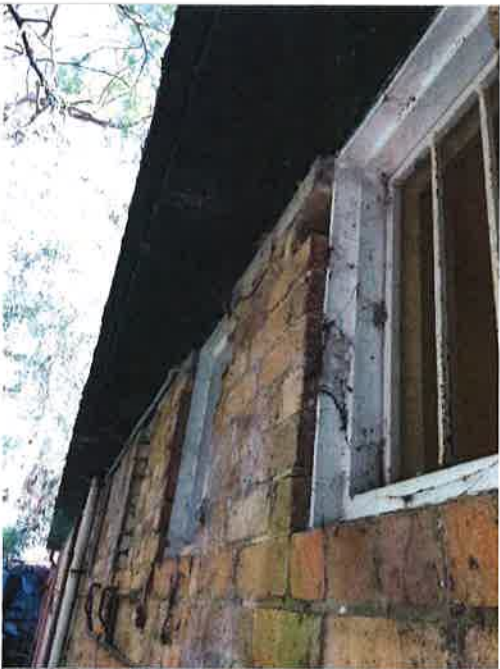
Item	Description	Photograph
6	Missing brickwork rear wall

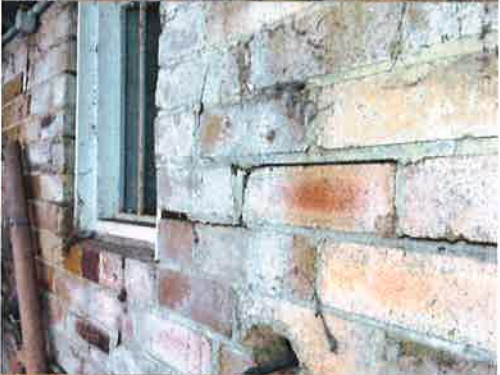
7	Cracked brickwork rear wall

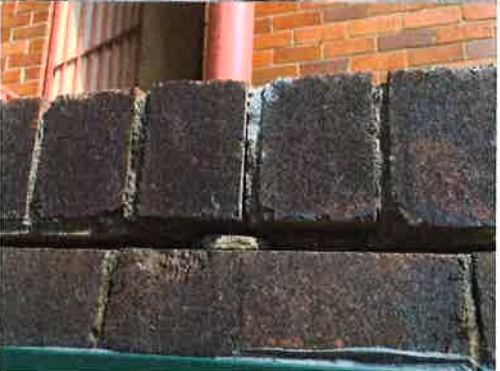
8	Displaced brick capping over corroded handrail post base

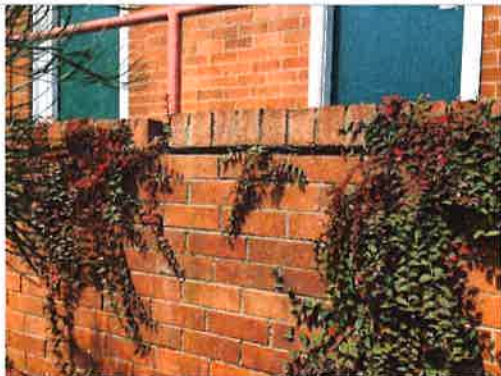
Item	Description	Photograph
9	Displaced brick capping over corroded handrail post base

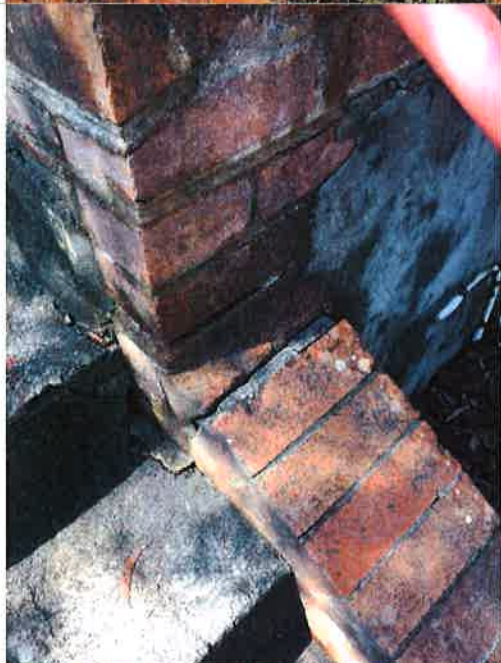
10	Cracked brick capping

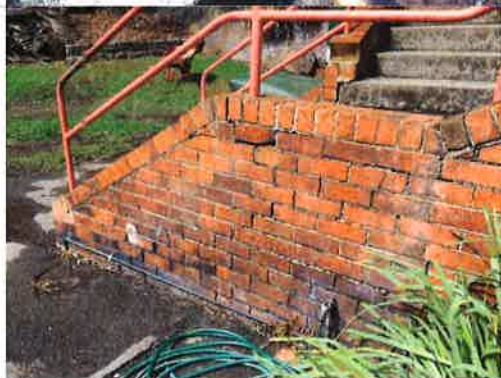
11	Cracked brick wall due to settlement

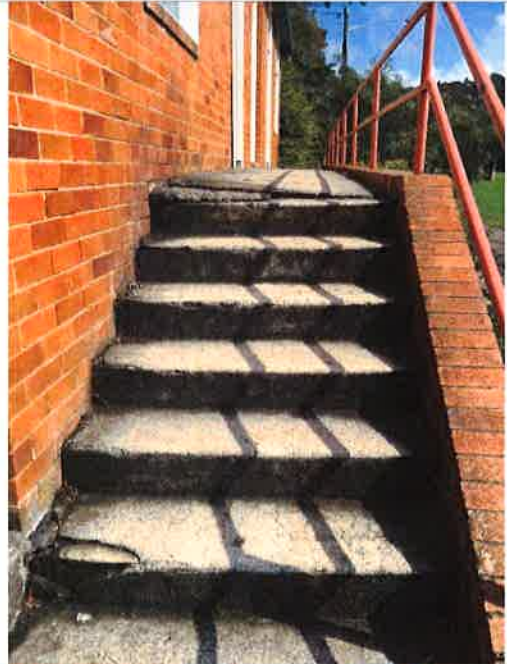
14 Settled stair with cracked topping applied to create falls

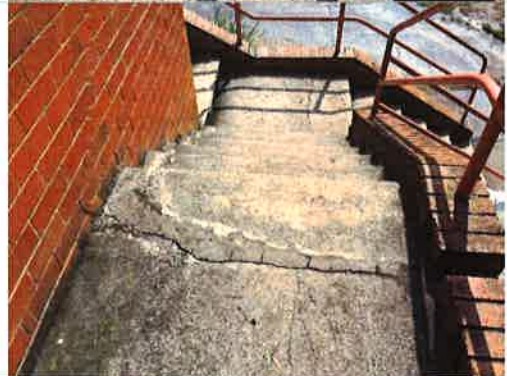
15 Stair crack

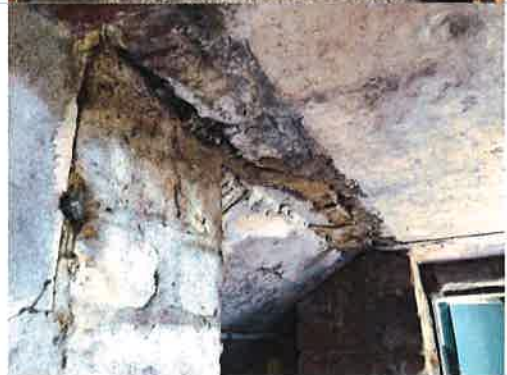
16 Stair crack from below

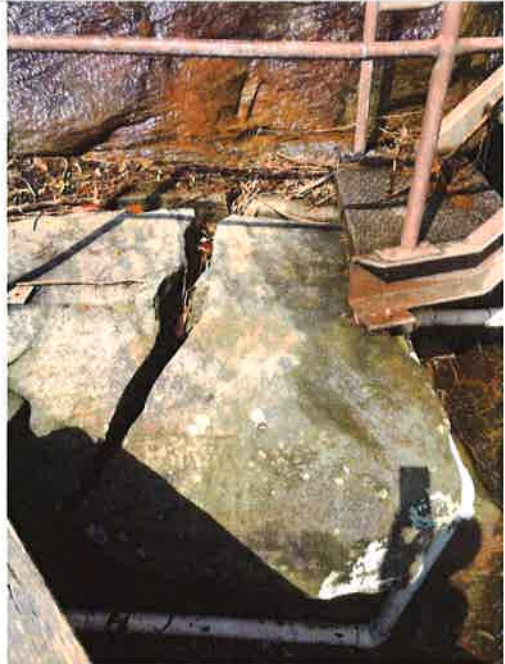
17 Cracked foundation rock to rear steel stair

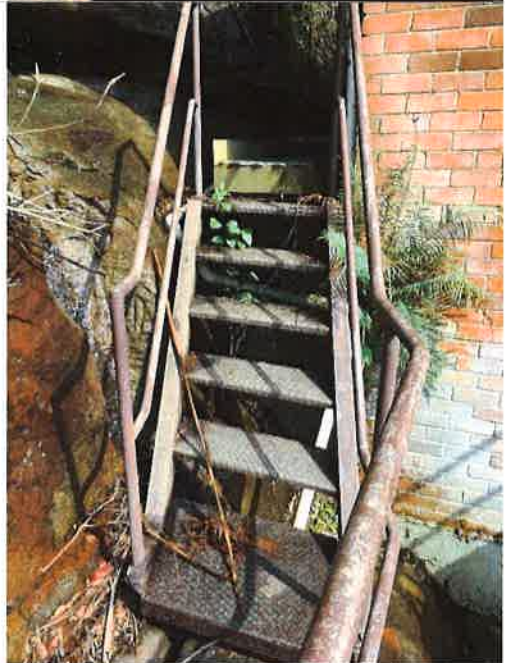
18 Corroded rear steel stair and platform
