SUBJECT: North Sydney Council Stormwater Inlets Risk Management**AUTHOR:** Ibrahim Malla, Acting Assets Manager**ENDORSED BY:** Duncan Mitchell, Director Engineering and Property Services**EXECUTIVE SUMMARY:**

Risk Management Plan

Stormwater Drainage Inlets

September 2019

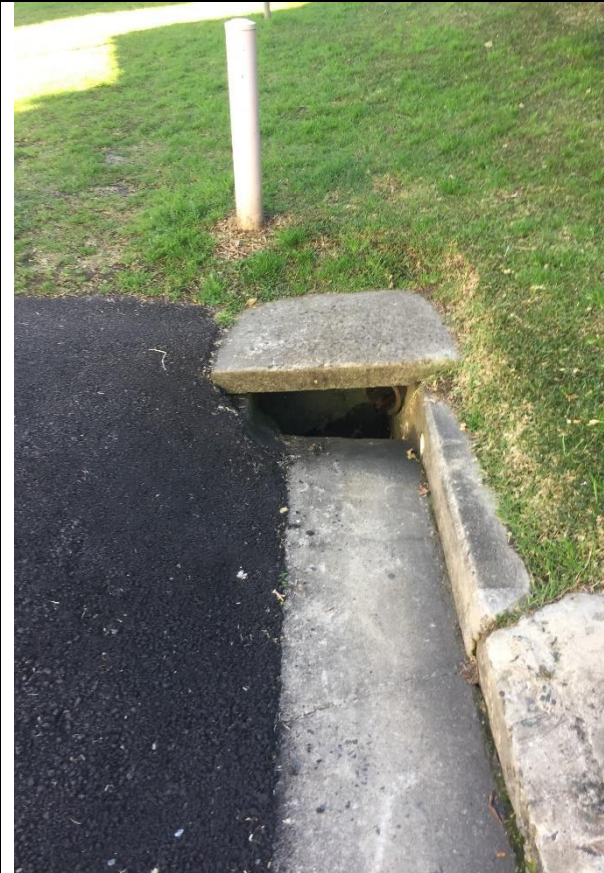
Low Risk

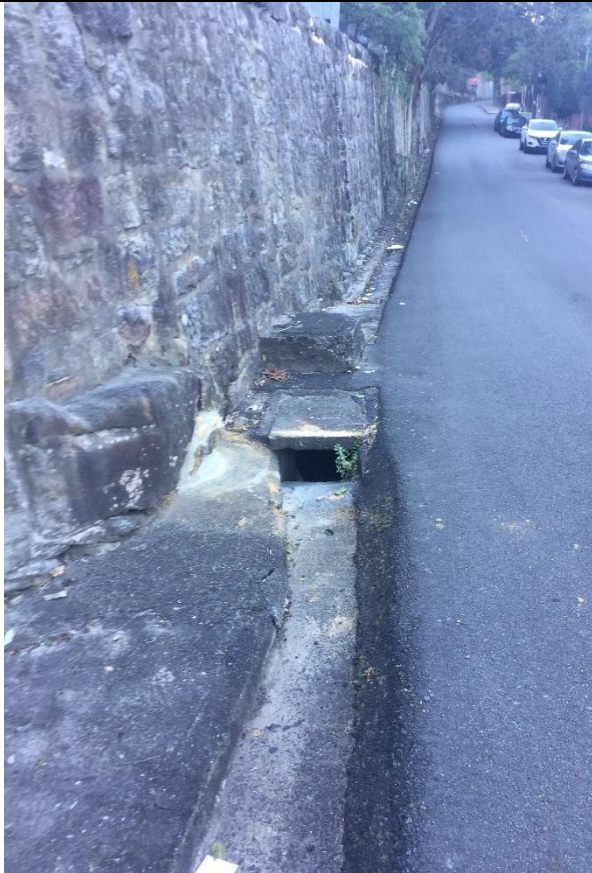
Low Risk

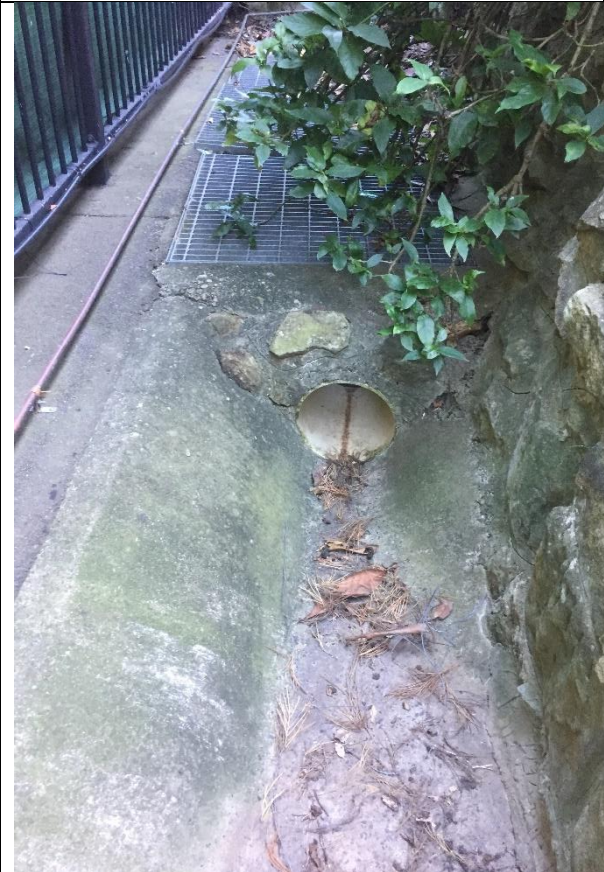
Medium Risk

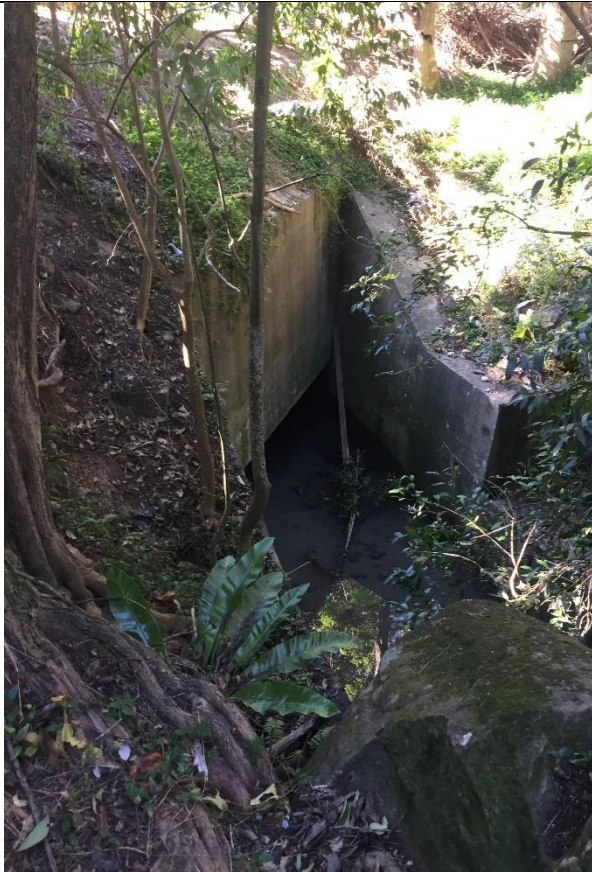
Medium Risk

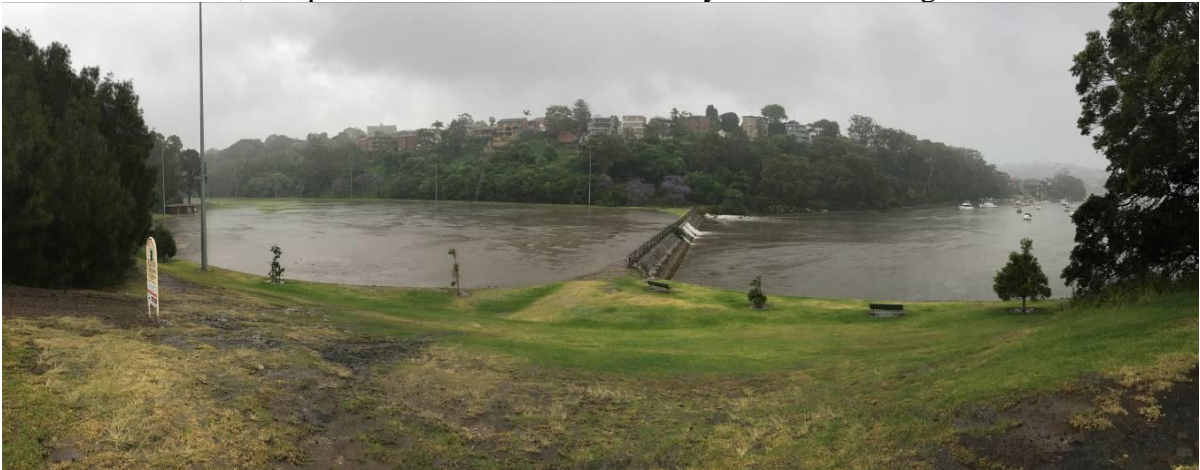
Primrose Park Flooding – 27 November 2018 – 1:100 year storm event

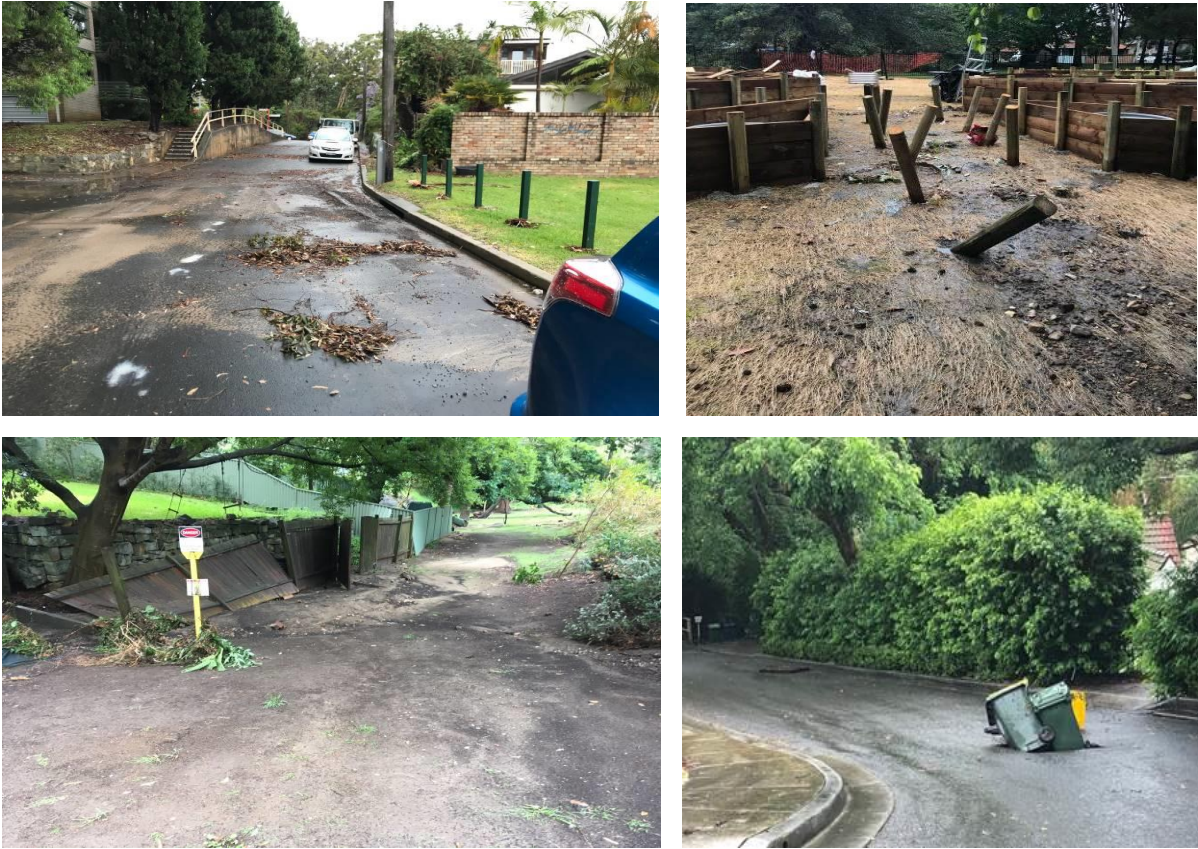
Flooding Damage examples in North Sydney LGA – 27 November 2018 – 1:100 year storm event
Figure 1. Map showing Inlets in each Risk Category below.

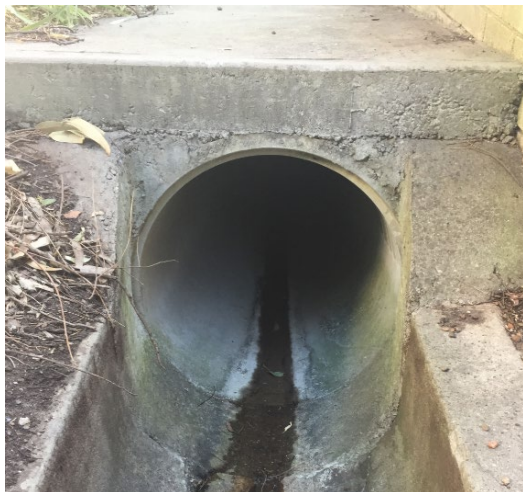
Figure 2: High risk inlet

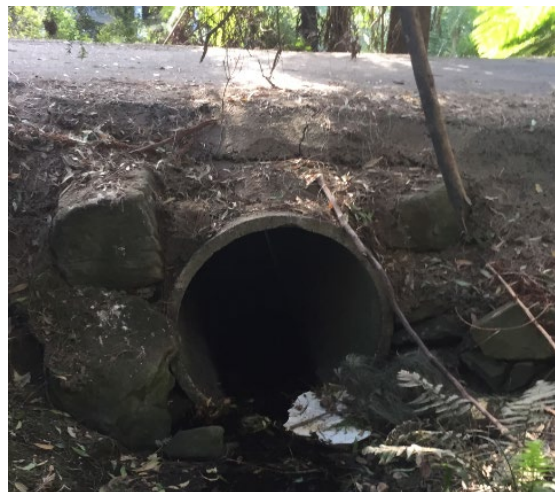
Figure 3: High risk inlet

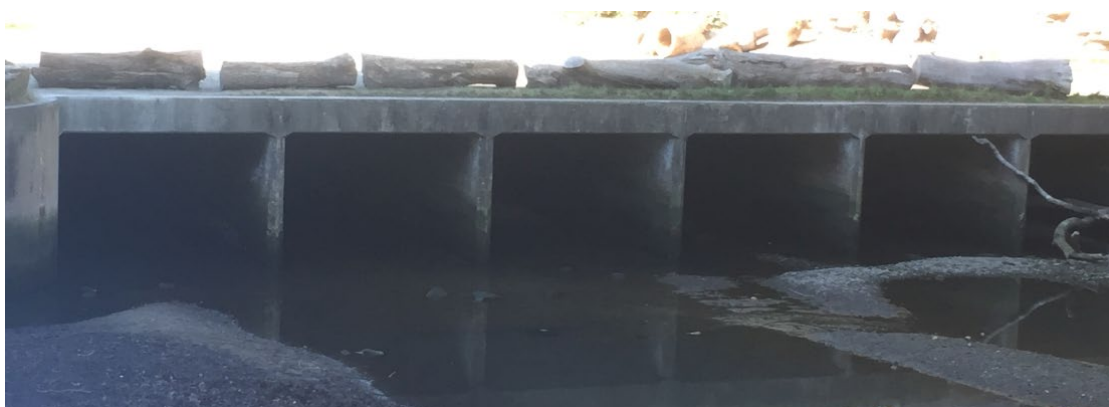
Figure 4: High risk inlet

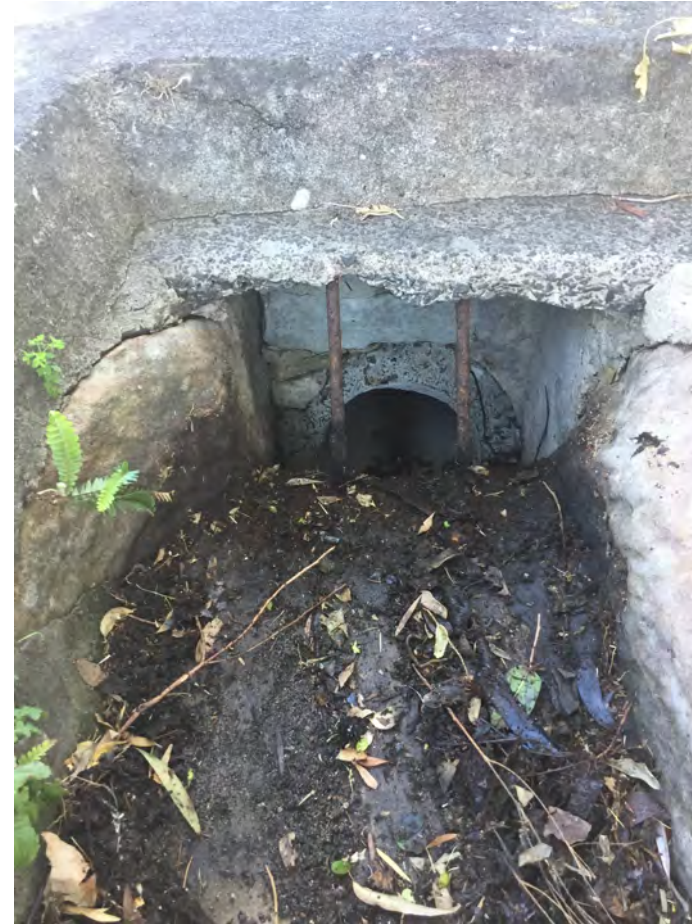
Inlet has exclusion bars, however are in a poor condition

| Low | Install within 5 years |
