*Arboricultural Assessment  
and Tree Protection Plan  
Panel Determination – Council correspondence  
D418/21JD(CIS)*

Commissioned by: T + P Dugal

Site: 37 Bay View Street, Lavender Bay 2060

Date of Inspection: 22 August & 5 November 2022

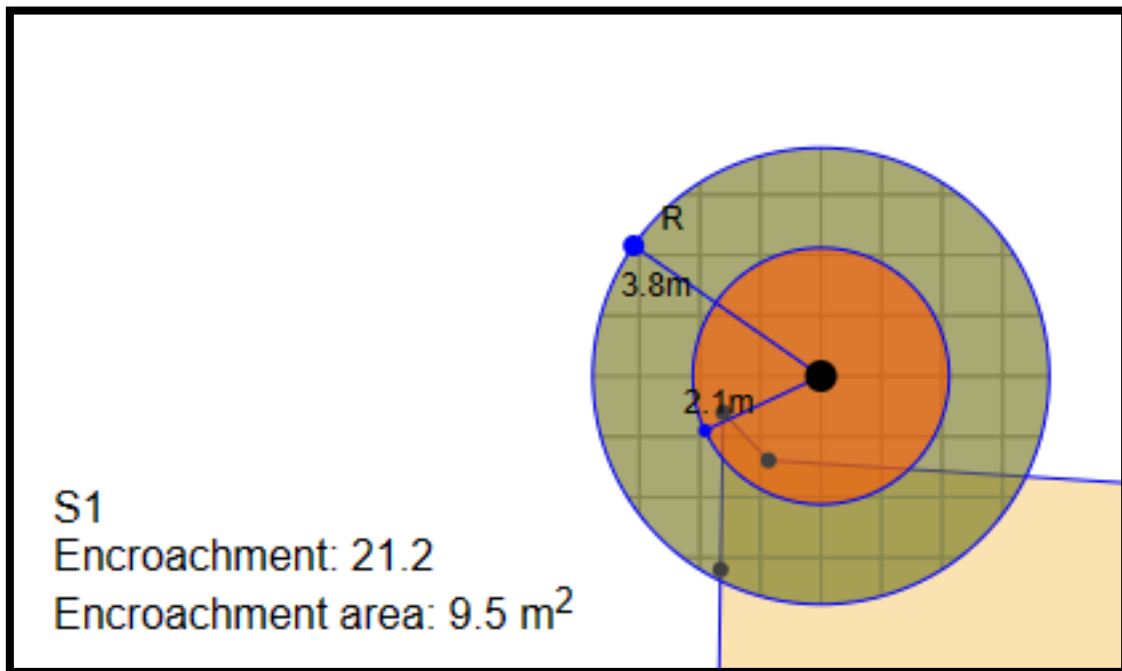
Figure 4. *Lagerstroemia indica*, Total incursion of 21.2% into the Tree Protection Zone & 12 % of the Structural Root Zone from the driveway footprint for development at 37 Bay View St, Lavender Bay, NSW 2060.

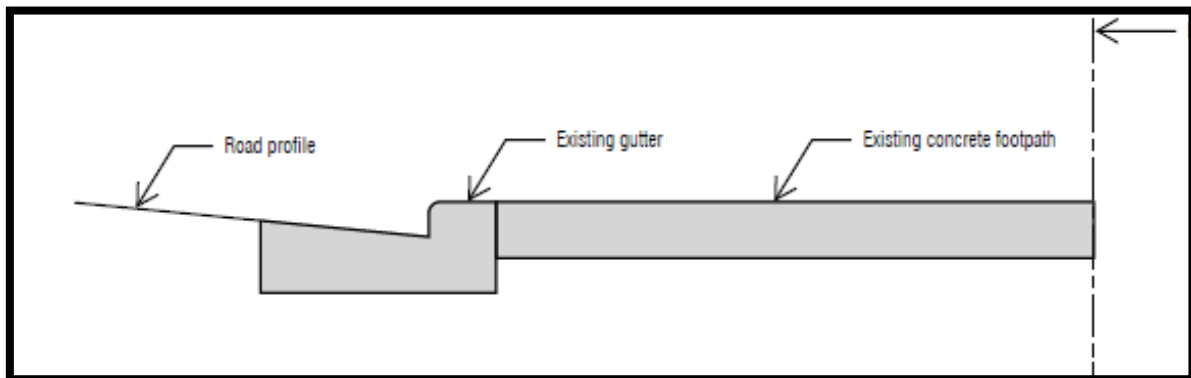
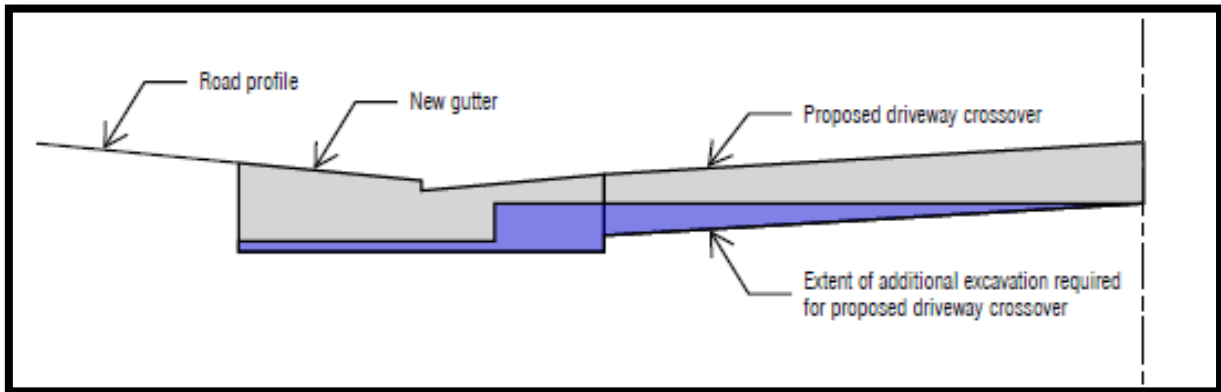
Figure 5. Existing gutter and footpath footprint for development at 37 Bay View St, Lavender Bay, NSW 2060.

Figure 6. Reduced area required for new excavation at 37 Bay View St, Lavender Bay, NSW 2060.

It is noted that the roots have grown to accommodate the existing concrete infrastructure footprint. In particular the depth of the footprint is a significant consideration as this will result in less excavation for the installation of the new infrastructure. The tree roots within this area are likely to be deeper in the soil profile and will not be required to be pruned. Therefore, the extent of excavation required, is reduced due to the existing footprint (Figure 5,6).

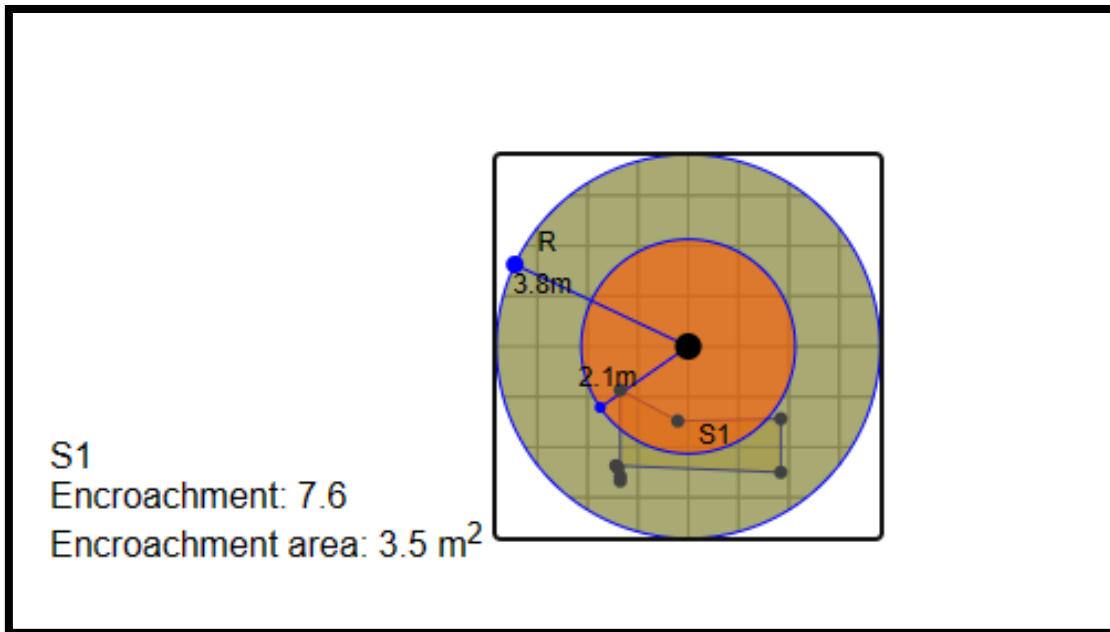
Figure 7. Reduced incursion from additional excavation requirements, 7.6% into the Tree Protection Zone & Structural Root Zone from the driveway according to the new location as outlined at 37 Bay View St, Lavender Bay, NSW 2060

**5.2 It is the belief and experience of the author** that the street tree will not be adversely impacted by the realignment of the driveway as outlined in the revised plans provided.
