NORTH SYDNEY COUNCIL
ASSET MANAGEMENT PLAN
KERB & GUTTER 2022-2032

Document Control		Asset Management Plan

Document ID : NSC AMP Roads 2023 Kerb and Gutter						
Rev No	Date	Revision Details	Author	Reviewer	Approver	
1	25/10/2021	First Draft	IM	JVH/DM	DM

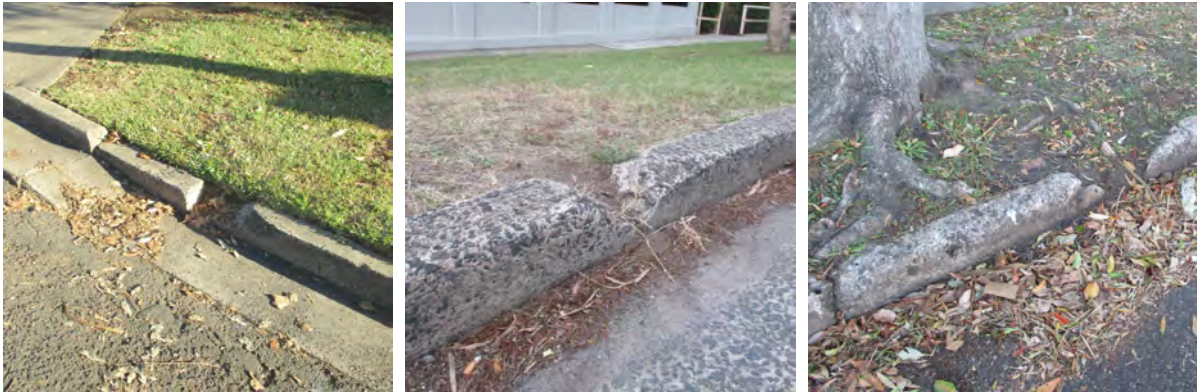
Examples of failed and failing Kerb and Gutter in the North Sydney LGA

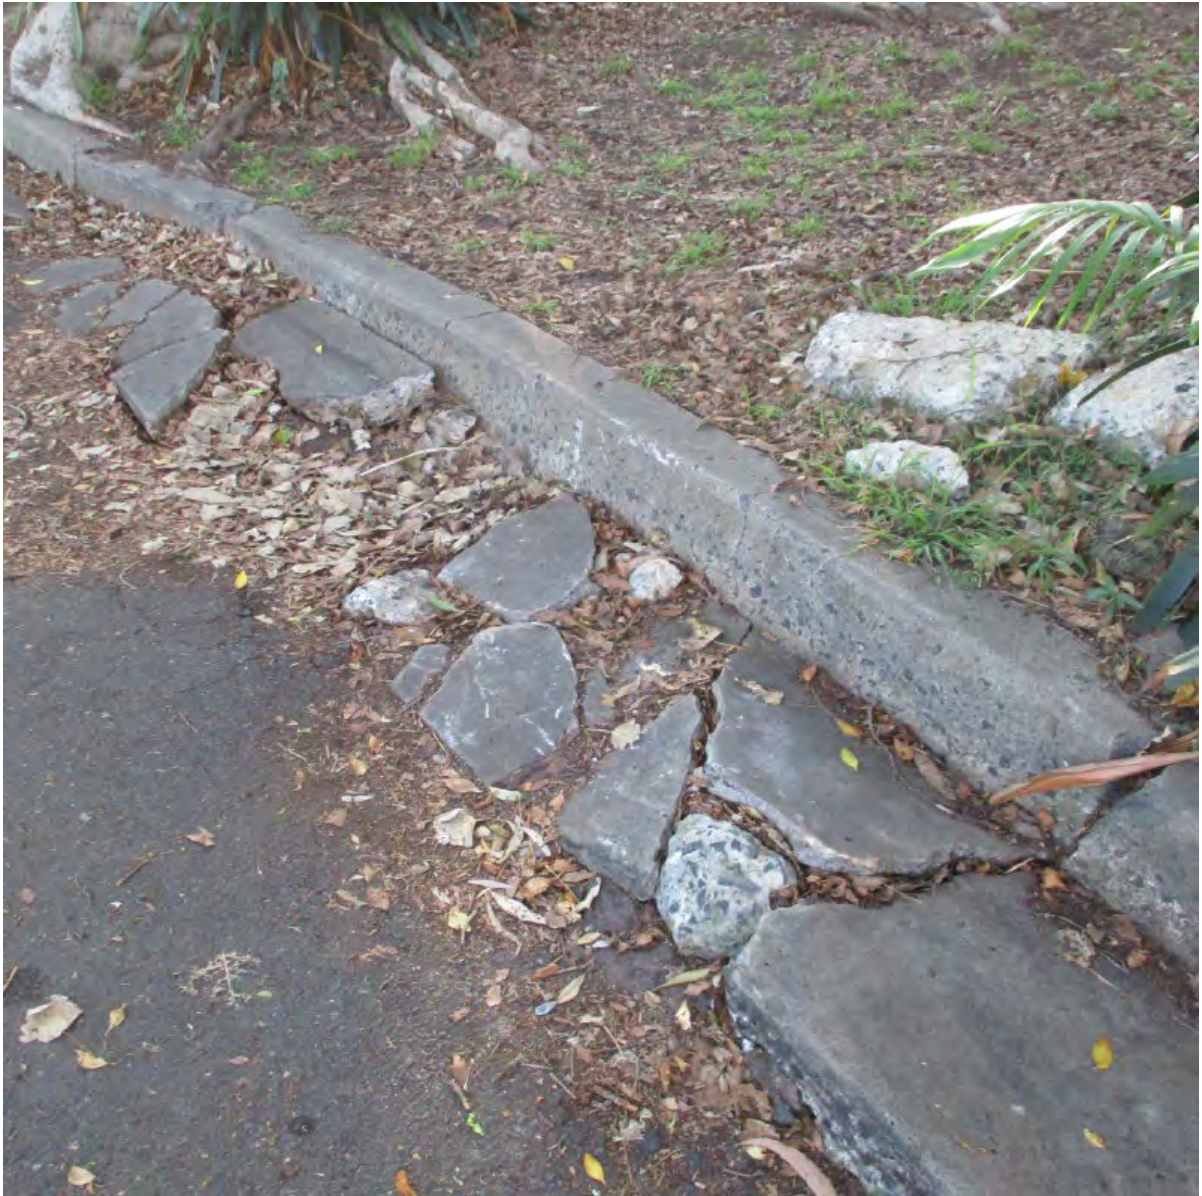
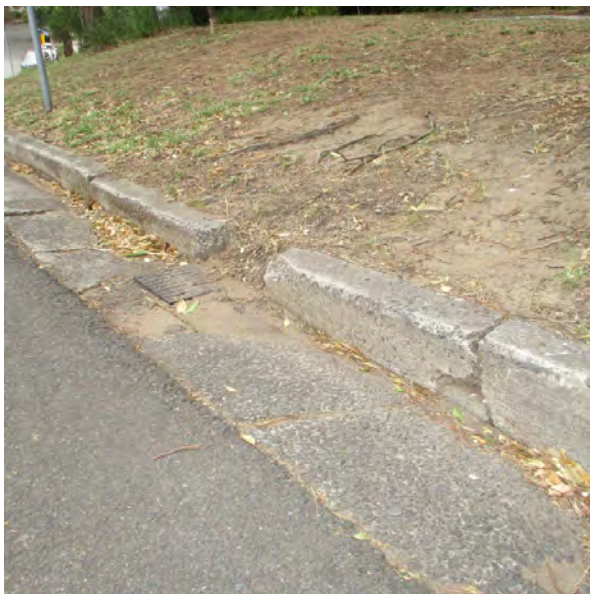
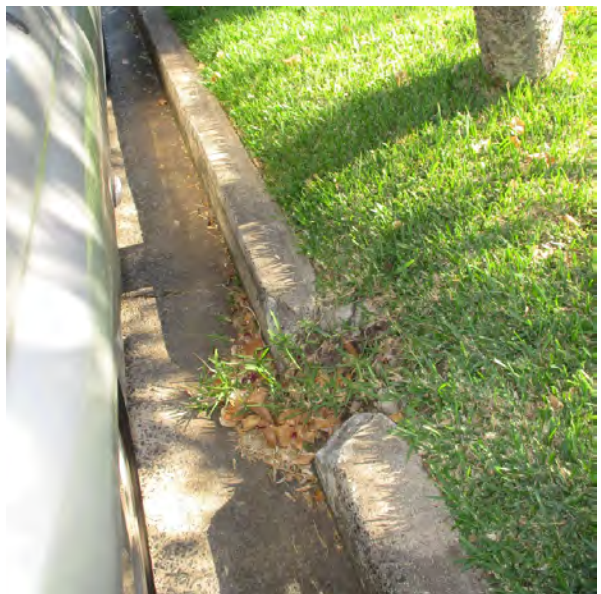
Examples of failed Kerb and Gutter in the North Sydney LGA

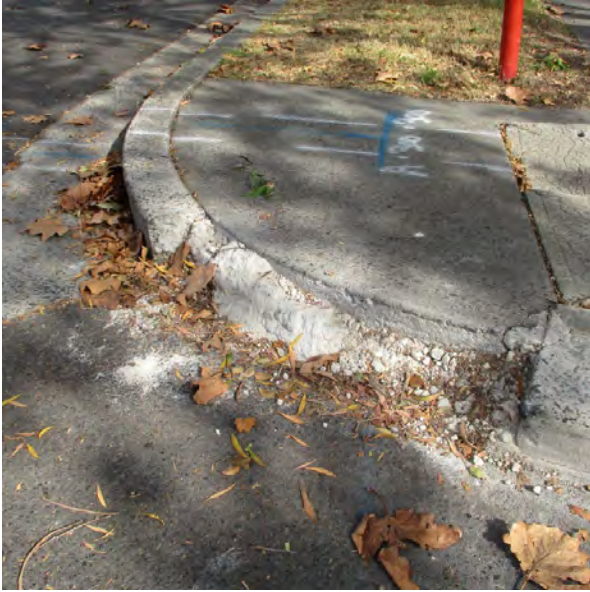
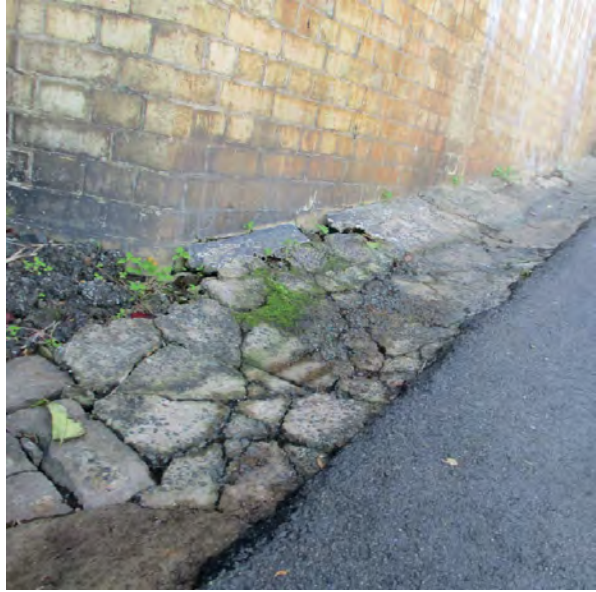
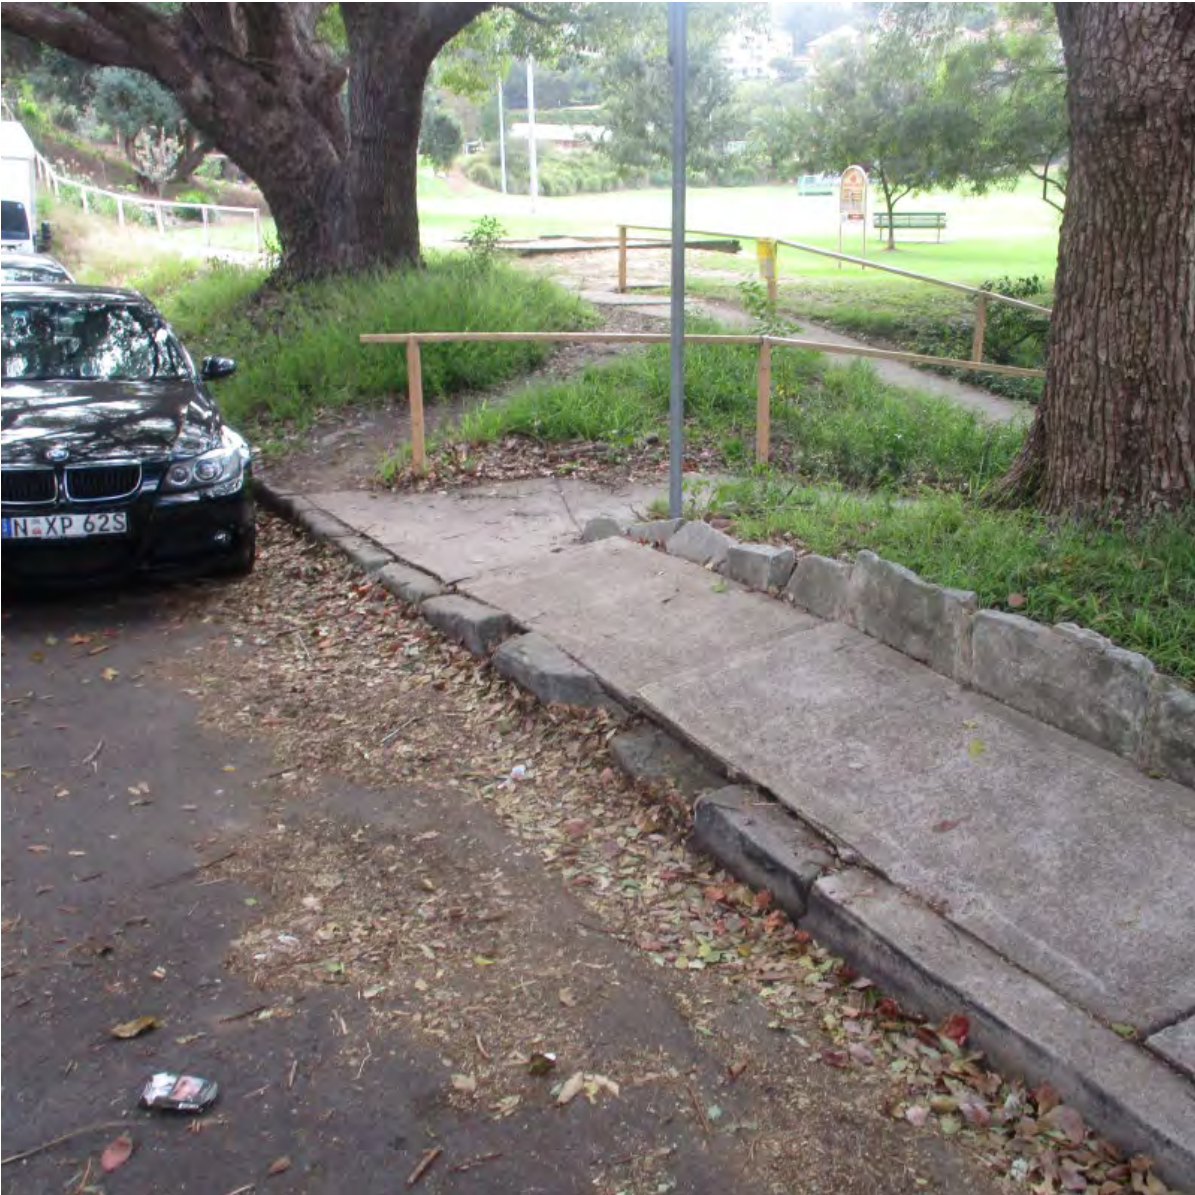
Examples of failed Kerb and Gutter in the North Sydney LGA

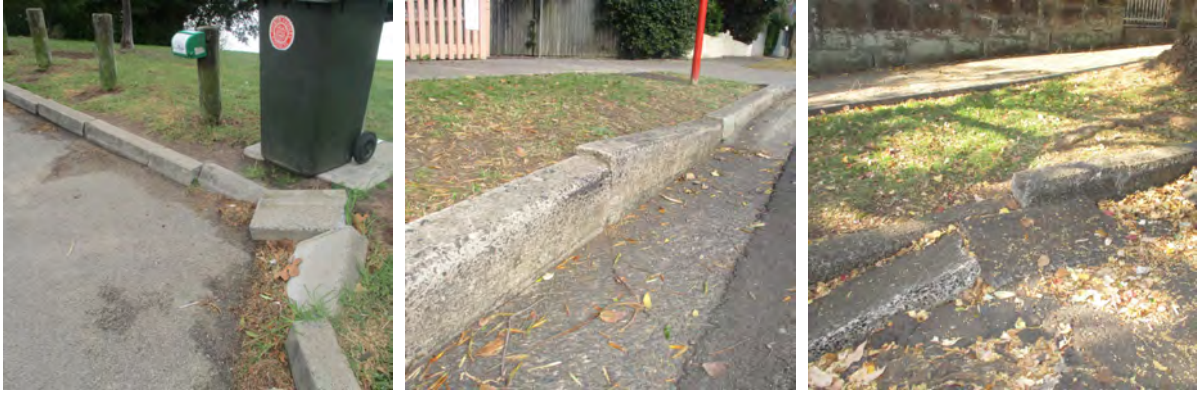
Examples of failed Kerb and Gutter in the North Sydney LGA
