NORTH SYDNEY COUNCIL ASSET MANAGEMENT PLAN

STORMWATER DRAINAGE & GROSS POLLUTANT TRAPS 2022-2032

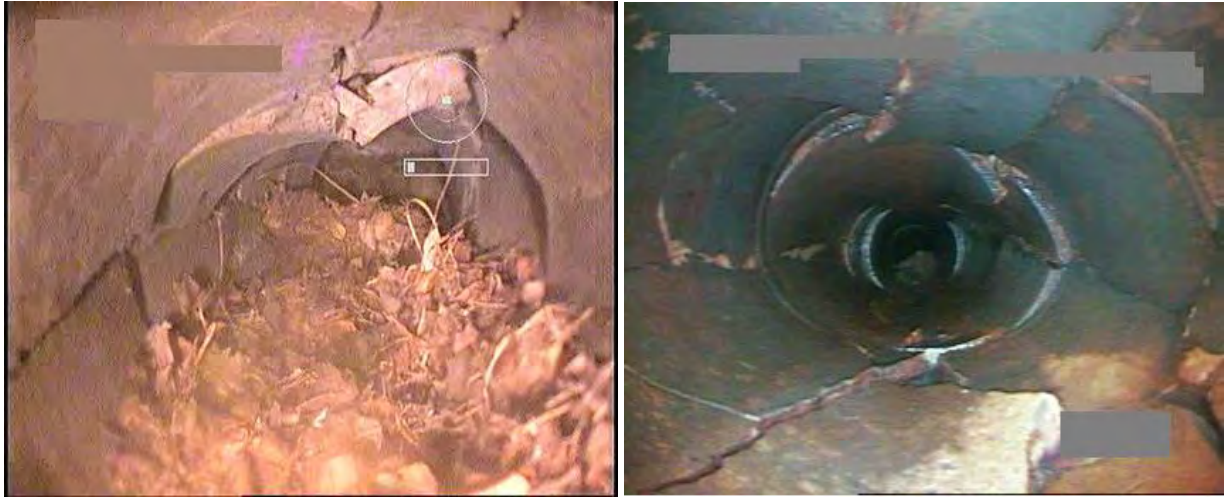
Stormwater Pipes in very poor condition – collapsed and blocked

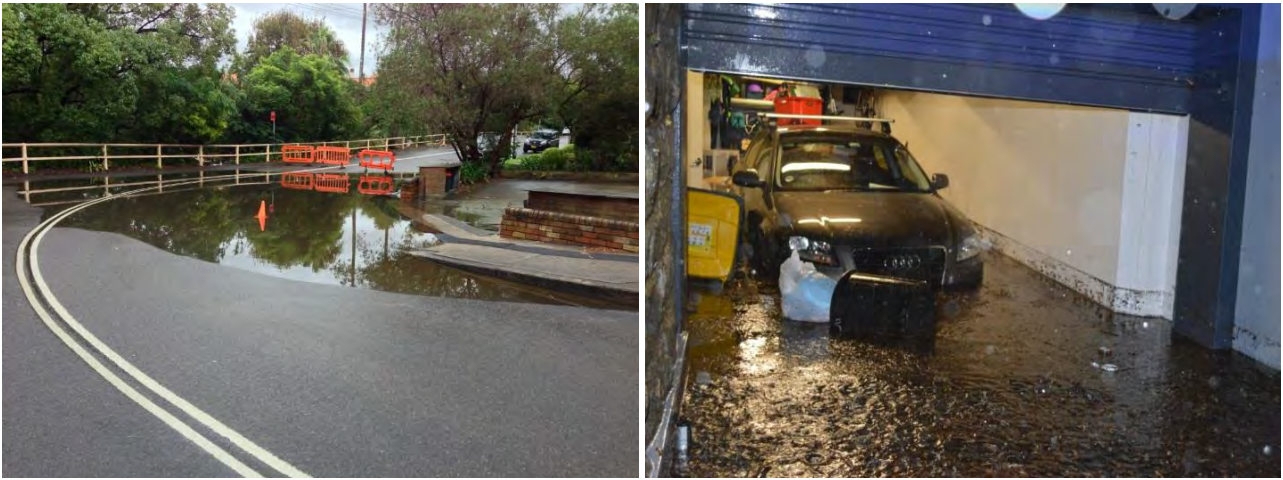
Flooding Issues

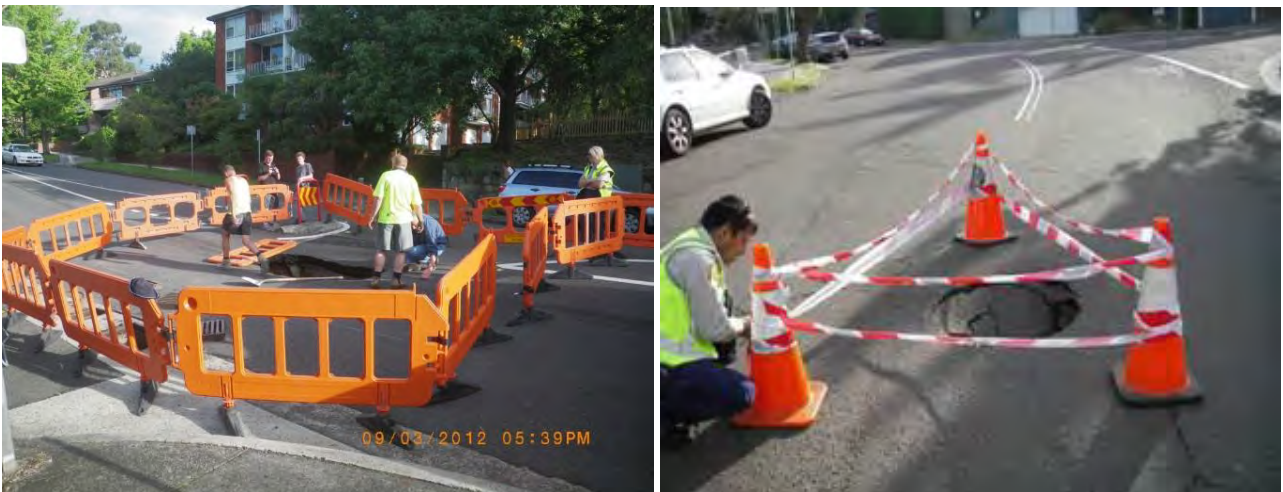
Sinkholes created from collapsed pipes and washout from leaking pipes

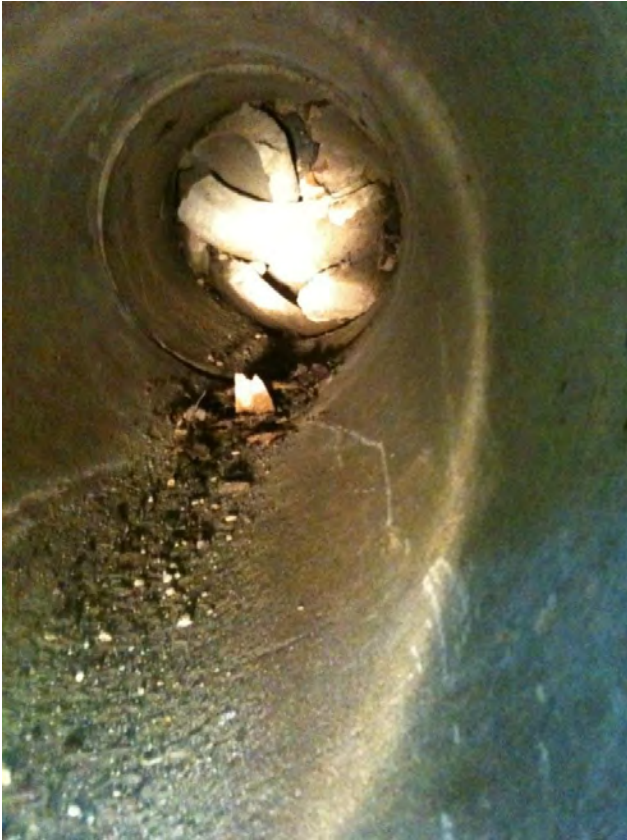
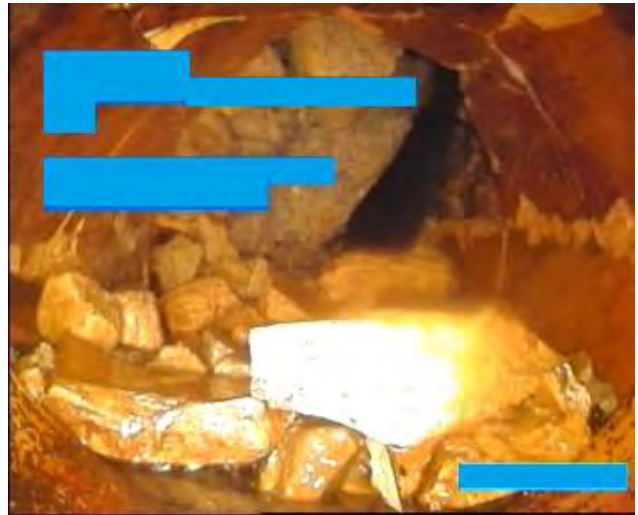
Stormwater Pipes in very poor condition – collapsed and blocked

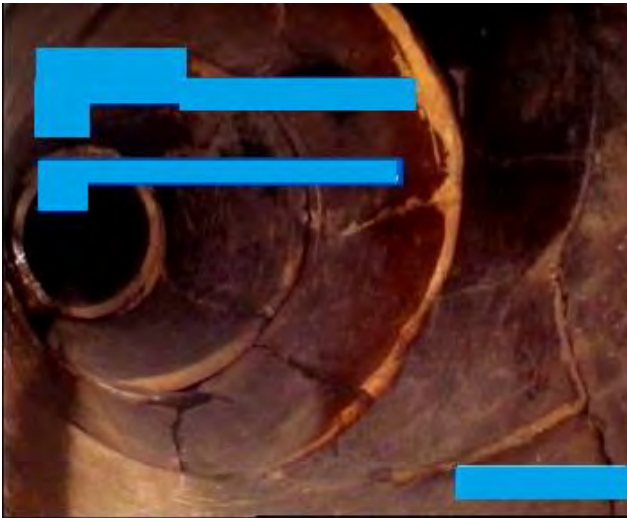
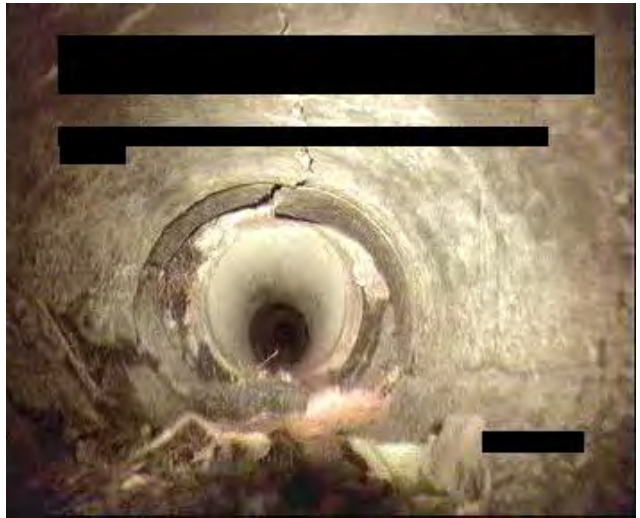
Stormwater Pipes in very poor condition – collapsed and blocked

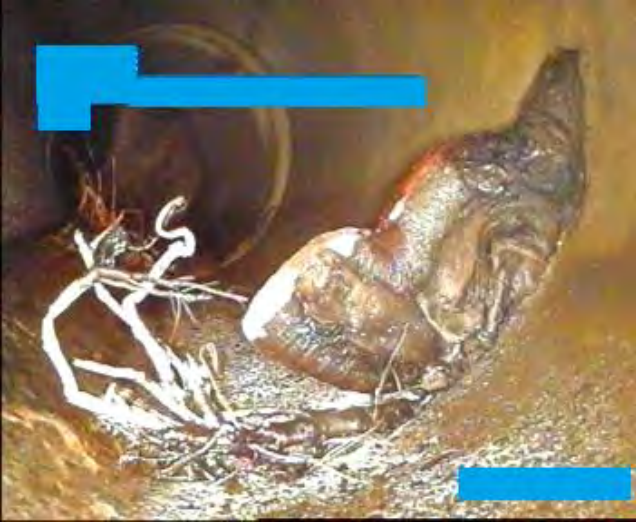
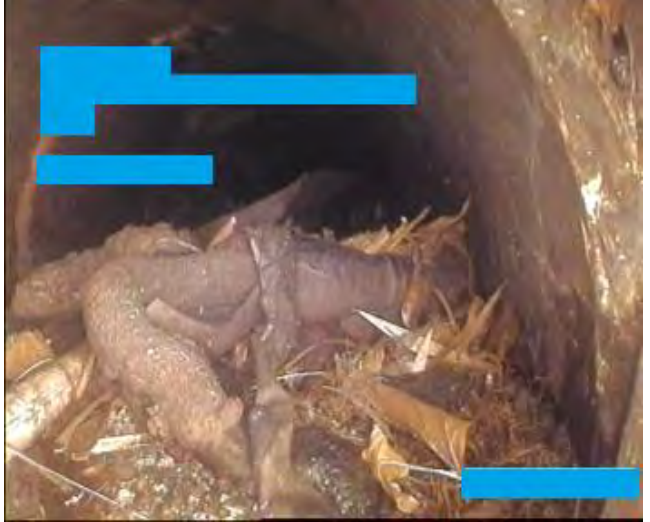
Stormwater Pipes in very poor condition – Tree root infiltrations and blocked

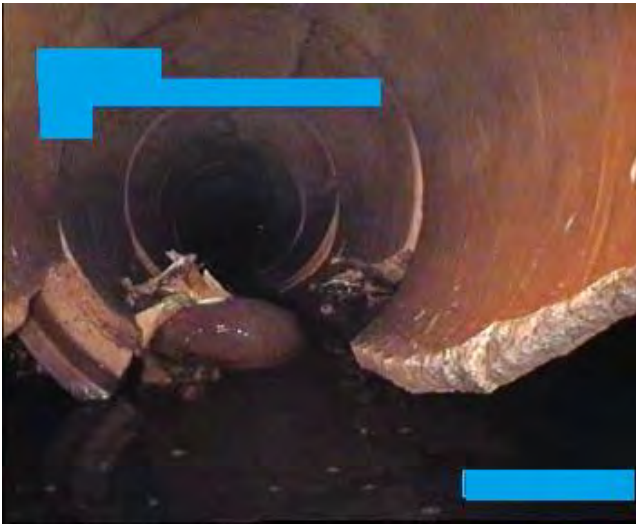
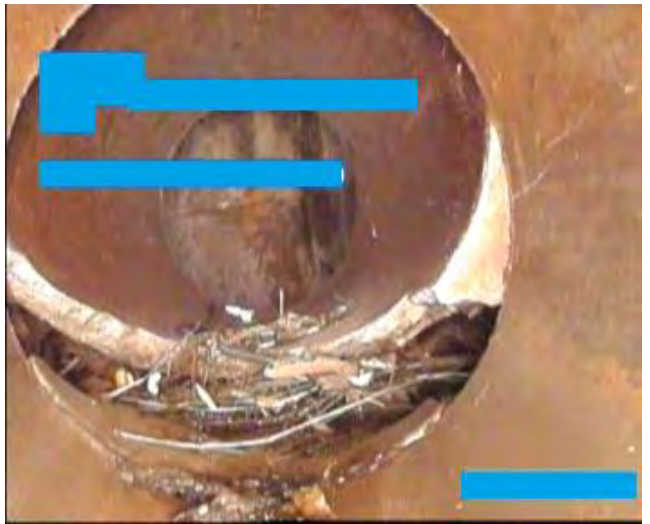
Stormwater Pipes in very poor condition – collapsed

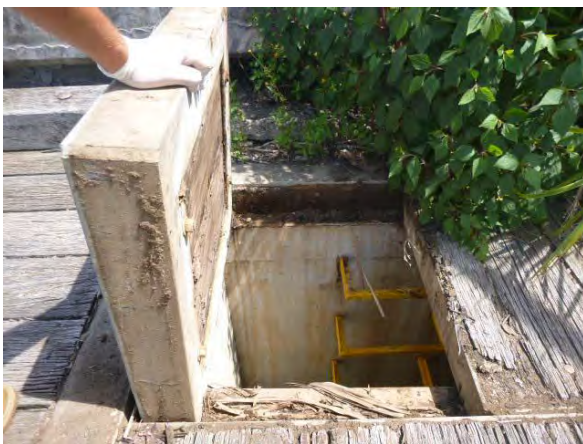
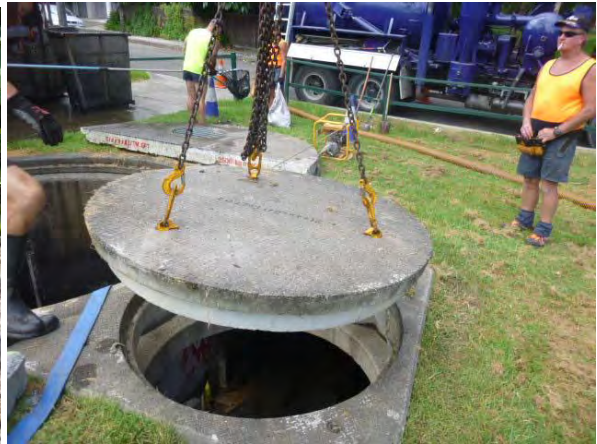
Lids are too heavy - The wood is starting to chip; they should be replaced. Lifting points rusted or broken off

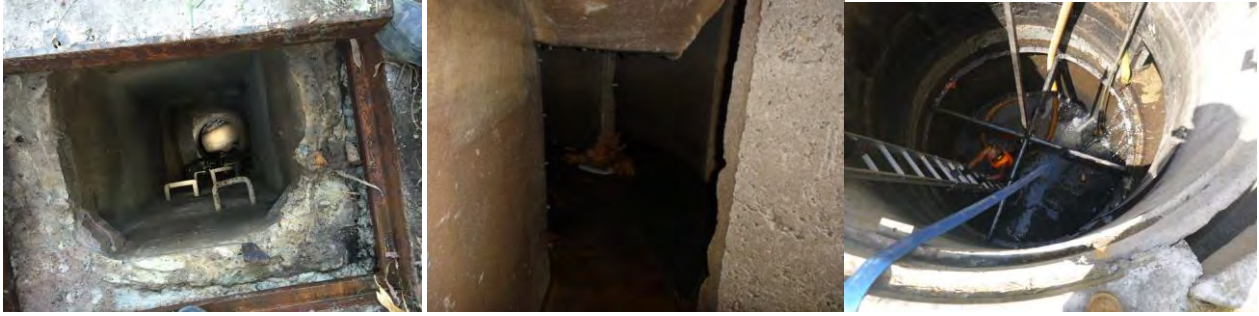
Difficult access to a lot of pits

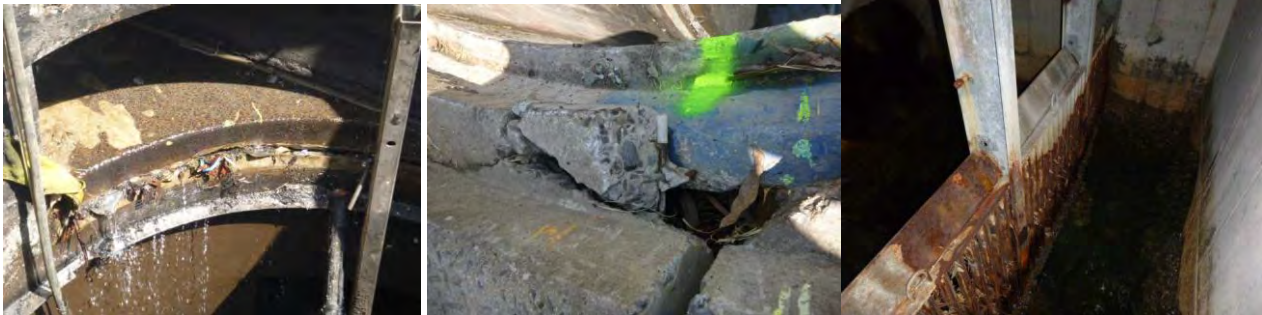
Corrosion and structural damage to a number of pits

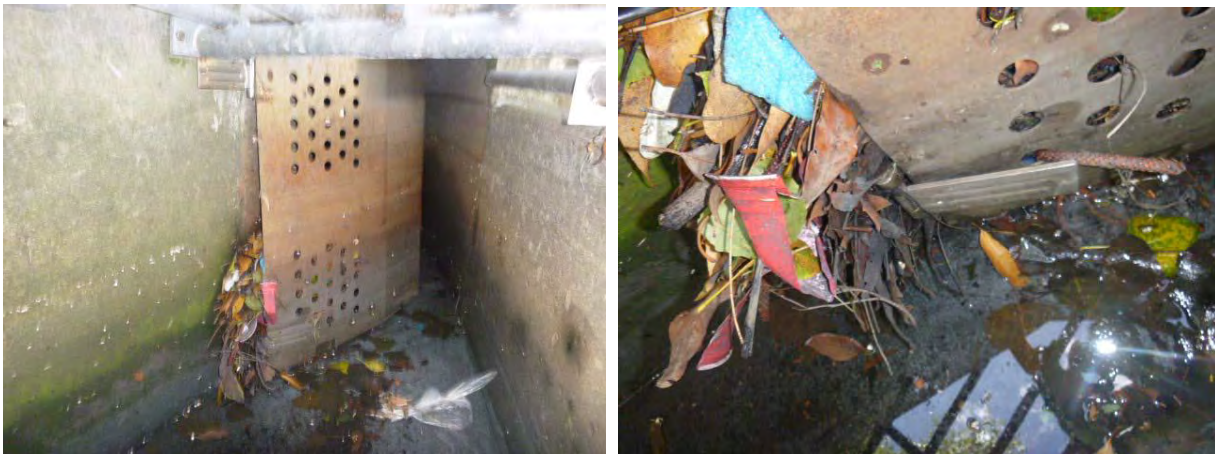
The floatables flap was jammed open due to a broken hinge and pollution trapped in it stopping it closing.

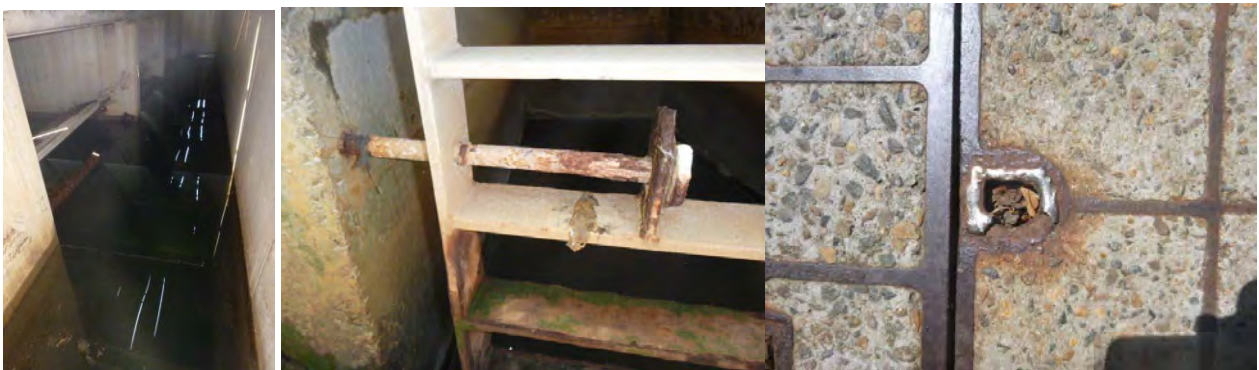
Trashracks is bent over and there is a lot of rust. Exclusion bars are rusting – lifting points are rusting due to the corrosive environment

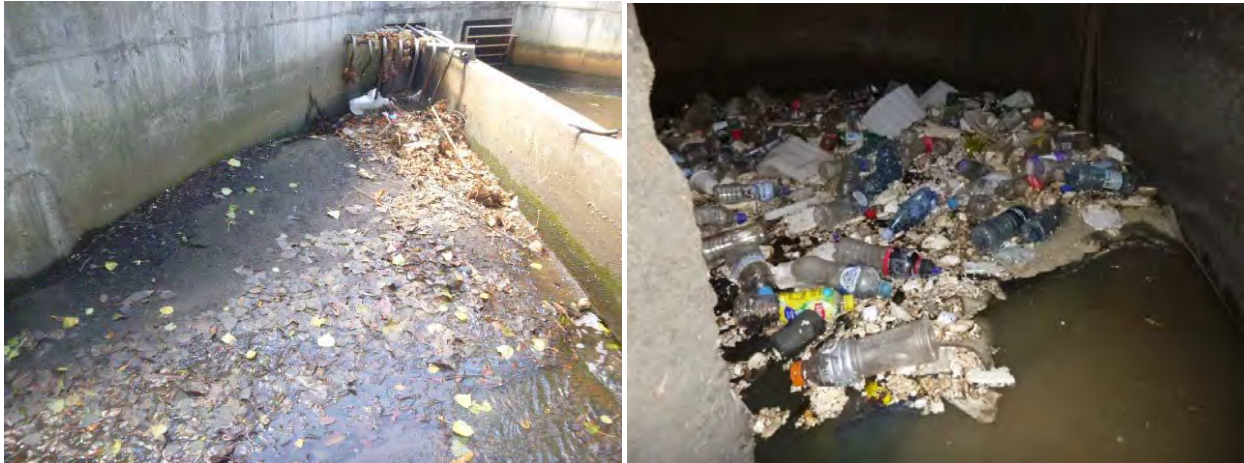
Sediment and trash build up in front of the weir and in pits generally – low capacity.
