## 8.4. Asset Management Plans

The purpose of this report is to seek adoption of Council's Asset Management Plans suite in accordance with Integrated Planning & Reporting (IP&R) requirements.

NORTH SYDNEY COUNCIL  
**ASSET MANAGEMENT PLAN**  
**BUS SHELTERS 2022-2032**

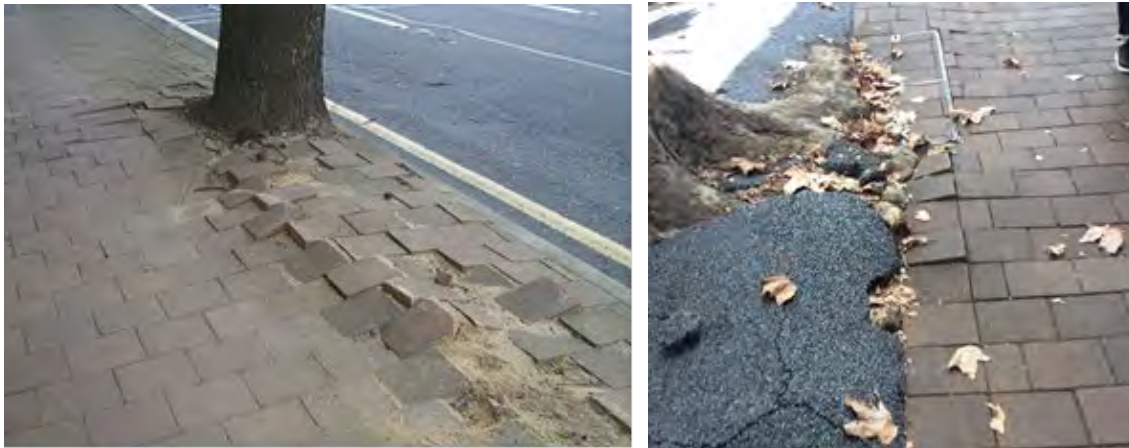
Concrete footpath in poor condition

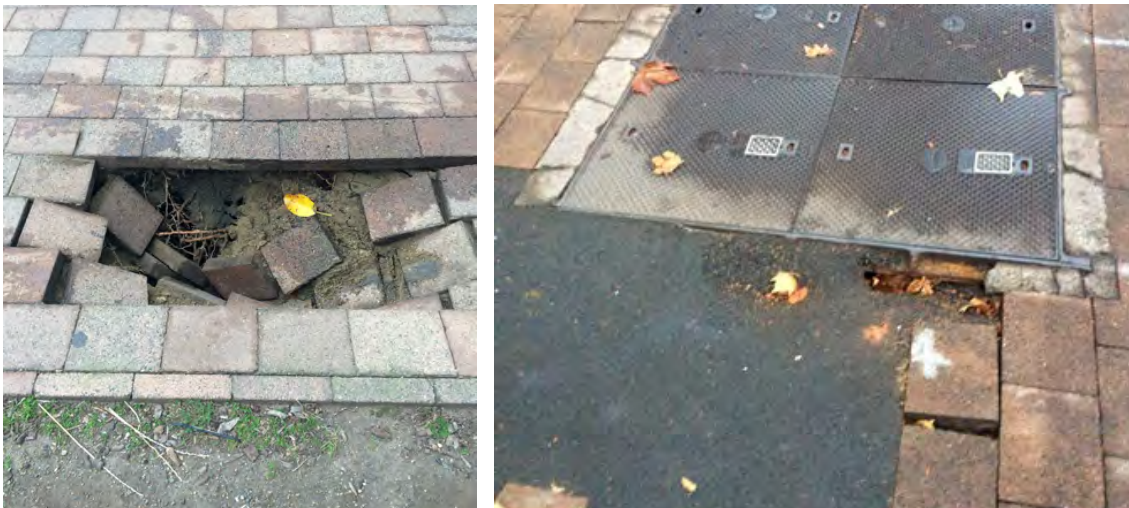
Tree root affected concrete footpath including ponding

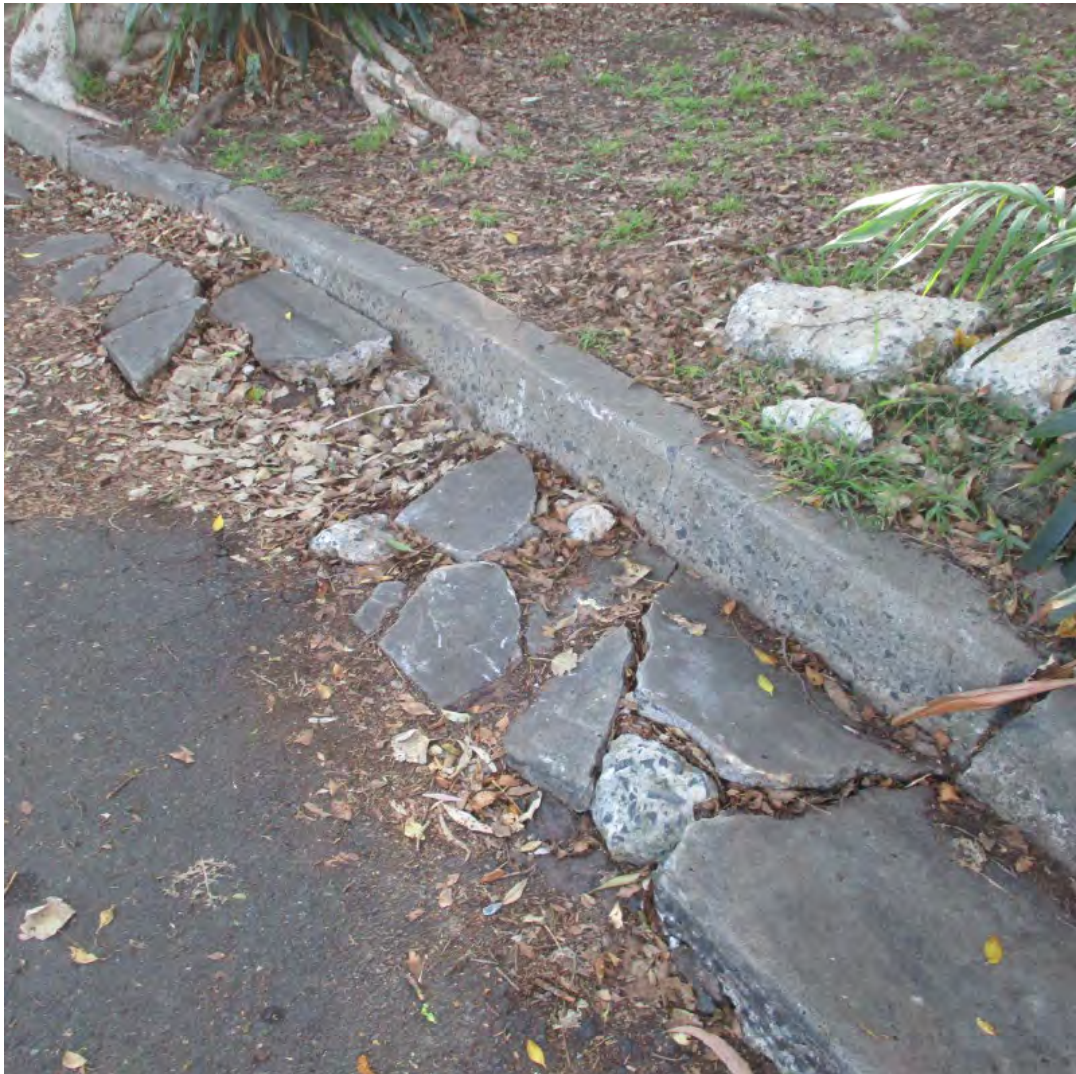
Examples of failed and failing Kerb and Gutter in the North Sydney LGA

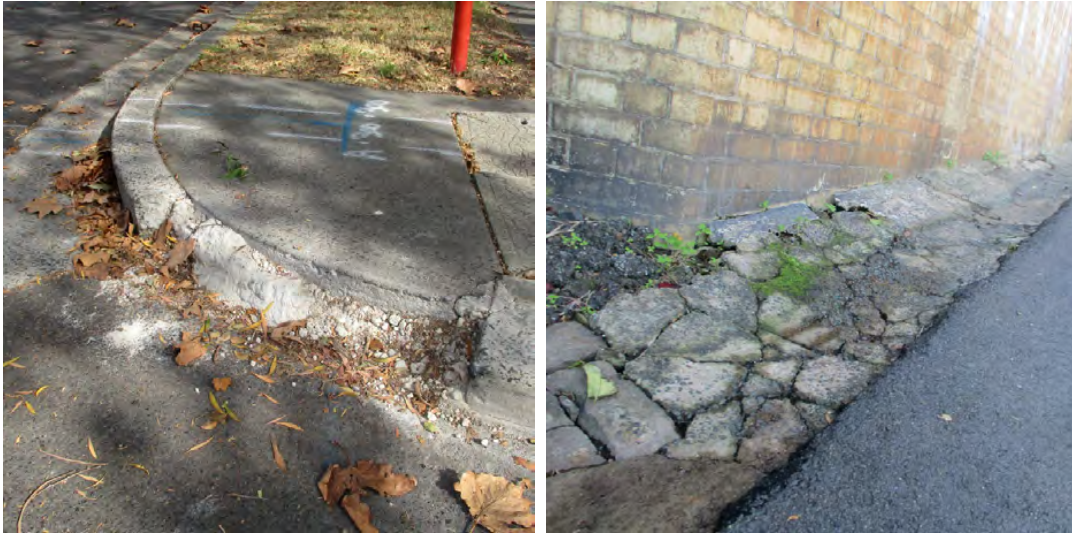
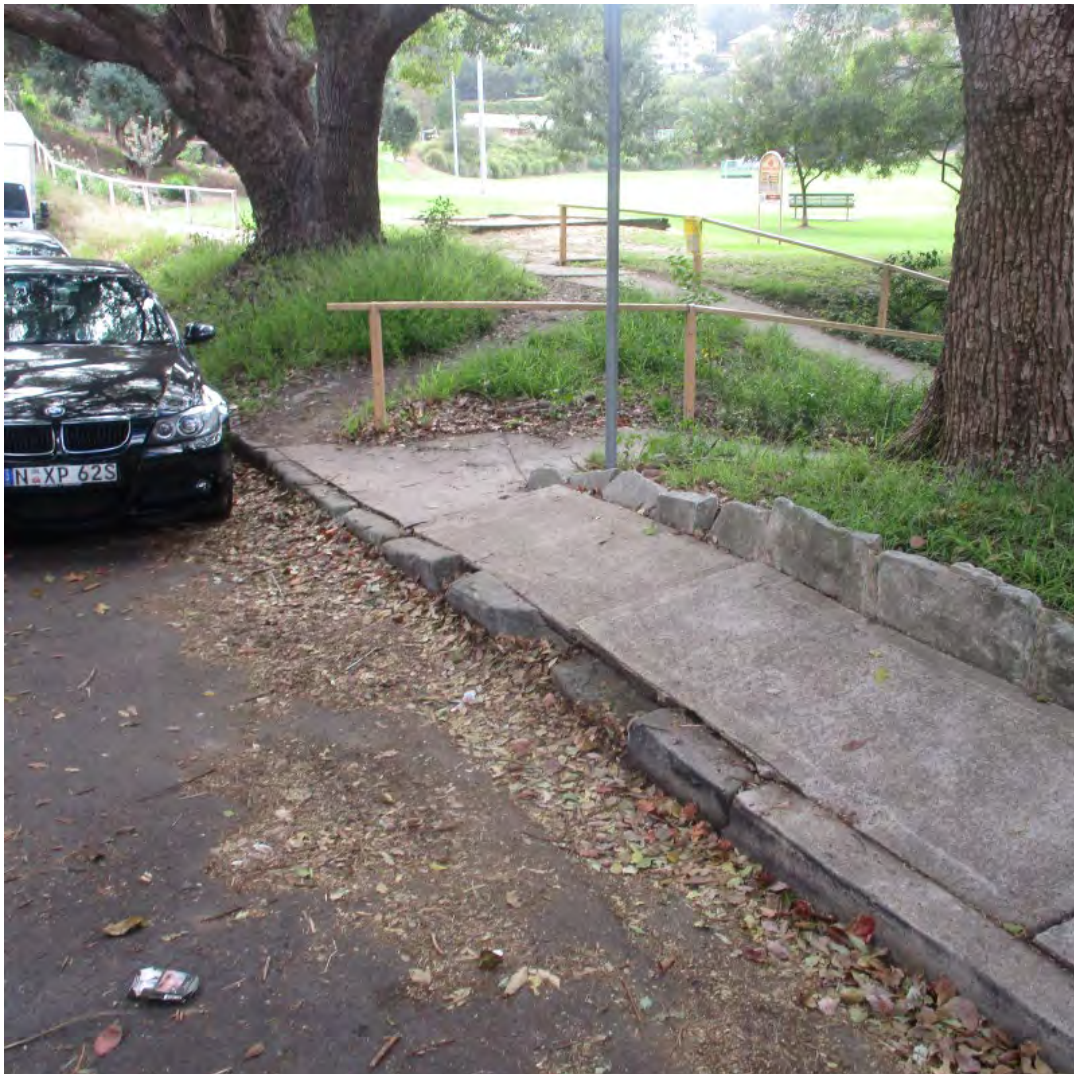
Examples of failed Kerb and Gutter in the North Sydney LGA

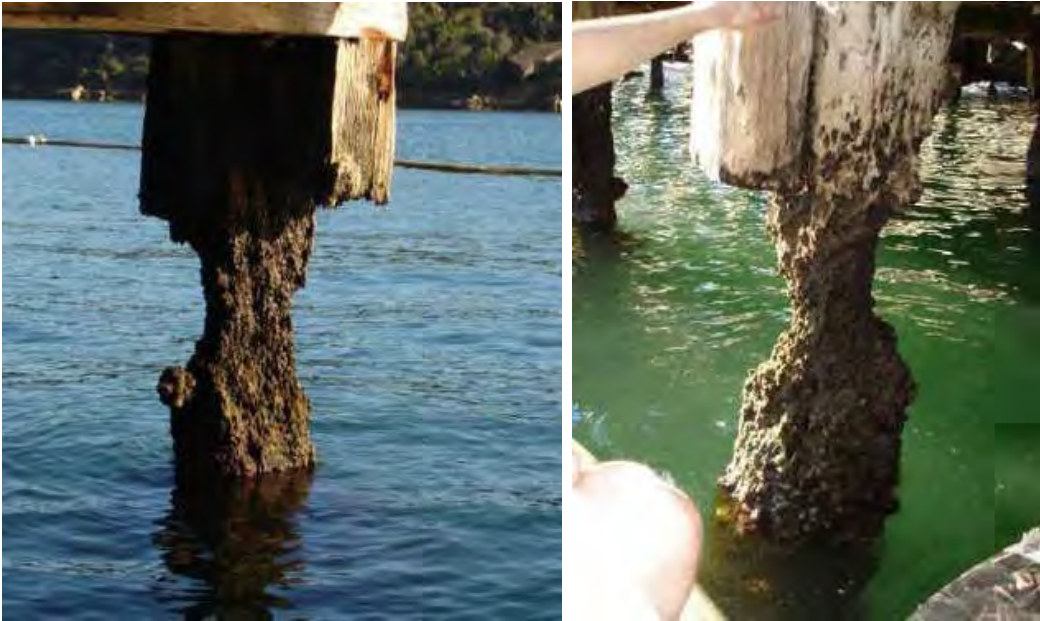
Examples timber piles – Hayes Street Boardwalk – Currently closed

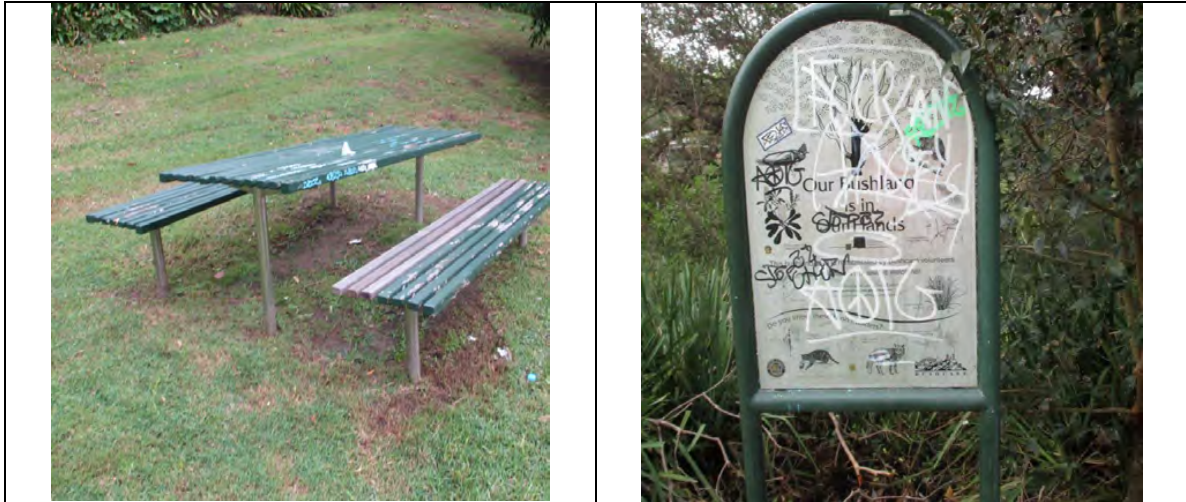
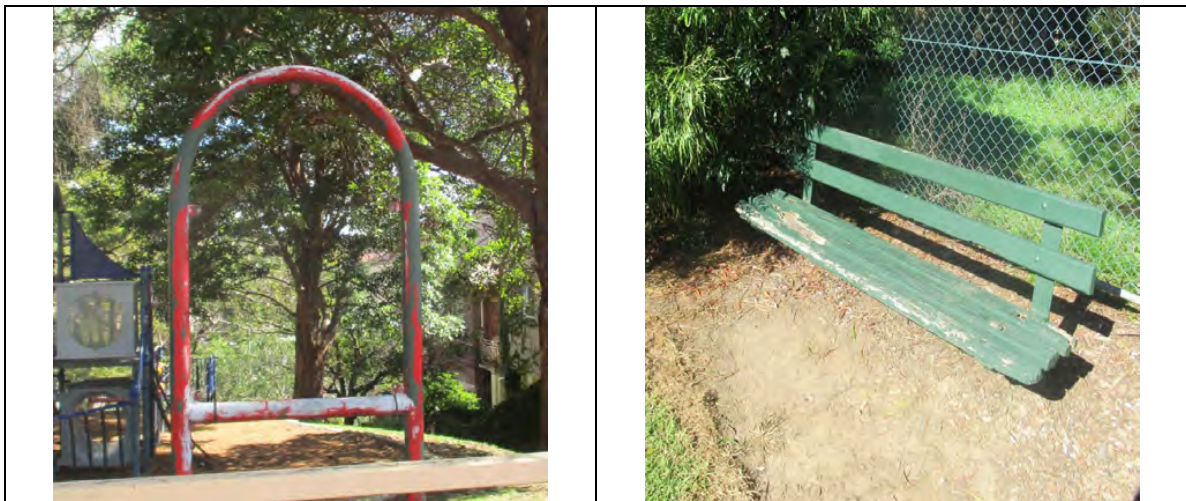
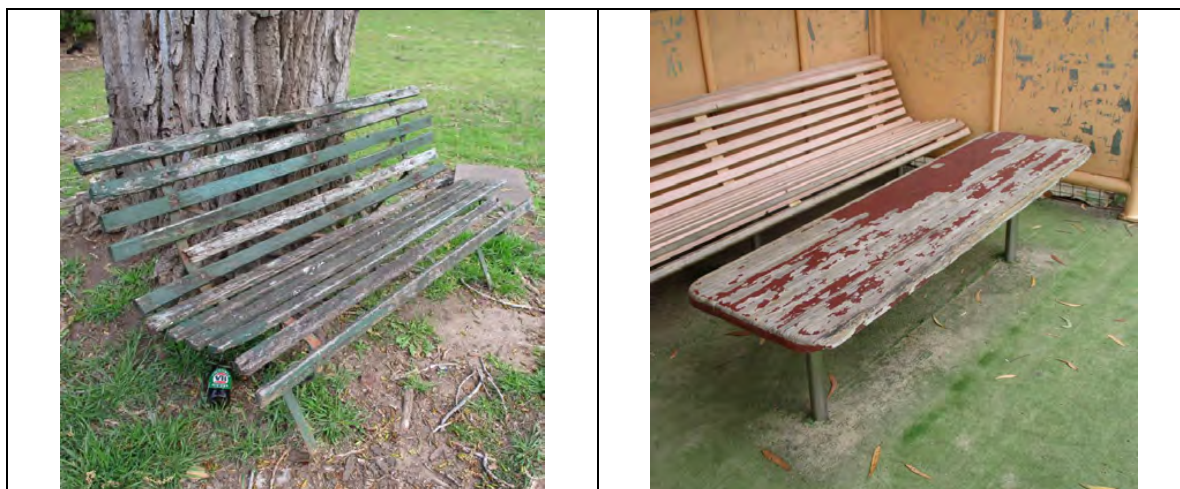
Examples of failed and failing Park Furniture, Playgrounds, Sporting Infrastructure assets in the North Sydney LGA

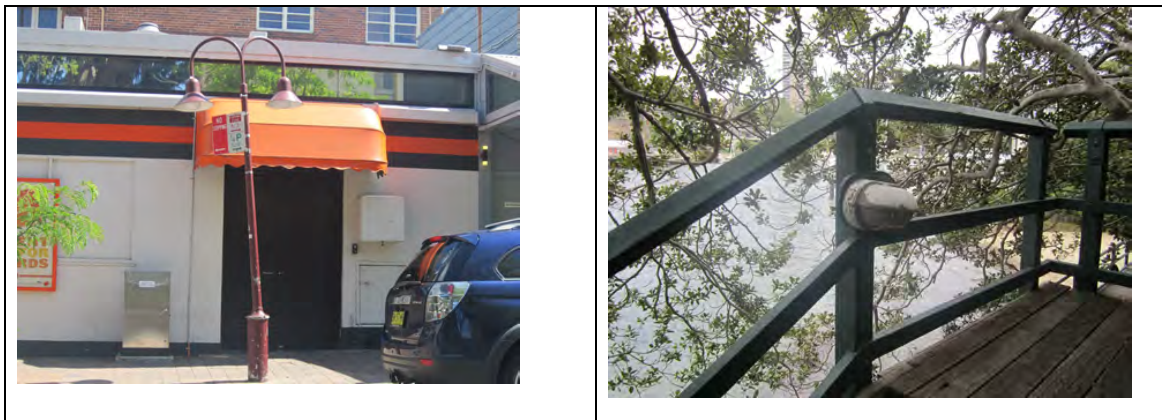
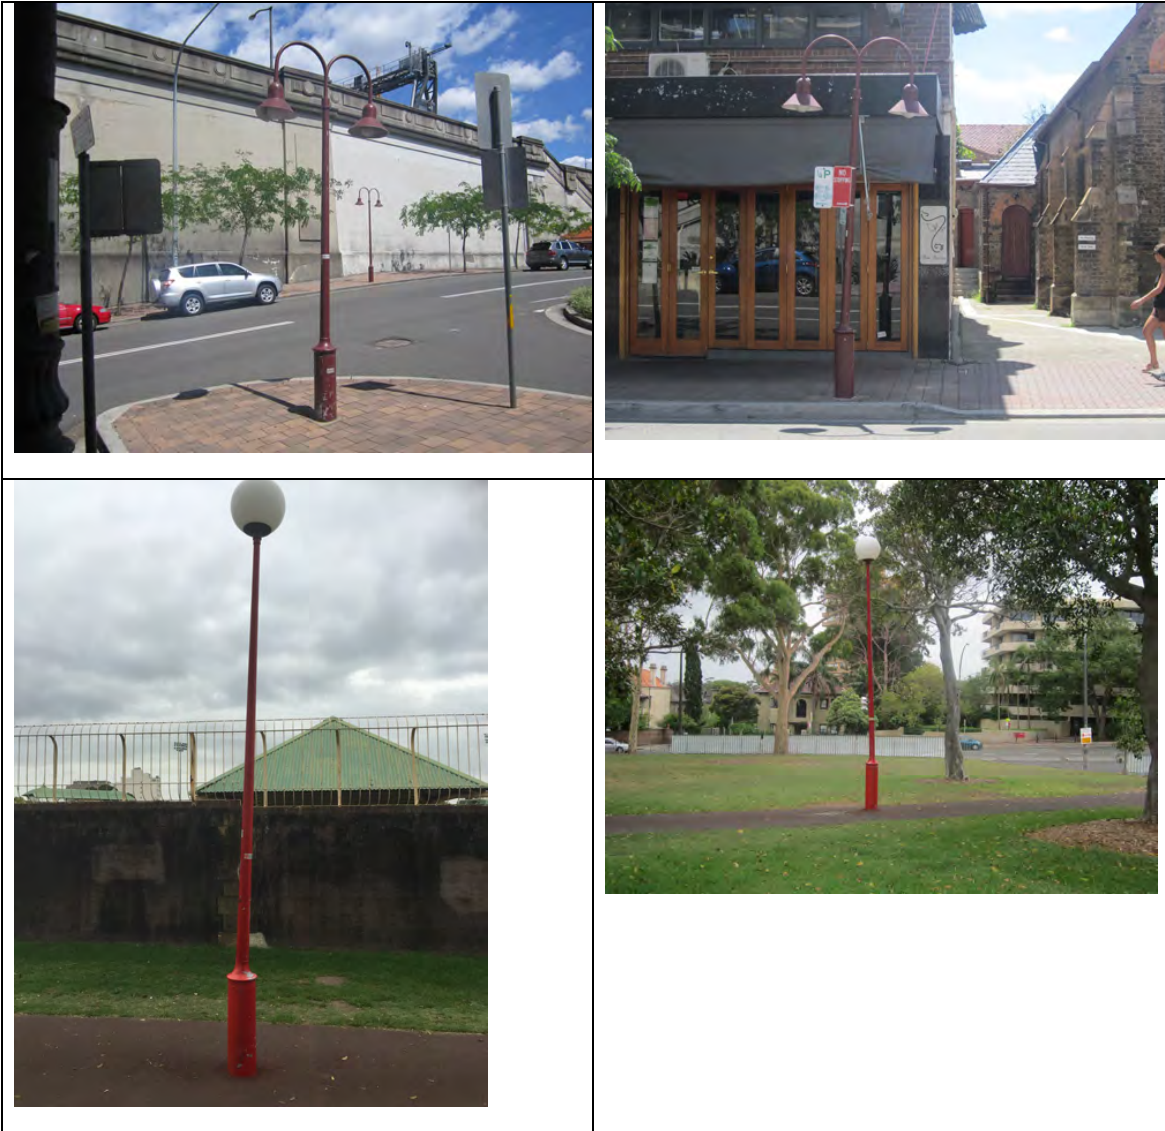
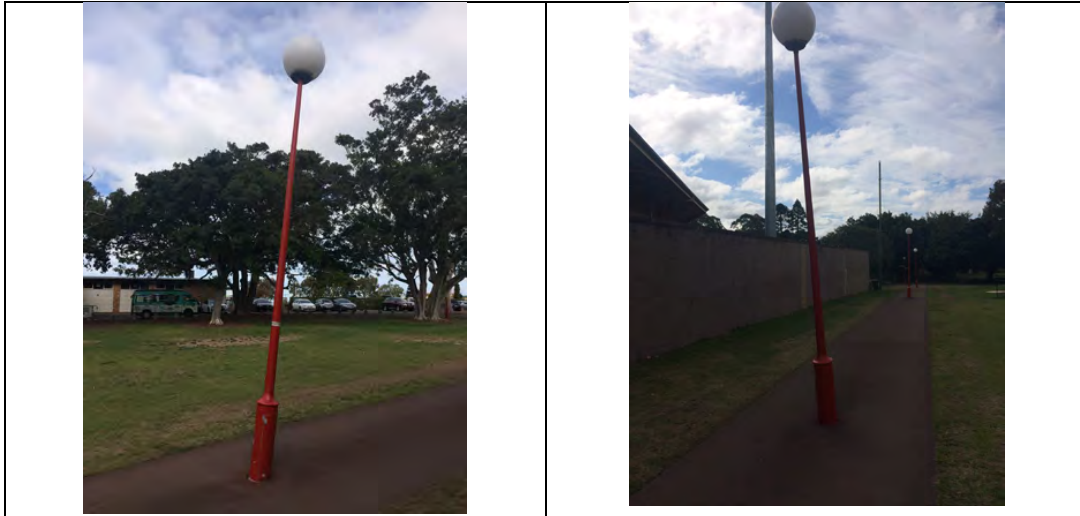
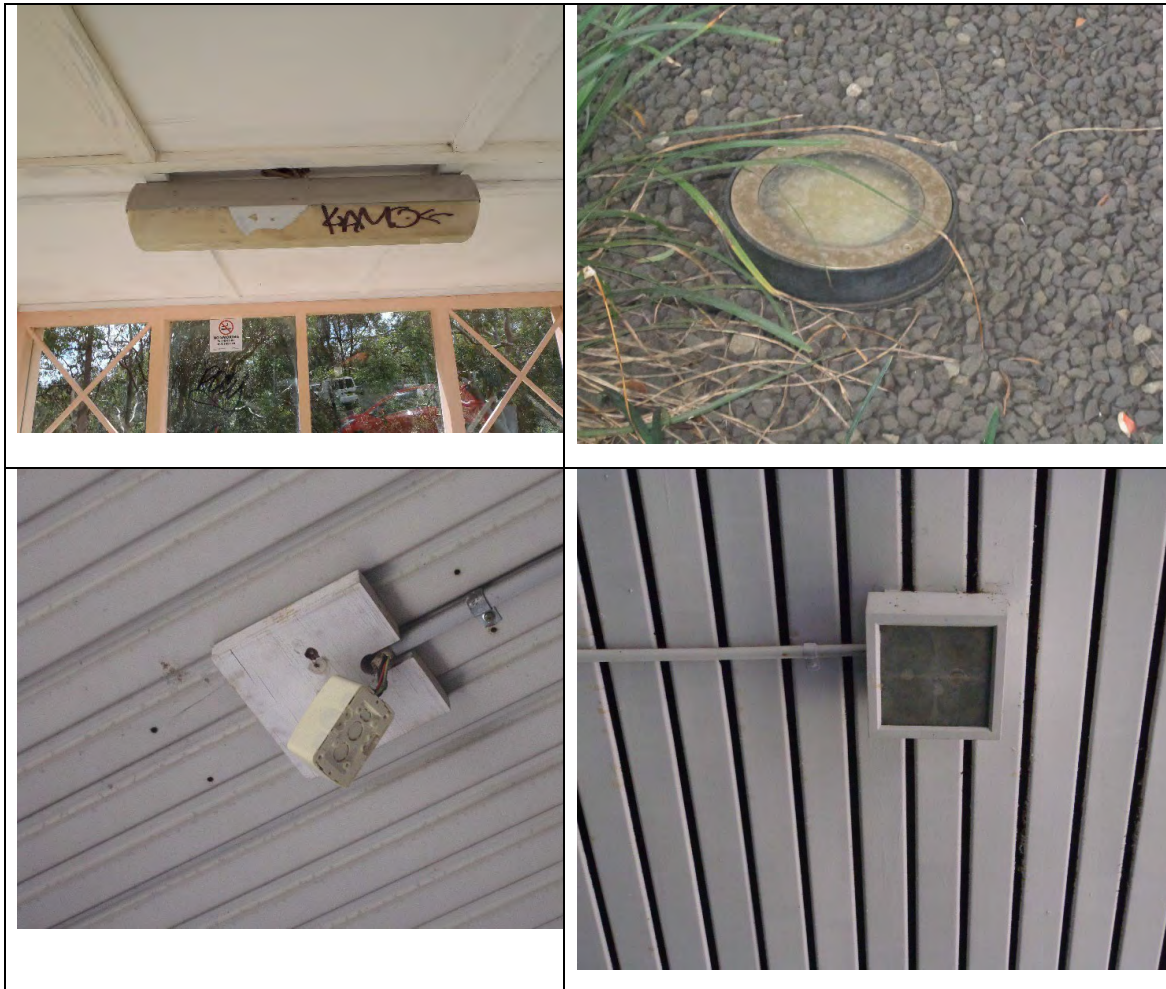
**Examples of Lighting Assets in Poor Condition**

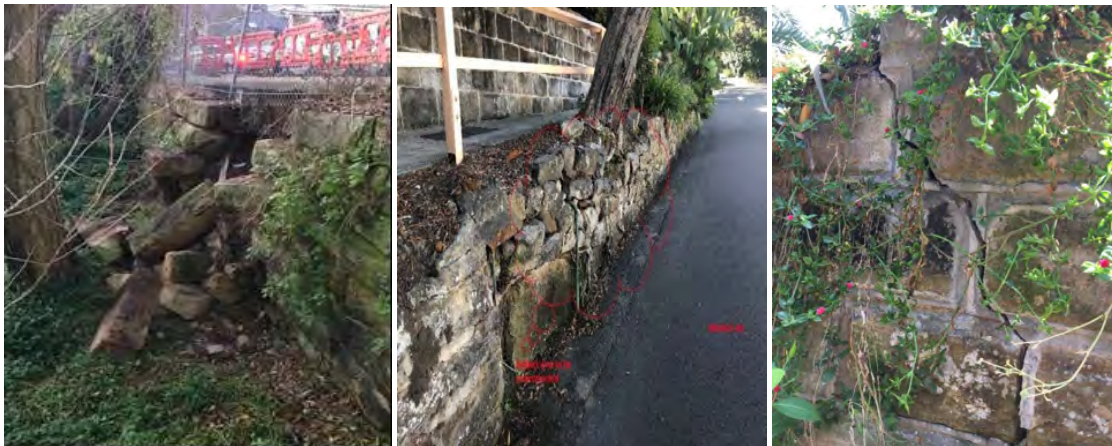
Examples of failed and failing retaining walls in the North Sydney LGA

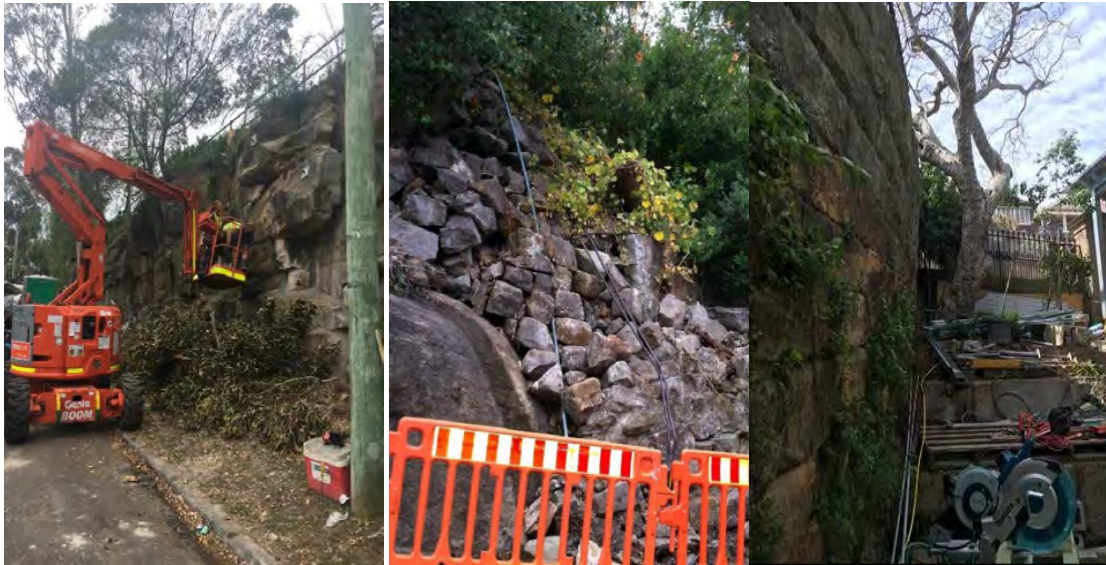
Examples of failed and failing retaining walls in the North Sydney LGA

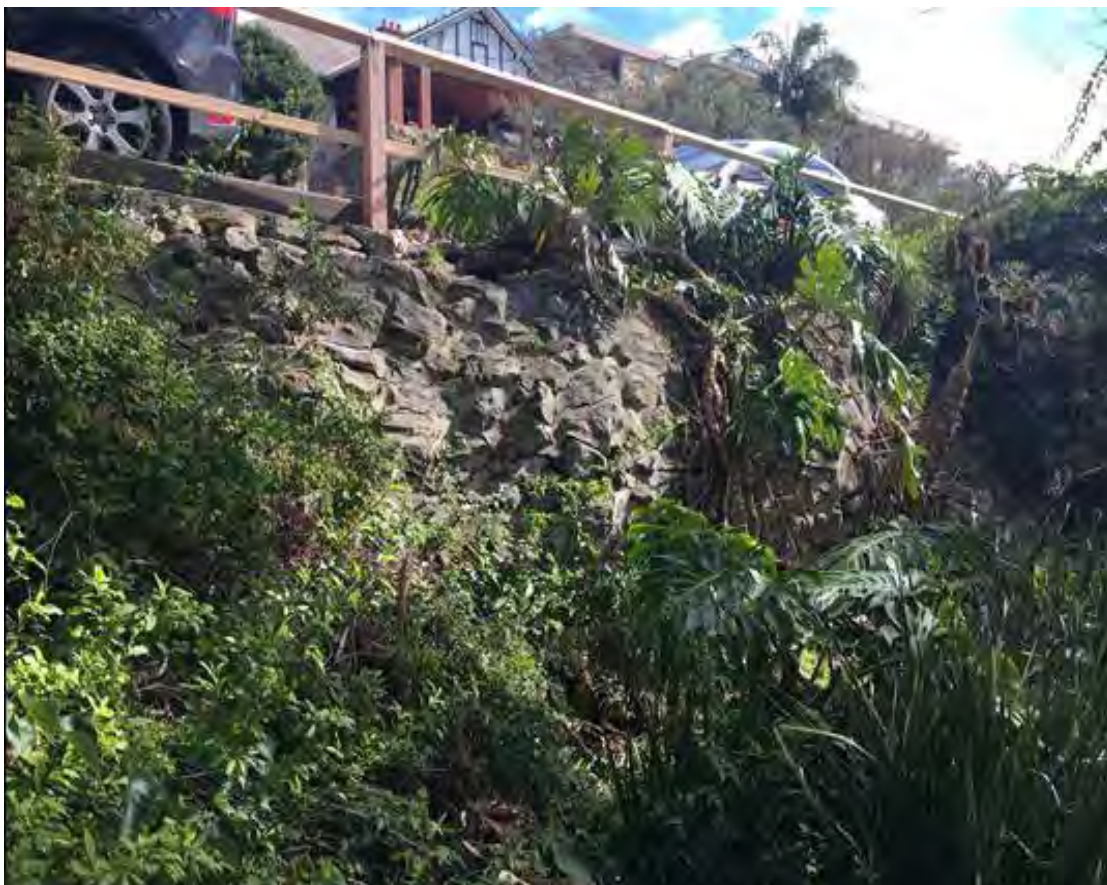
Examples of failed and failing retaining walls in the North Sydney LGA

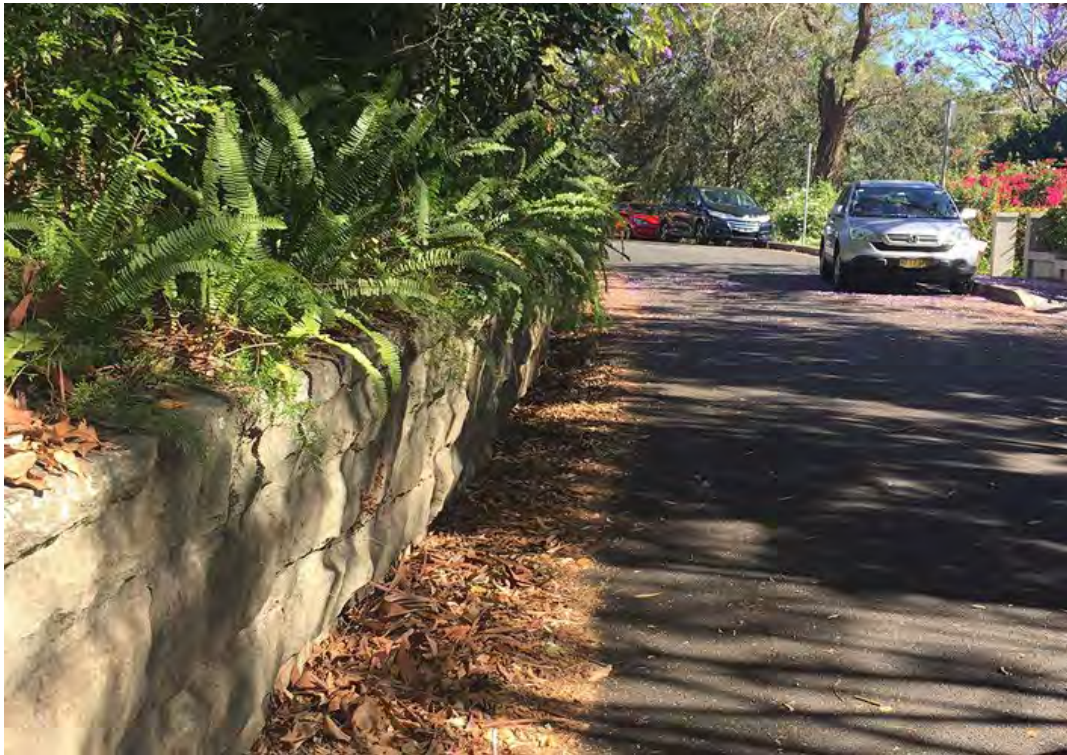
Examples of failed and failing retaining walls in the North Sydney LGA

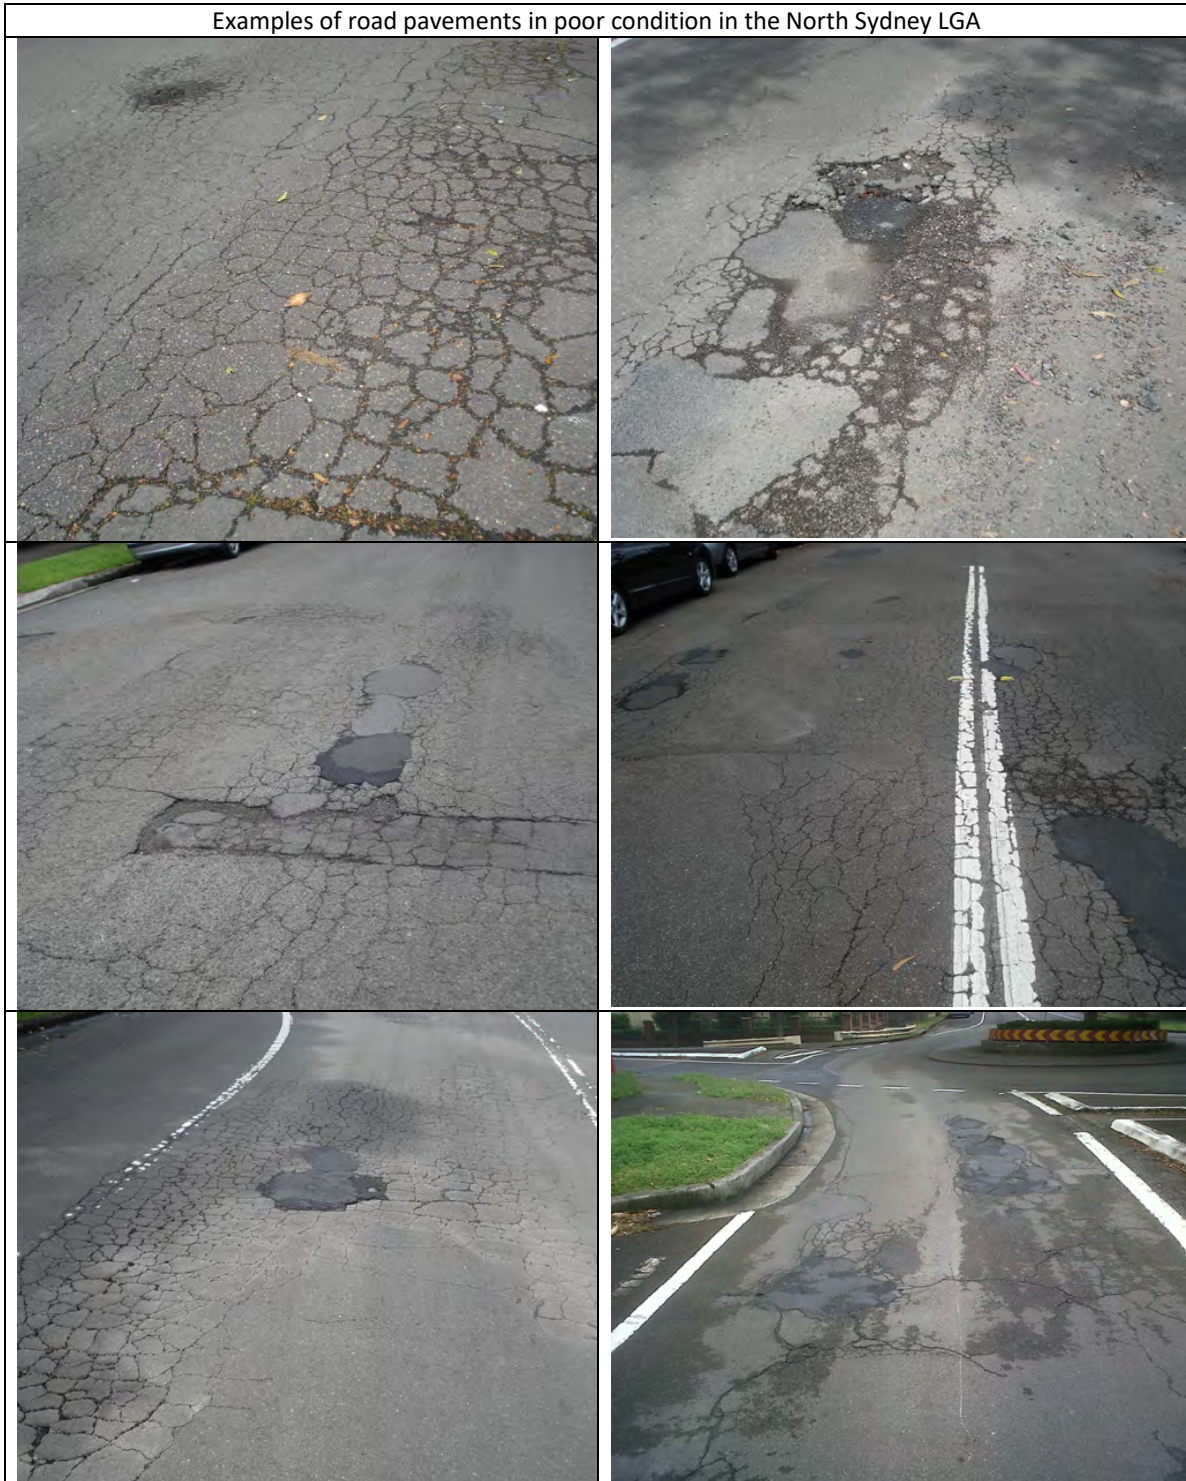
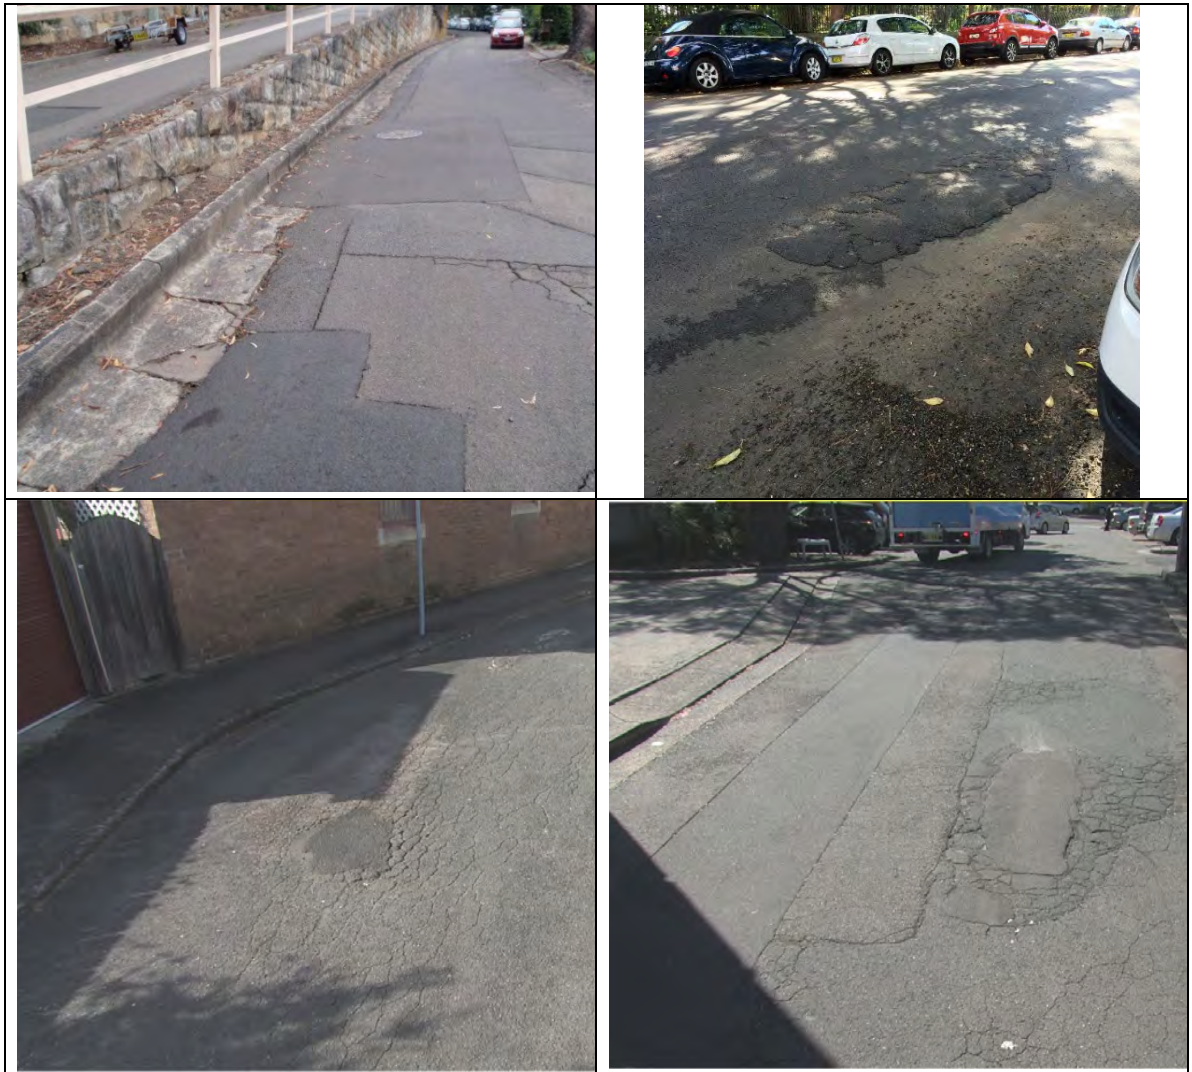
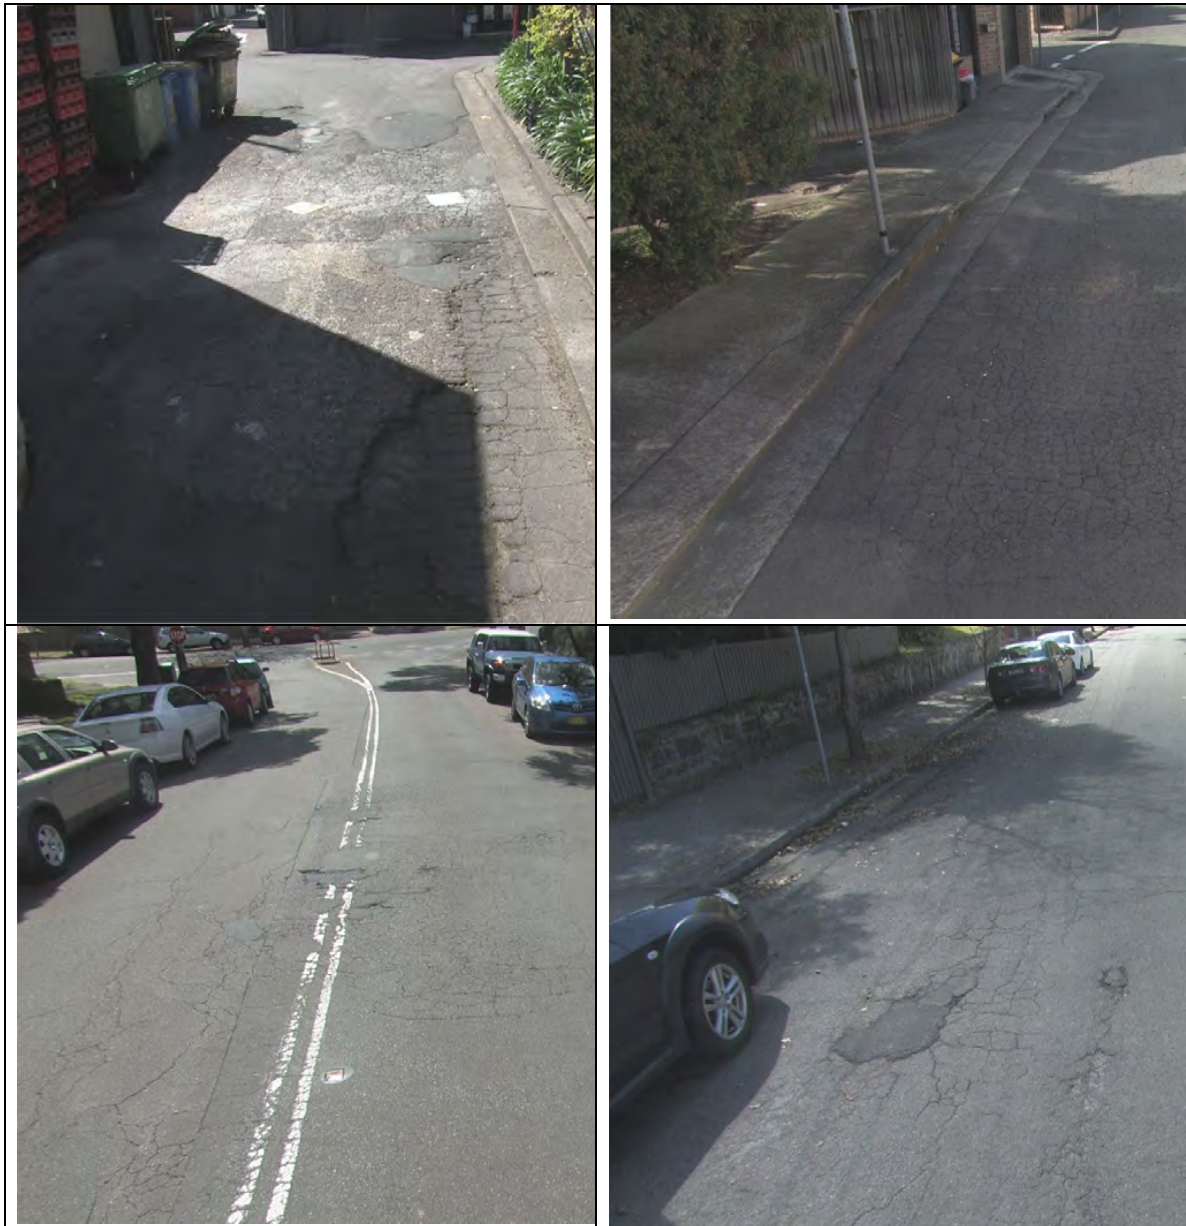
Examples of road pavements in poor condition in the North Sydney LGA

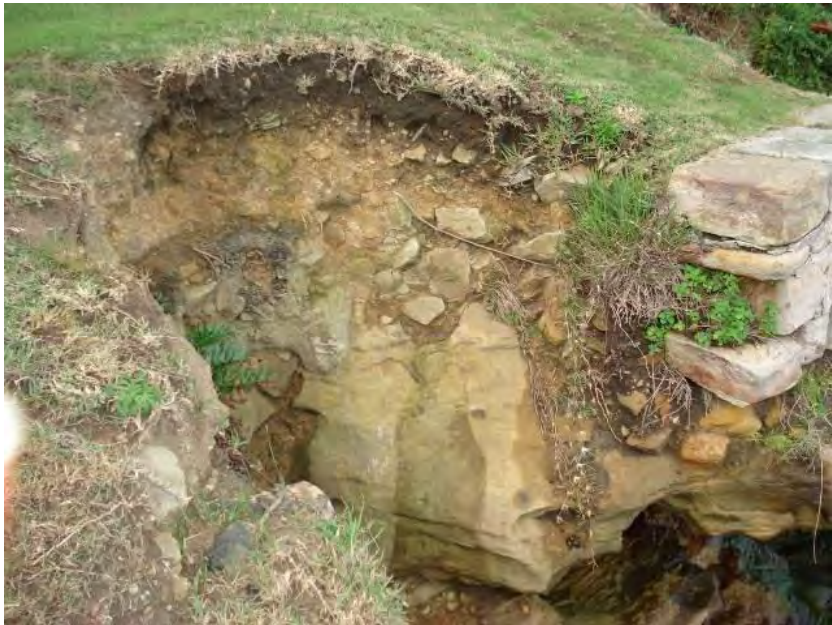
Examples of failed and failing seawalls in the North Sydney LGA – Cremorne Point

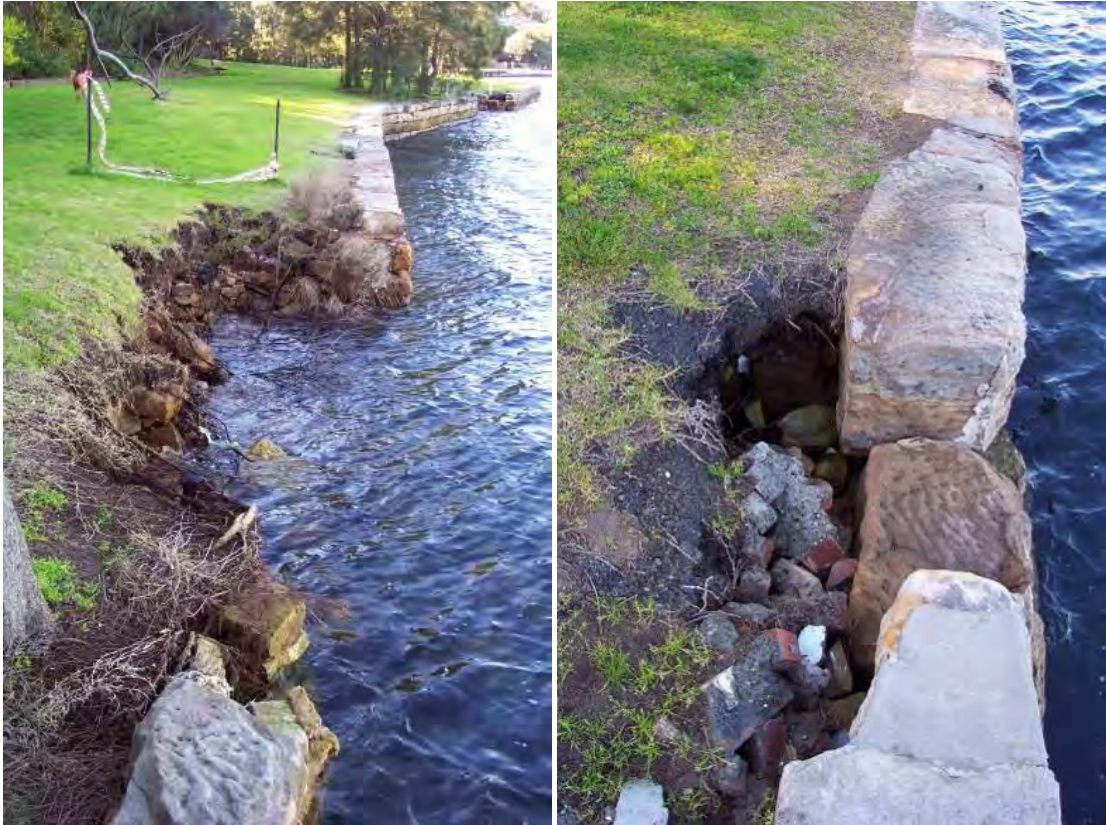
Examples of failed and failing seawalls in the North Sydney LGA – Sawmillers Reserve

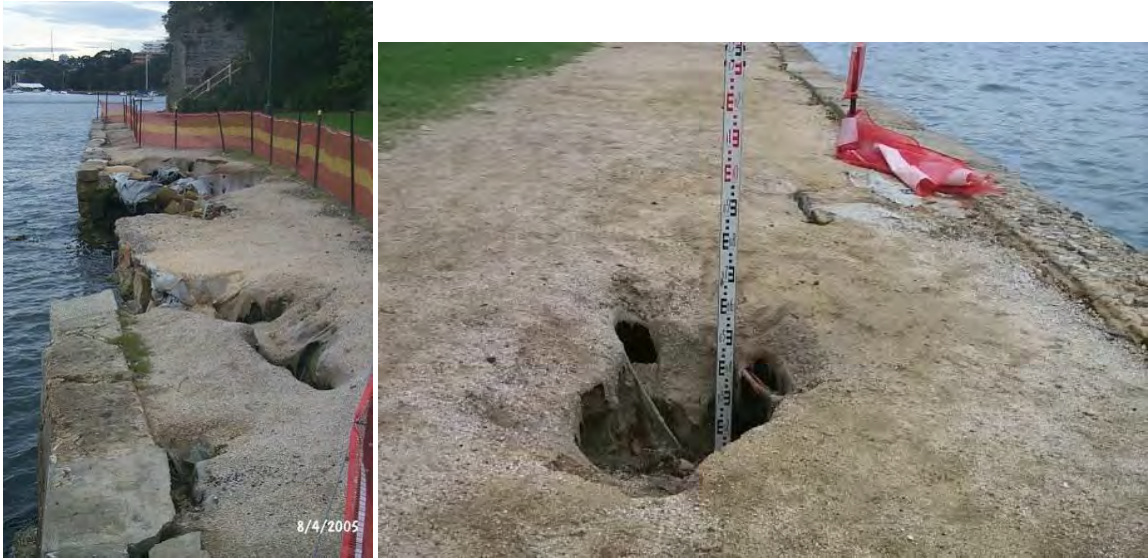
Examples of failed and failing seawalls in the North Sydney LGA – Blues Point

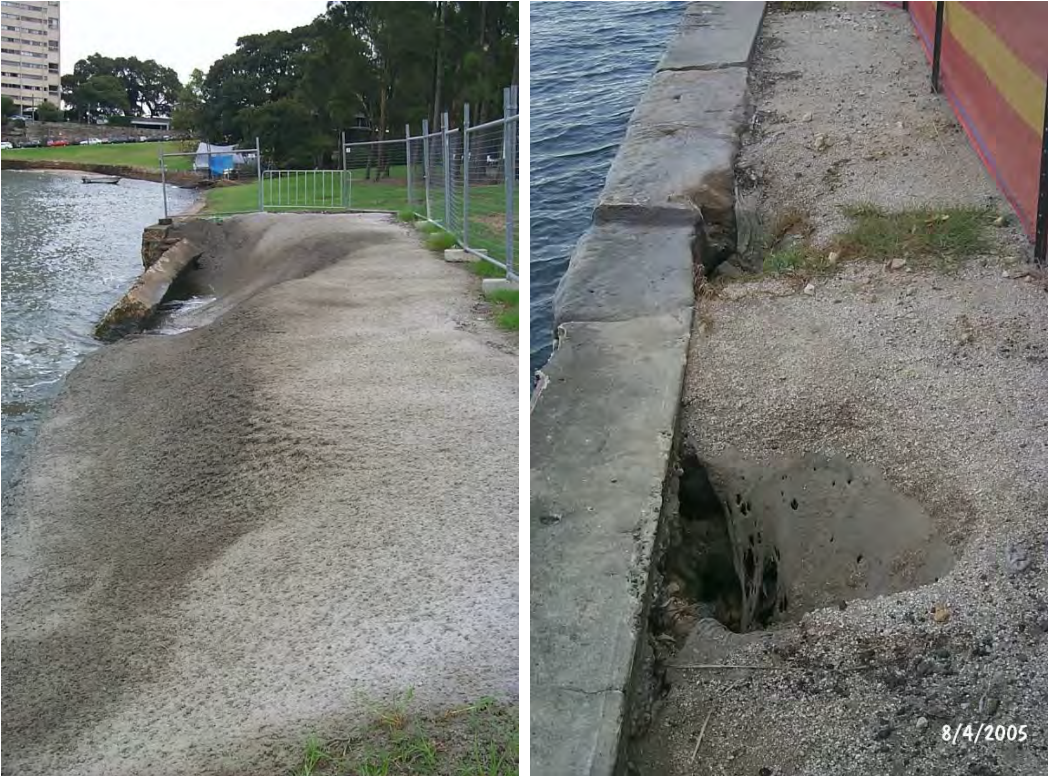
Examples of failed and failing seawalls in the North Sydney LGA – McMahons Point
