## 8.4. Asset Management Plans

The purpose of this report is to seek adoption of Council's Asset Management Plans suite in accordance with Integrated Planning & Reporting (IP&R) requirements.

NORTH SYDNEY COUNCIL  
**ASSET MANAGEMENT PLAN**  
**BUS SHELTERS 2022-2032**

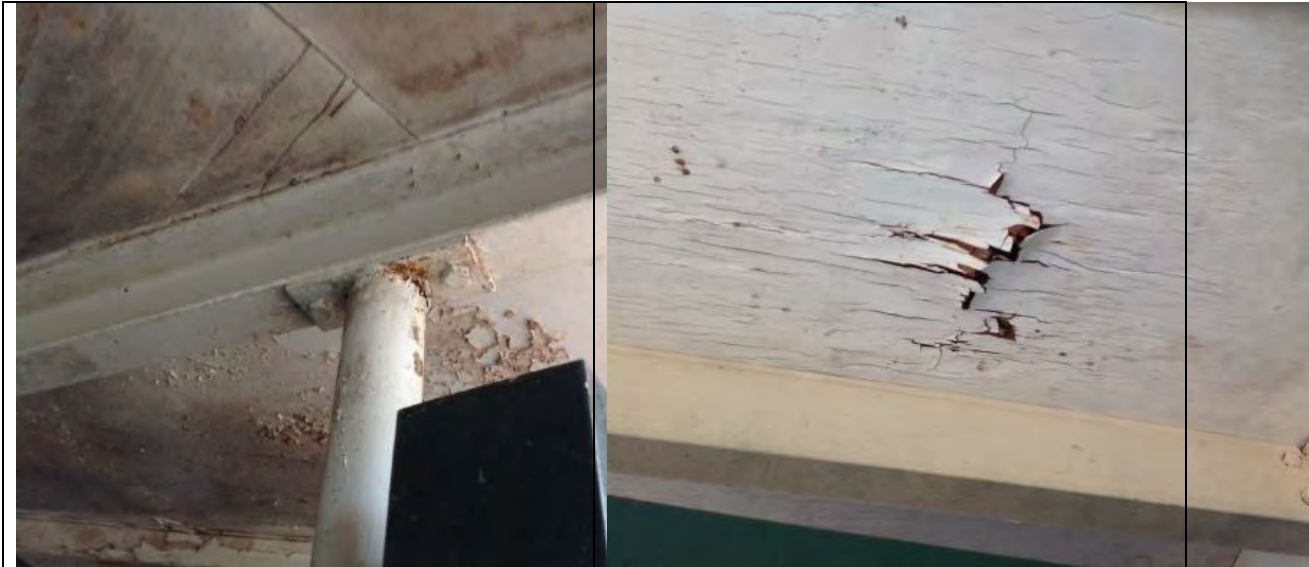
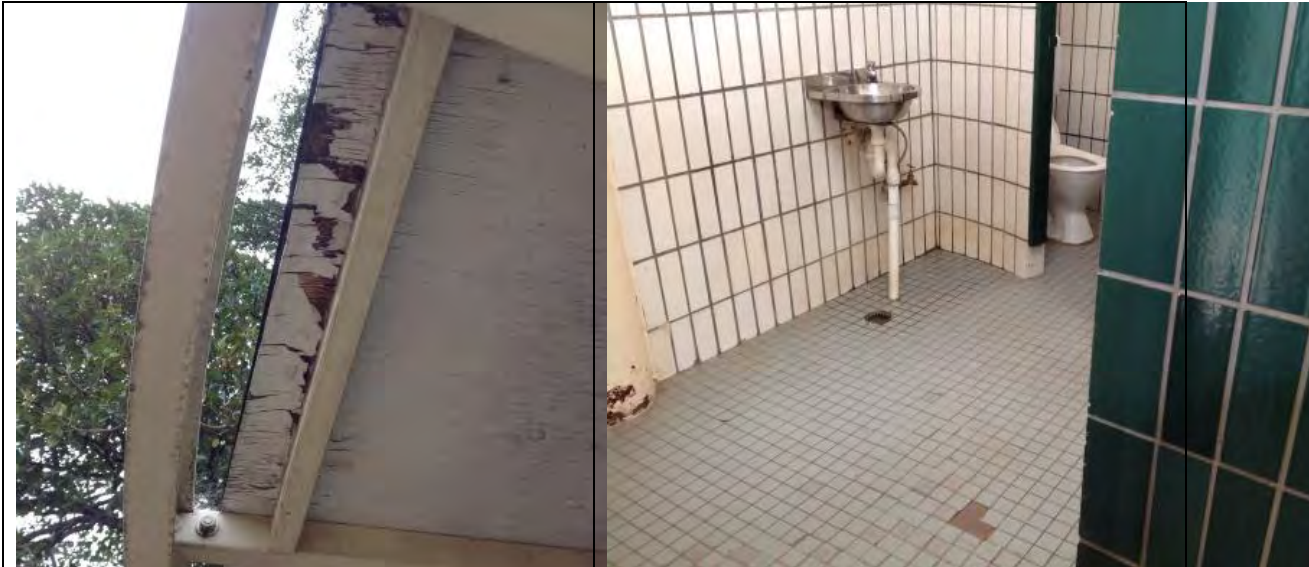
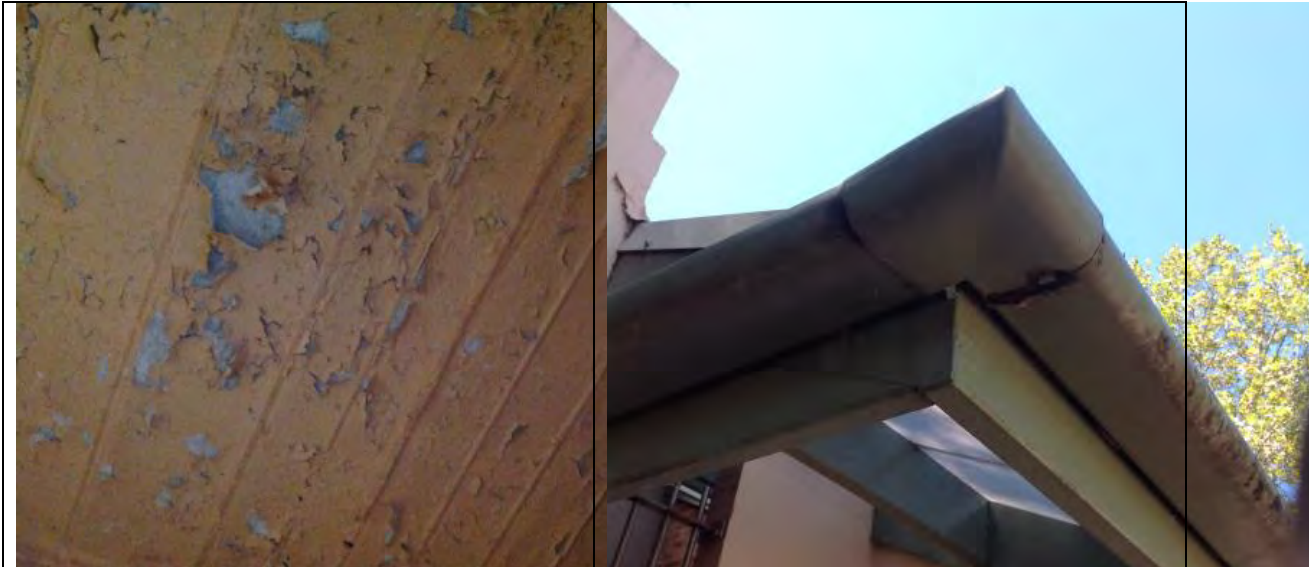
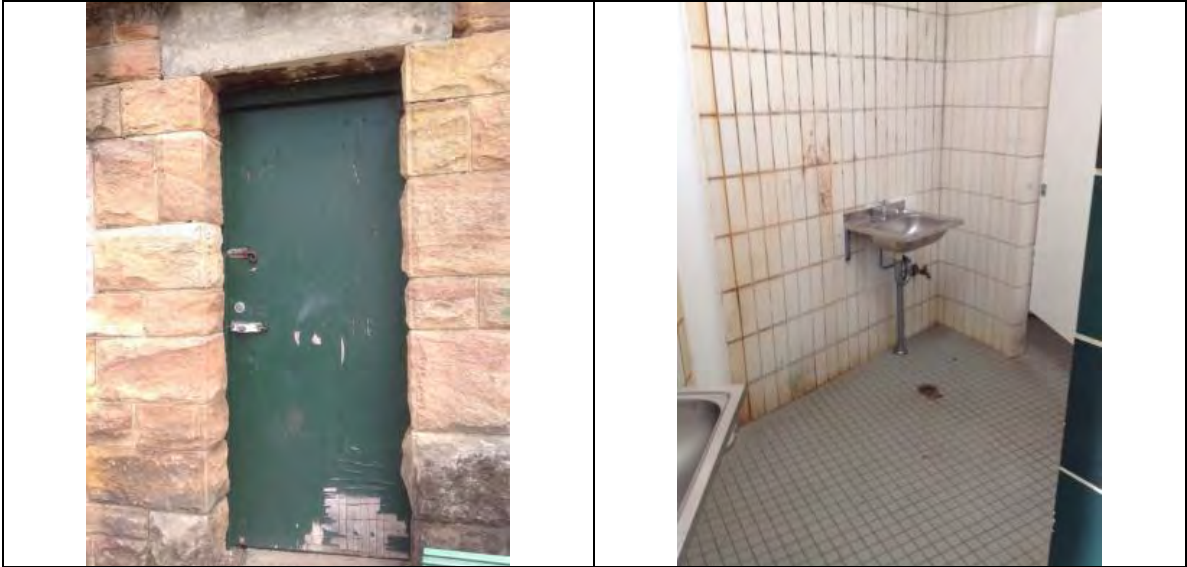
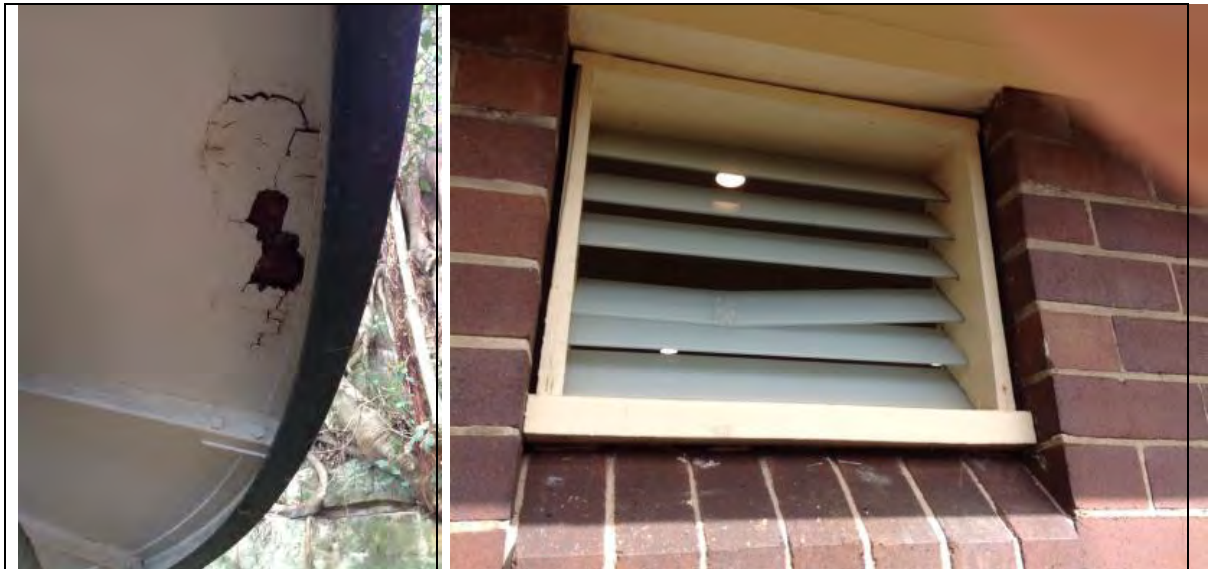
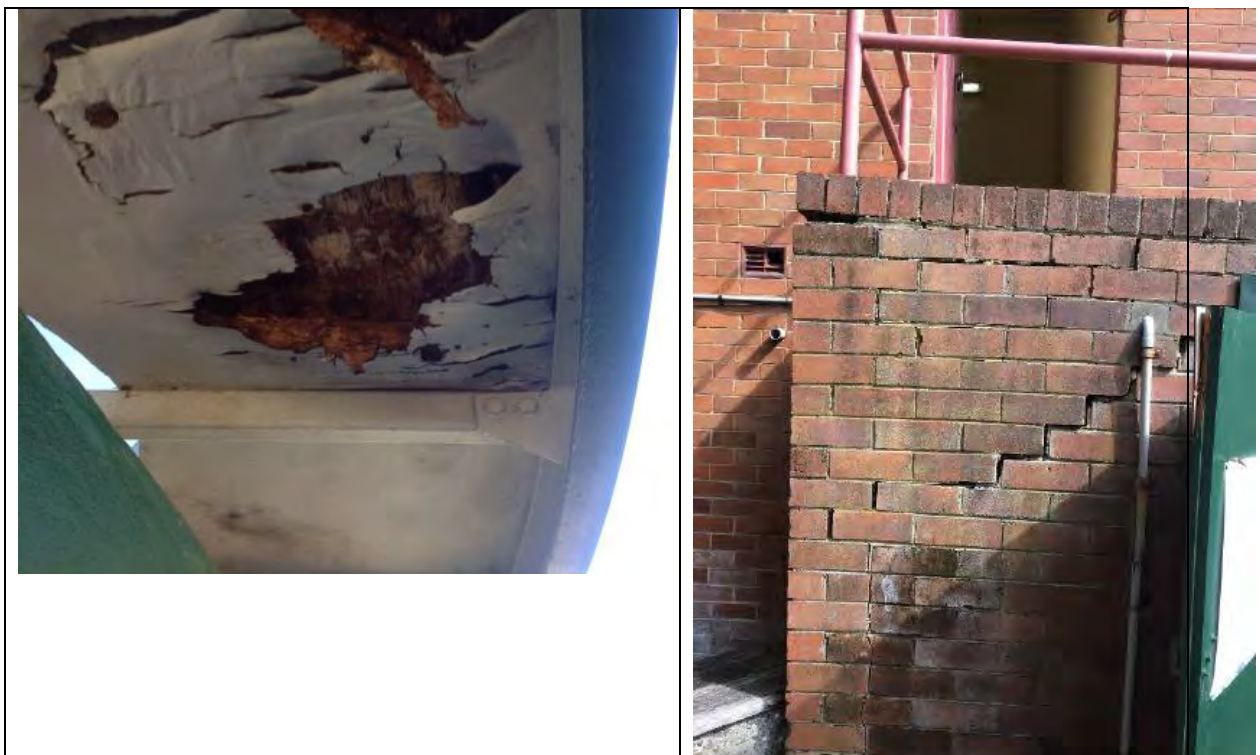
Examples of defects in Specialised Buildings (Amenities) in the North Sydney LGA

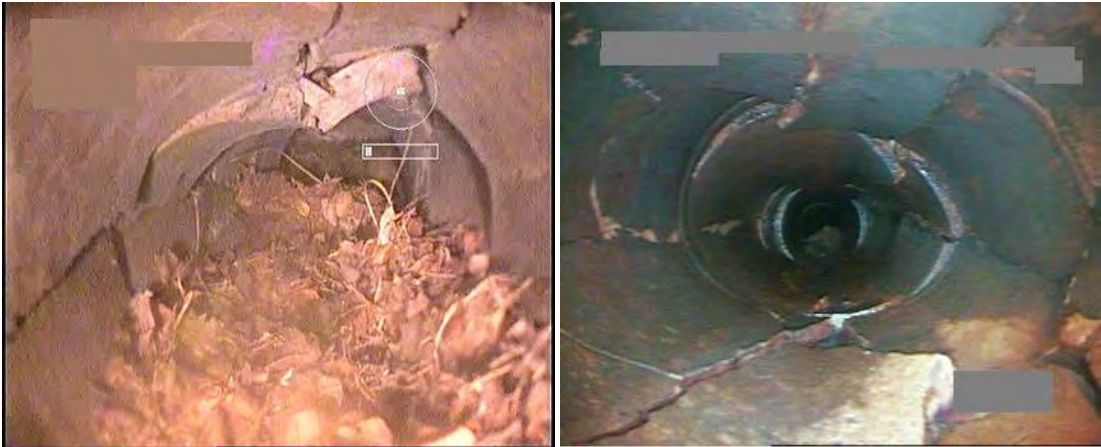
Stormwater Pipes in very poor condition – collapsed and blocked

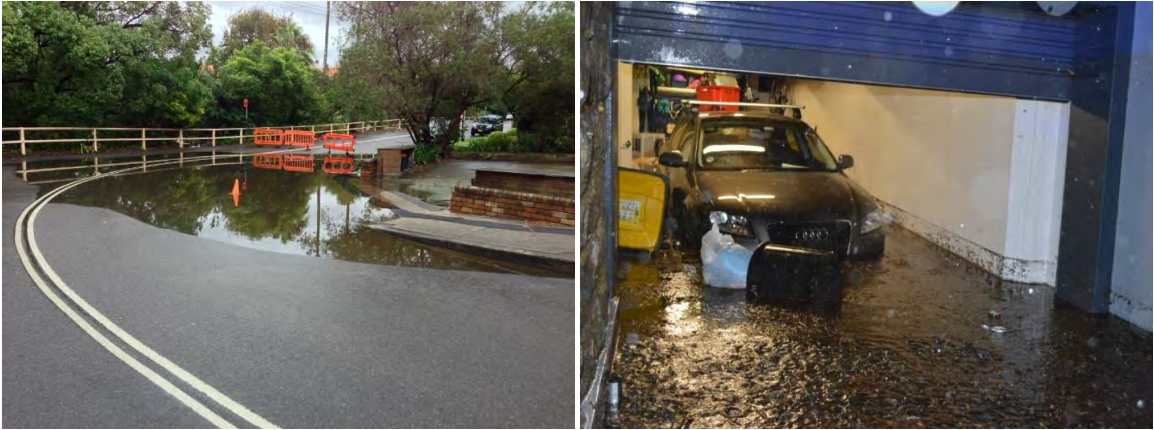
Flooding Issues

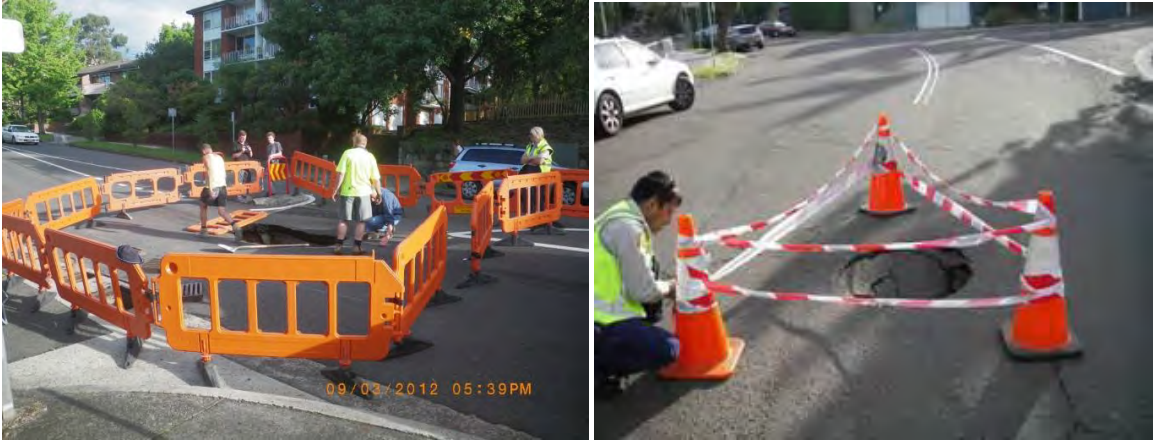
Sinkholes created from collapsed pipes and washout from leaking pipes

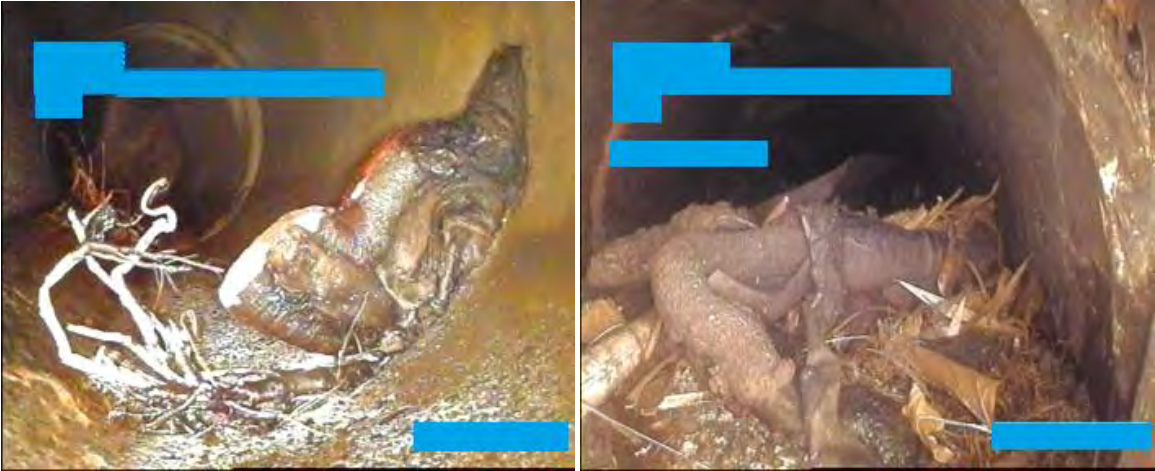
Stormwater Pipes in very poor condition – Tree root infiltrations and blocked

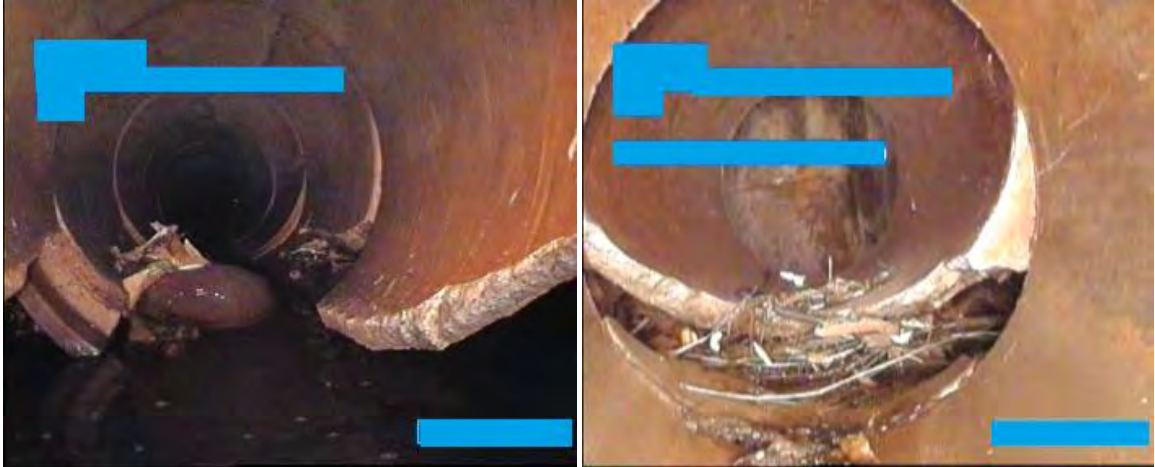
Stormwater Pipes in very poor condition – collapsed

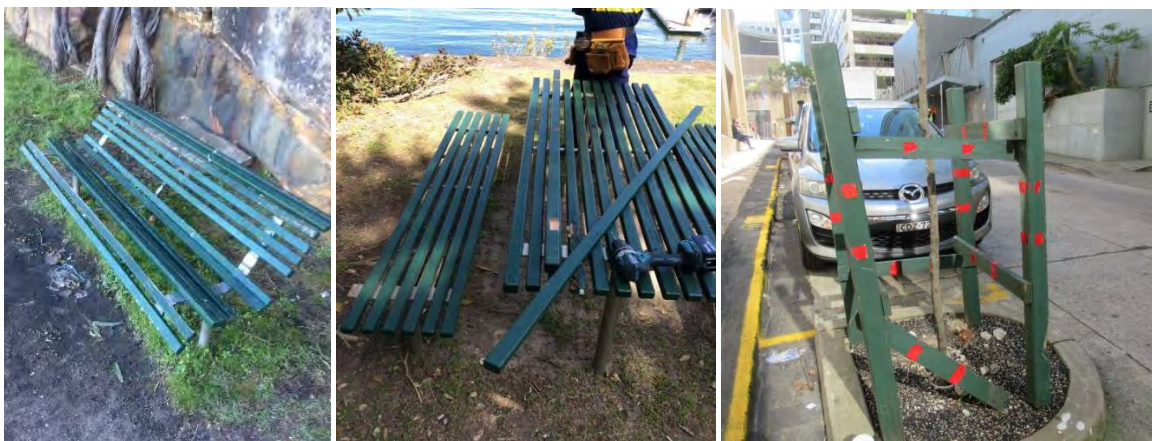
Examples of failed and failing Street Furniture in the North Sydney LGA

**Note:** The old style of Street Furniture depicted in these photographs is being progressively replaced by the new style of Street Furniture adopted by Council in the 2014 Public Domain Style Manual.

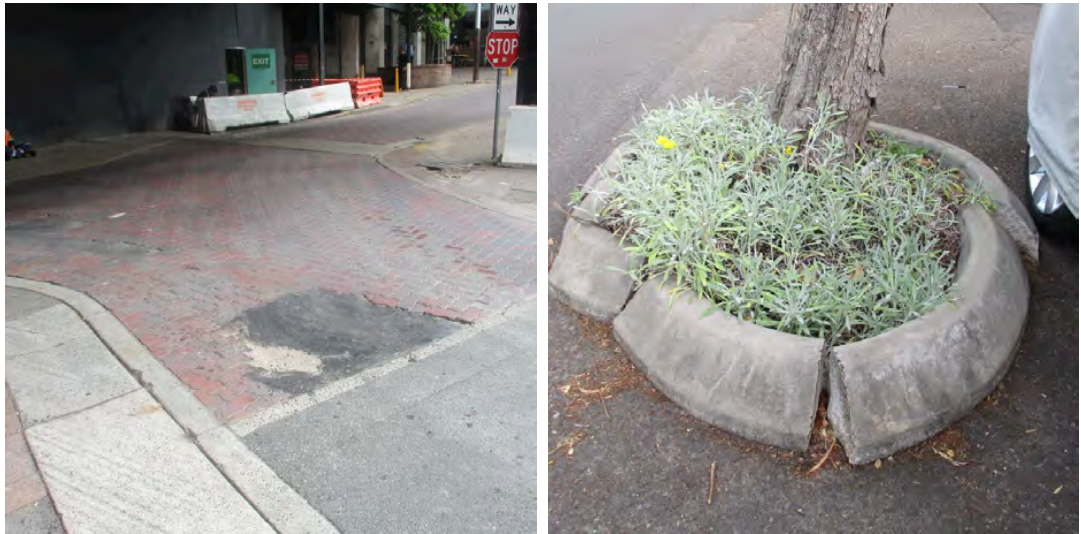
Examples of failed and failing Traffic Facilities in the North Sydney LGA

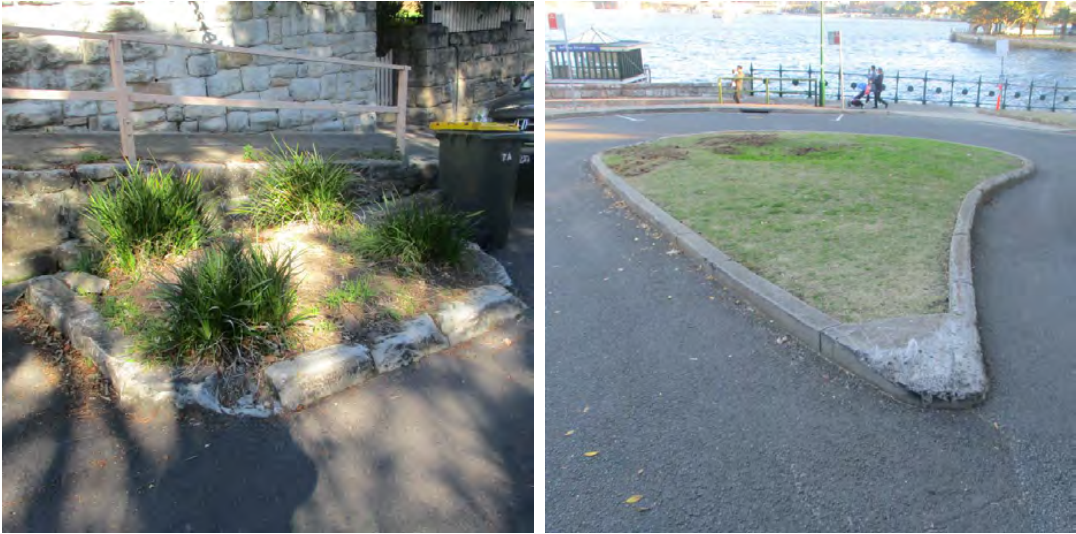
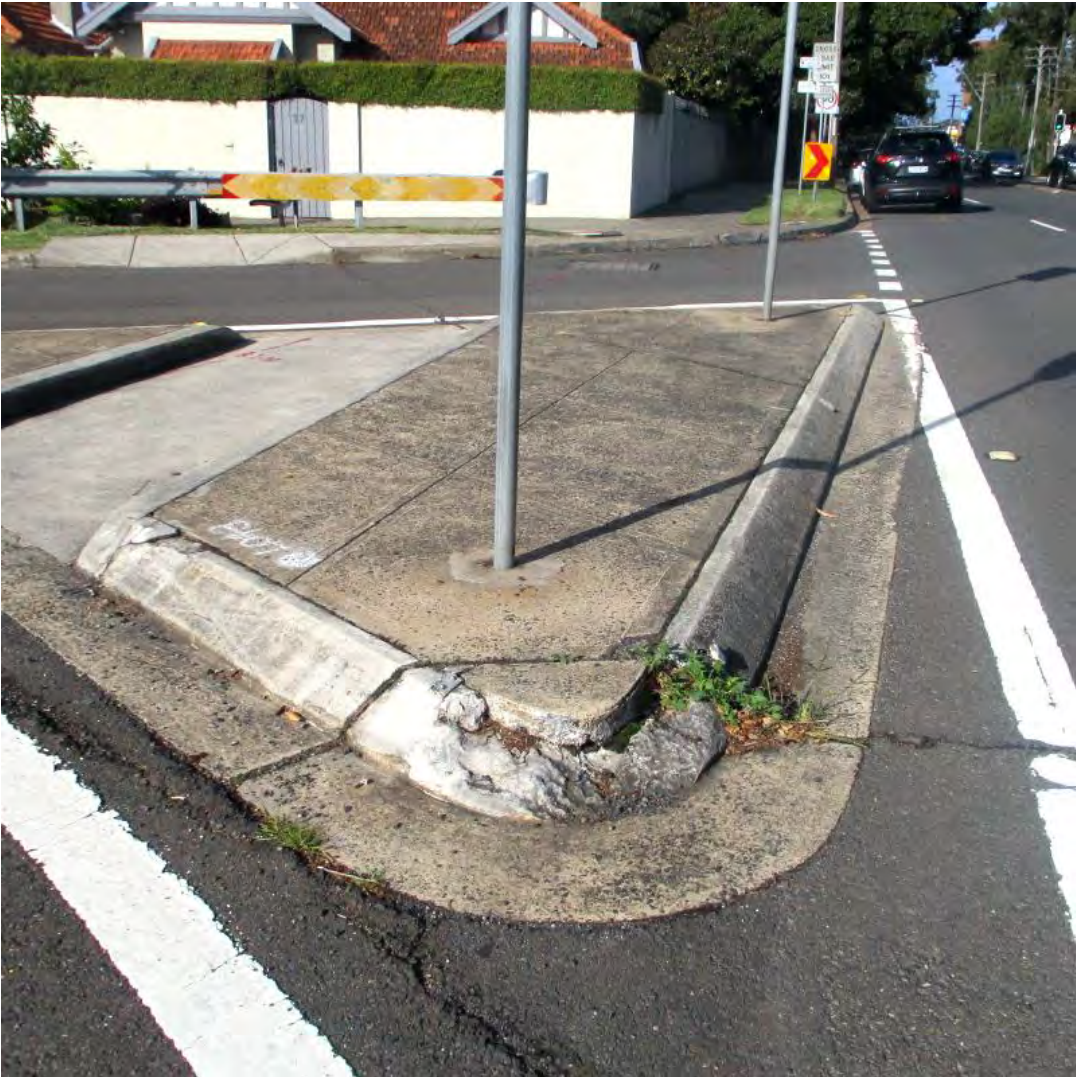
Examples of failed Traffic Facilities in the North Sydney LGA

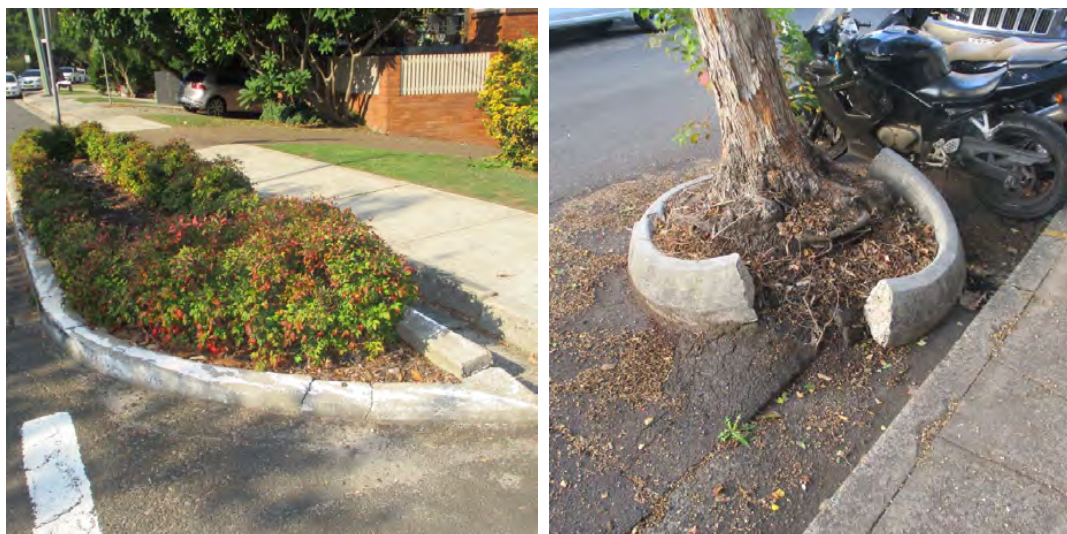
Examples of failed Traffic Facilities in the North Sydney LGA
