SUBJECT: (7.1) Late Item – Union Street McMahons Point – Proposed Speed Cushions – Road Safety Audit Report

**PROPOSED ROAD CUSHIONS
UNION STREET, McMAHONS POINT**

**ROAD SAFETY AUDIT
STAGE 2 PRELIMINARY DESIGN STAGE
AND
REVIEW OF EXISTING ROAD AND TRAFFIC CONDITIONS**

Audit Reference: 19153 RSA Stage 2

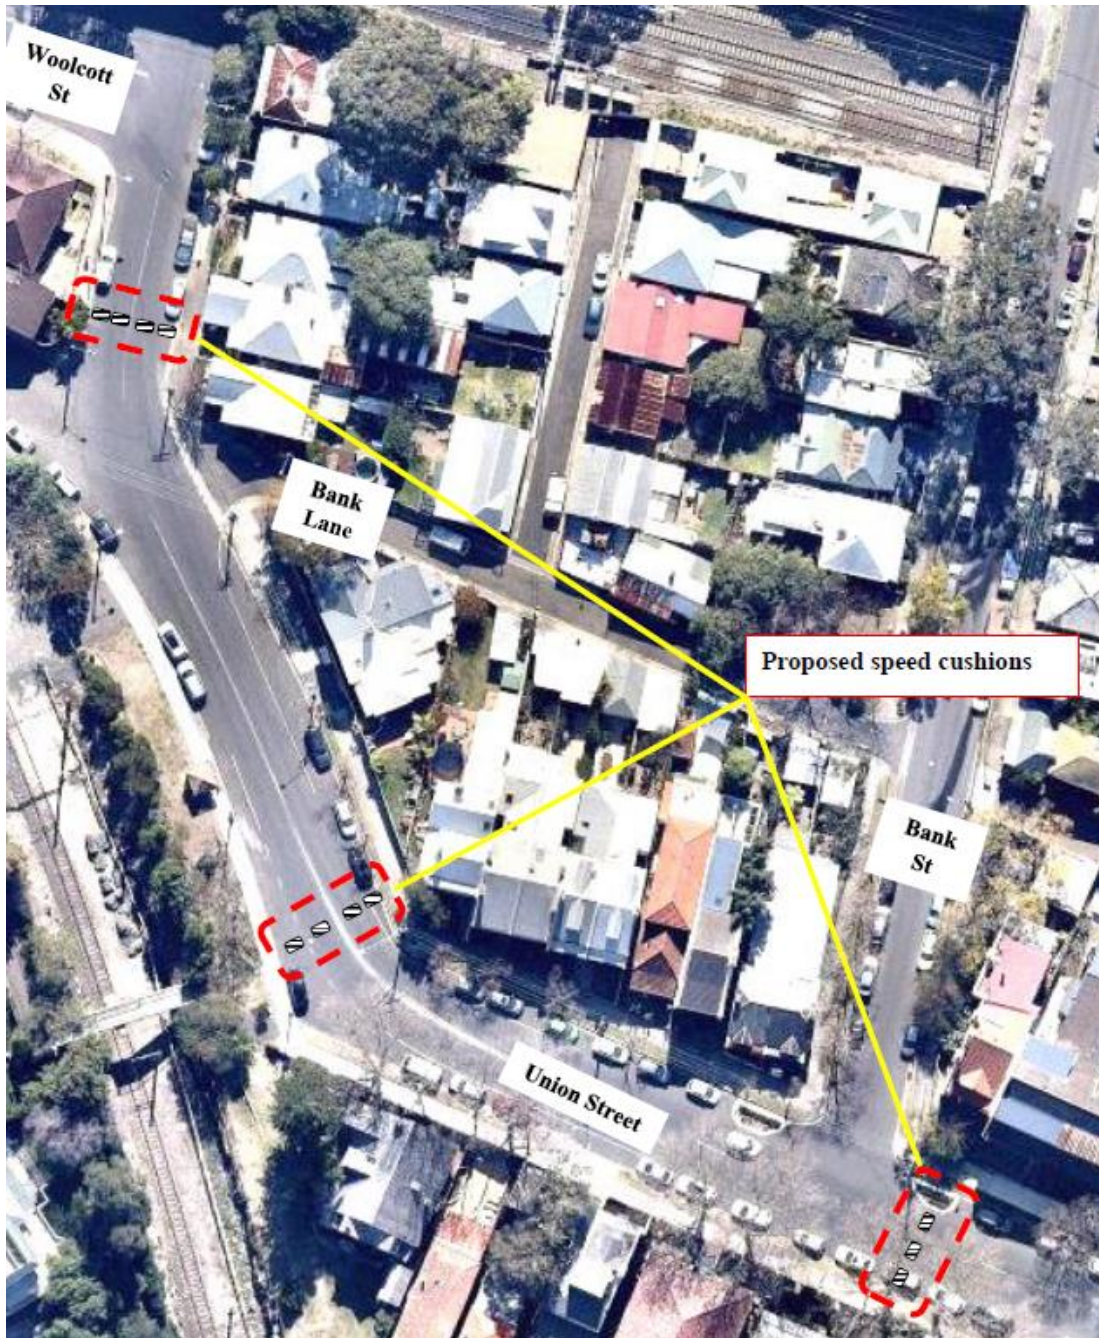
Concept Design by North Sydney Council

The road cushions are proposed in the through lane and adjacent parking bays at each location.

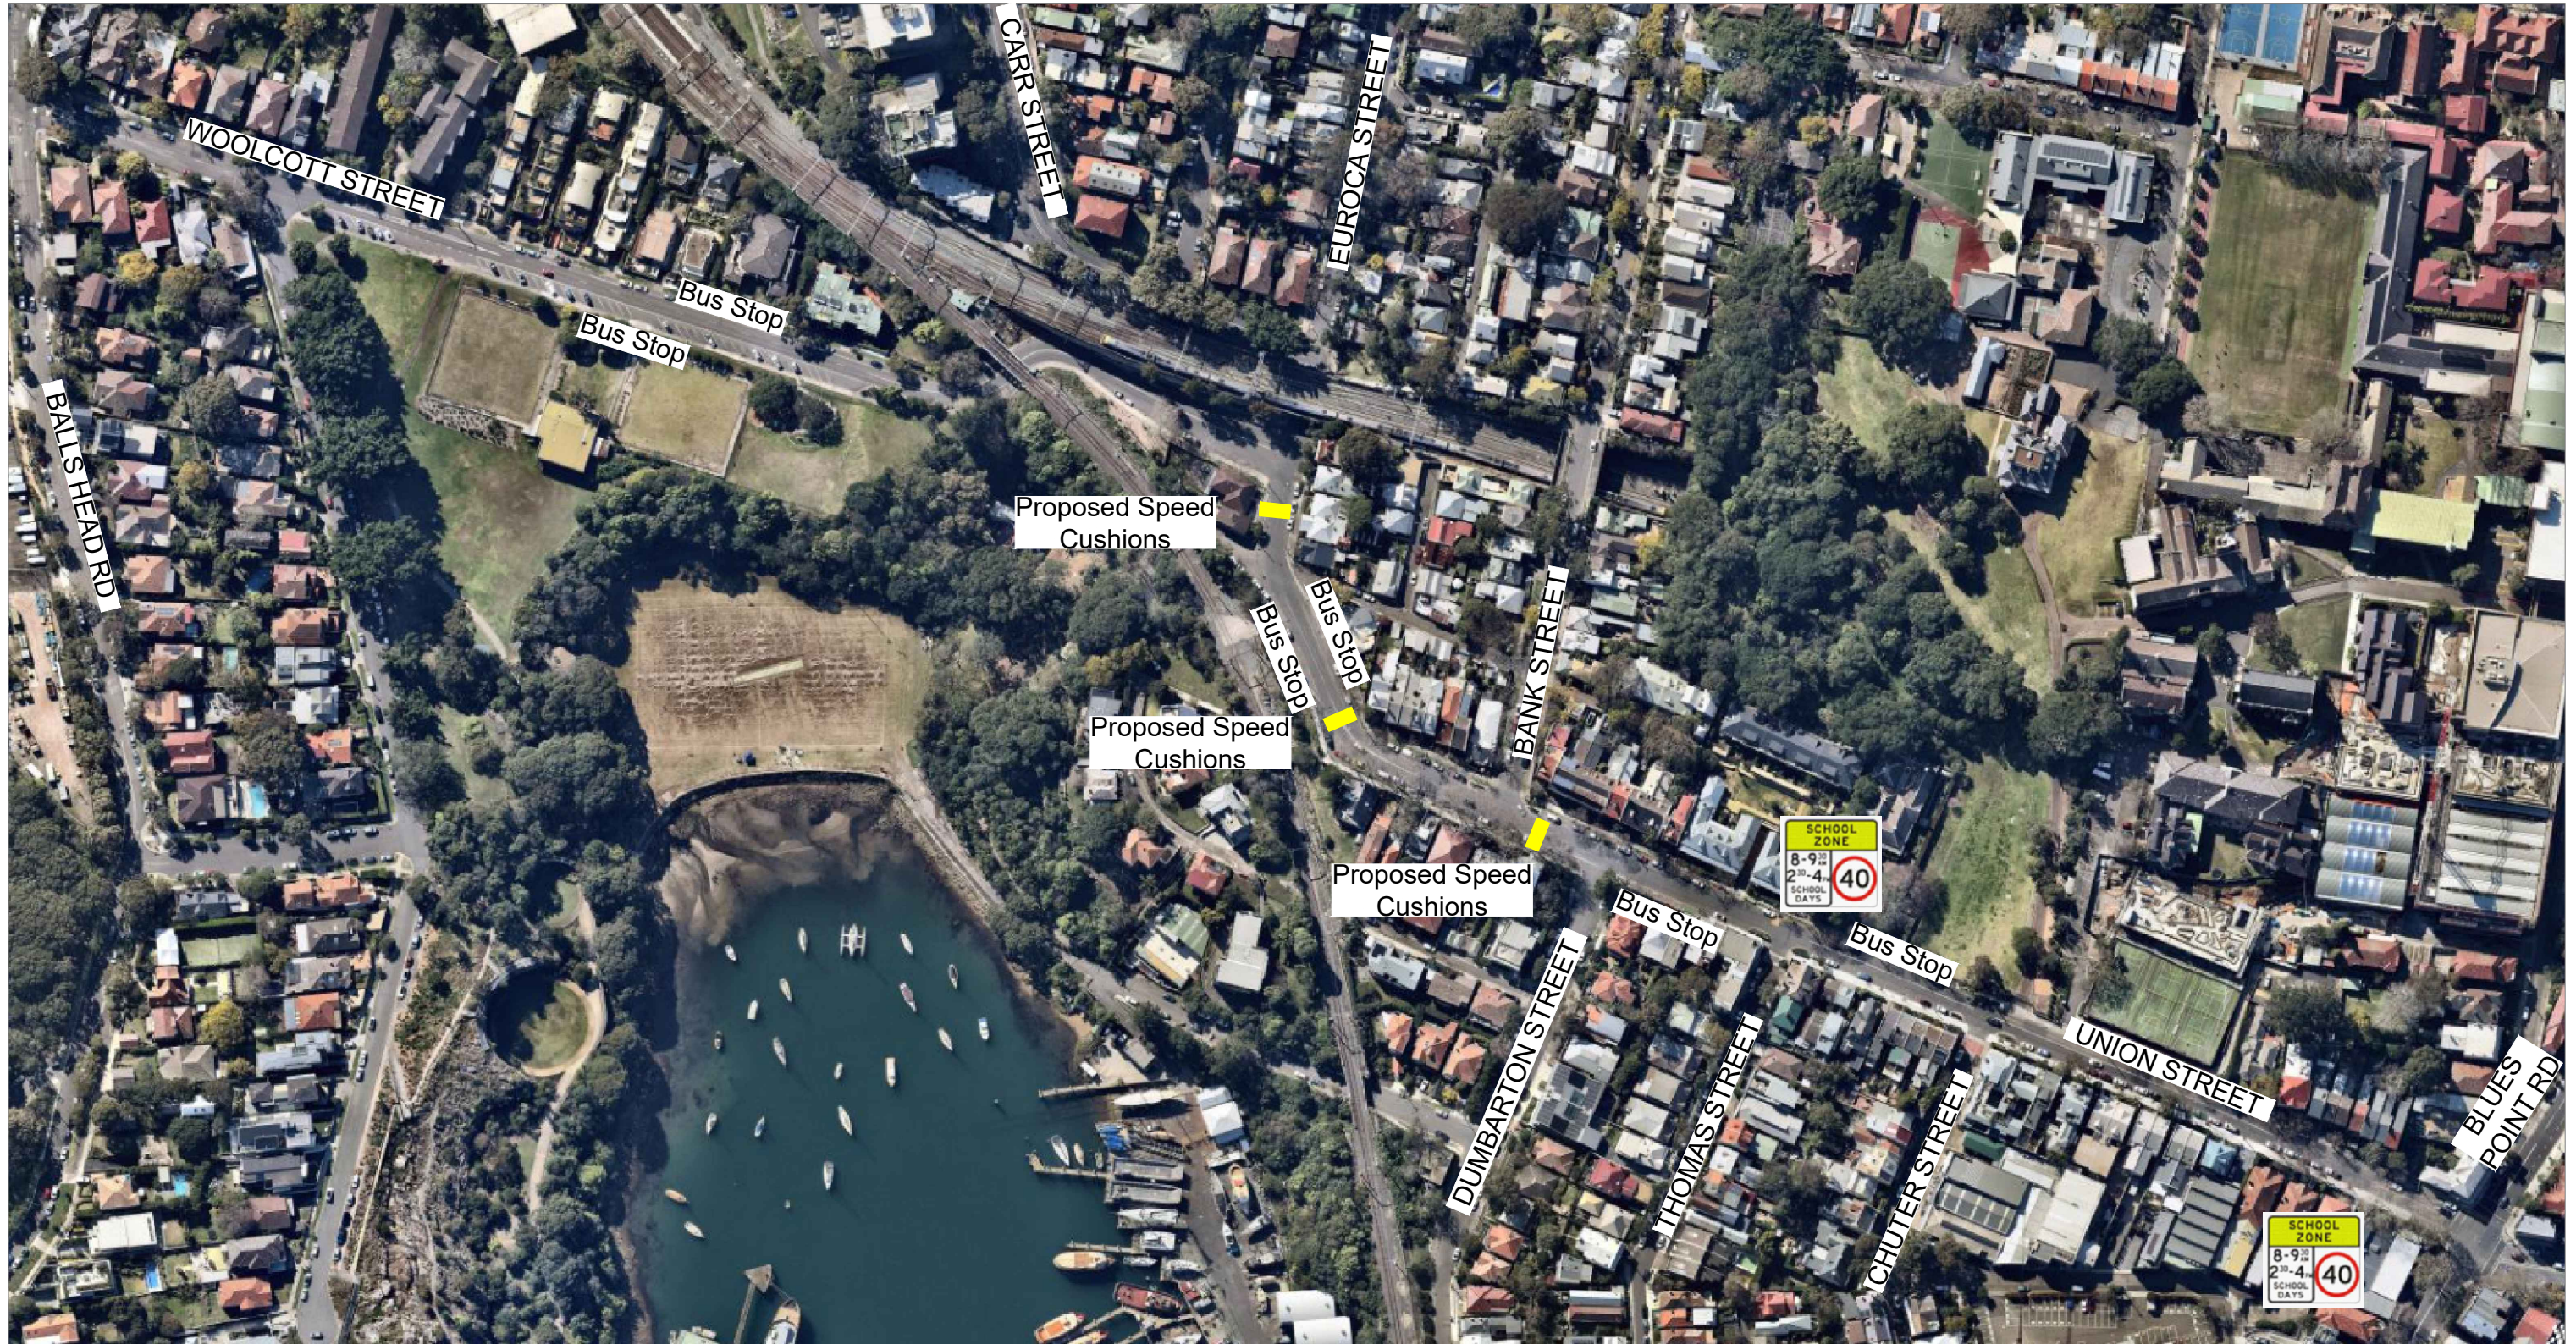
DRAWING NO.	REV.
FIGURE 1	-
SCALE: NOT TO SCALE

Location 1 - Union Street approx. 10m east of Bank Street

Location 2 - Union Street approx. 20m south of Euroka Bus Stop

Location 3 - Euroka Street between Bank Lane and Woolcott Street

Figure 1 shows the location of the proposed rubber road cushions.

Figure 1 shows the Surrounding Road Network.

SURROUNDING ROAD NETWORK

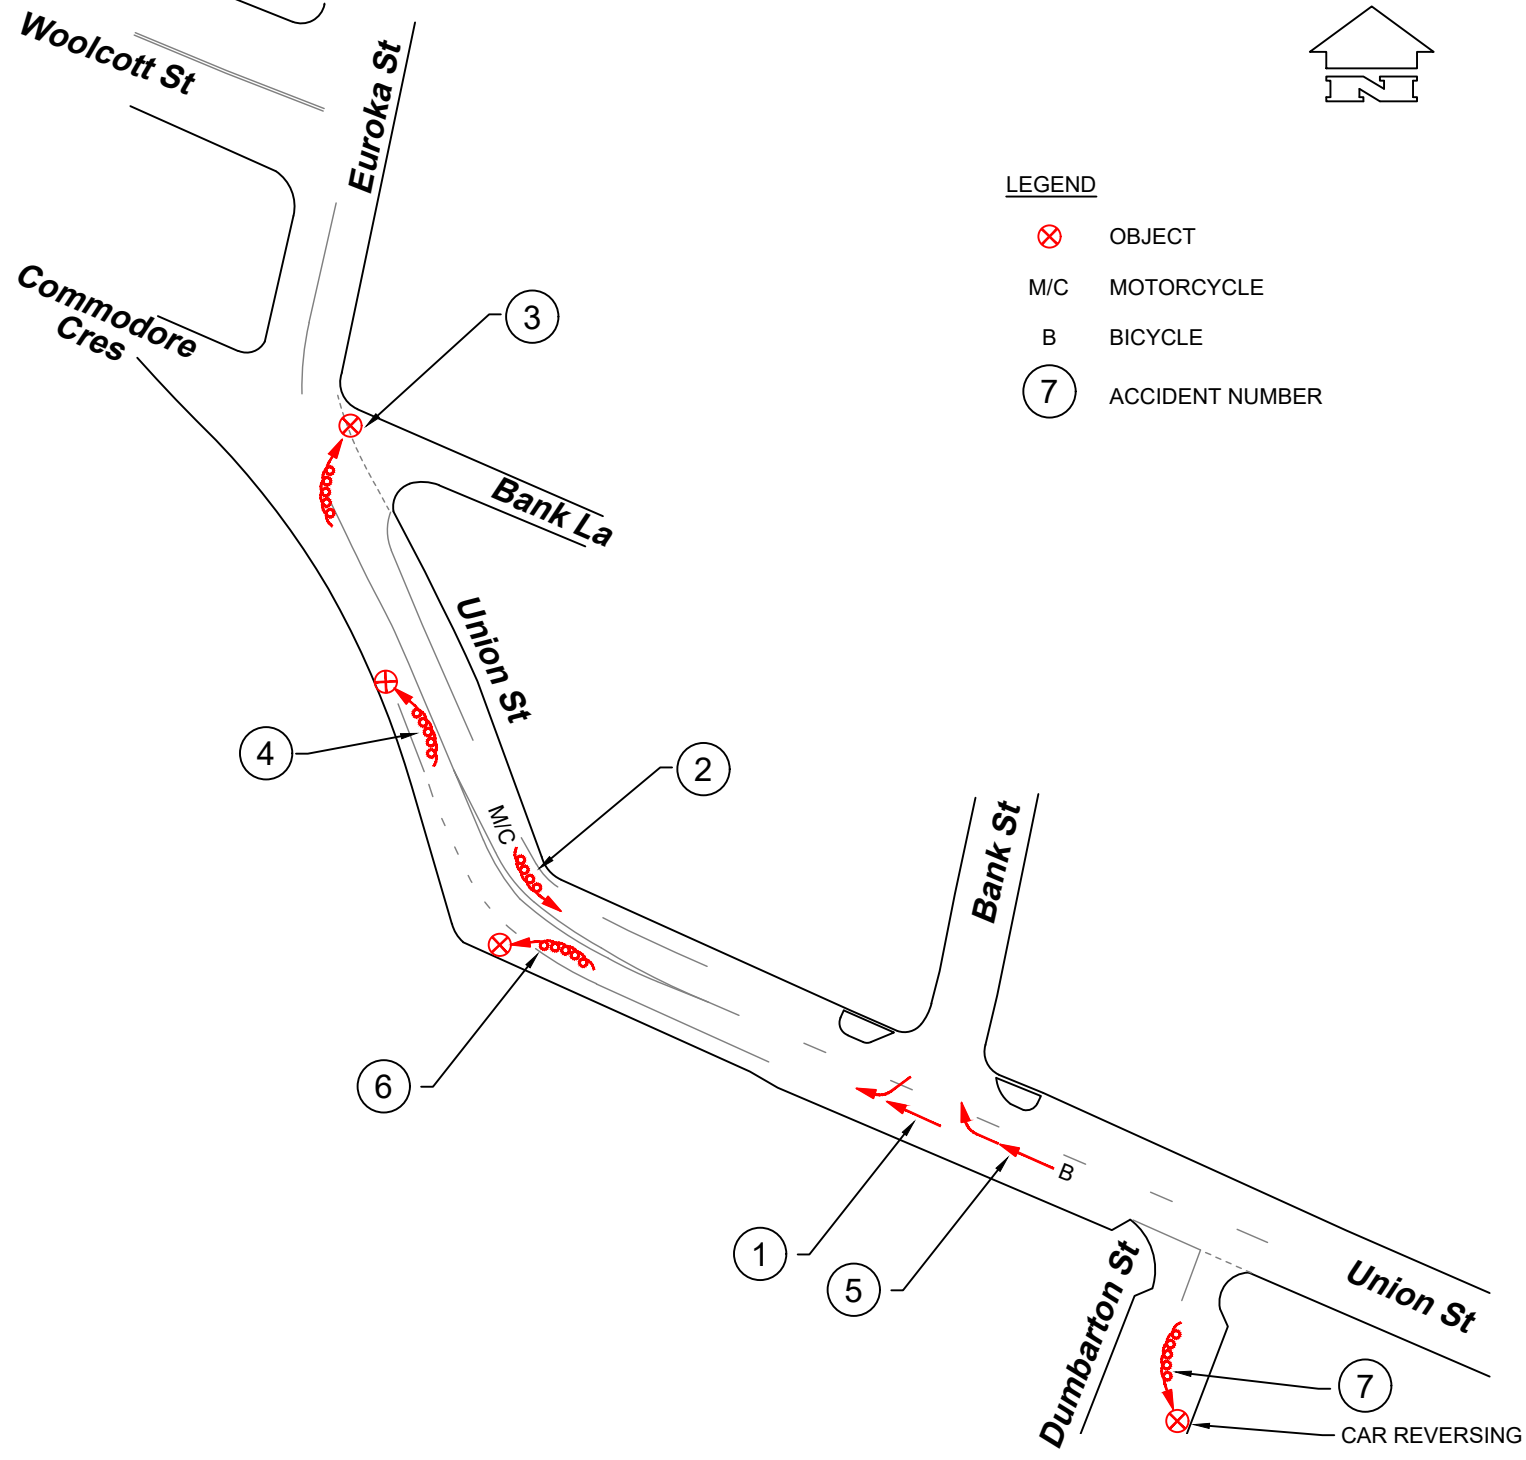
FIGURE 2
 ROAD SAFETY AUDIT
 UNION STREET, MCMAHONS POINT
CRASH DIAGRAM

A review of the crash data reveals that there was a total of 6 reported crashes, 4 of which were injury (casualty) crashes.

Two (2) crashes were intersection type accidents which occurred in Union Street at Bank Street. There were four (4) run off the road type crashes that occurred at or between the bends in Union Street. Three (3) of these were injury (casualty) crashes.

Figure 2 shows a crash diagram of this section of Union Street.

UNION STREET, DUMBARTON STREET - WOOLCOTT STREET, MCMAHONS POINT
 8 YEAR RMS CRASH DATA, 1 OCTOBER 2010 - 30 JUNE 2018
 7 Crashes, 3 Non Casualty, 4 Casualty
