3.1. Anderson Park Sportsfield Reconstruction

This report provides a status update on the Anderson Park Sportsfield Reconstruction and Lighting Upgrade.

This report presents information on the construction progress and ongoing program for the Anderson Park Sportsfield reconstruction and lighting upgrade.

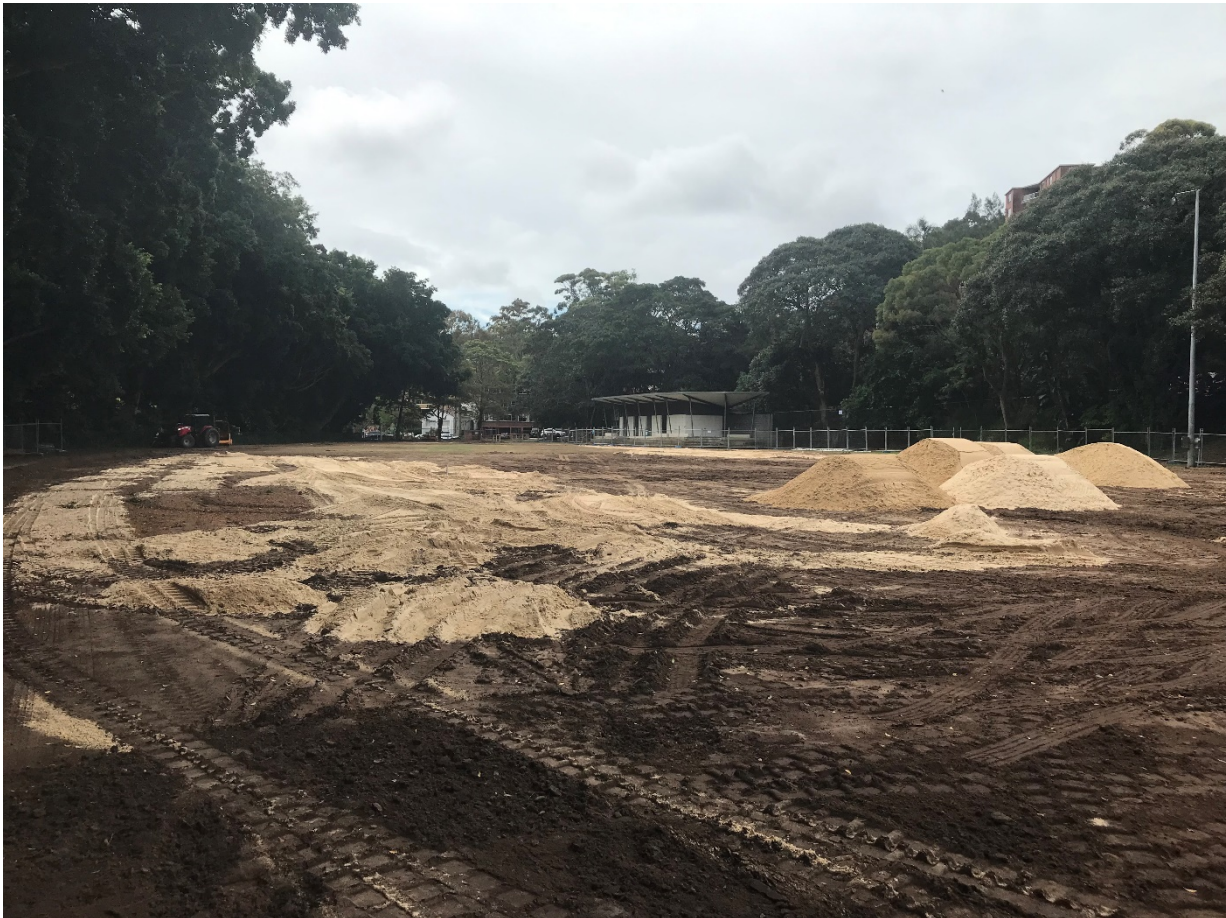
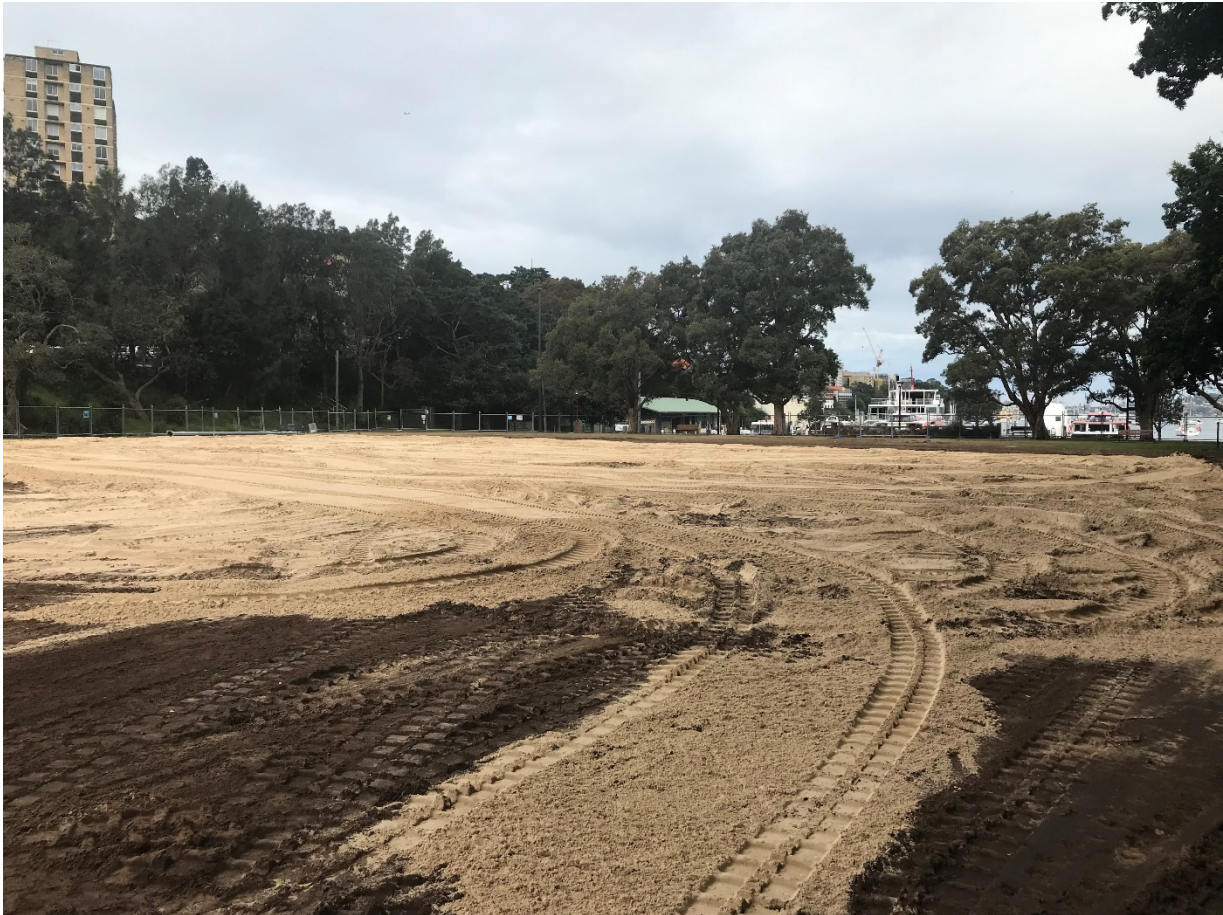
The Oval itself has been fenced off and was sprayed with herbicide 3 times over a 3-week period to kill the existing turf grass. The area of the sportsfield itself has been cultivated to pulverise and blend dead & decaying turf.

Levelling was carried out immediately after cultivation and done via laser guided earth moving equipment. Due to the predicted rain the area at the western end closest to Clark Road has been left to allow for ground to remain solid for truck deliveries.

The first 750 tonne of imported topsoil has begun to be delivered to site and spread. A total of 1500 tonne of sandy topsoil will be installed across the field to aid in the improved drainage capabilities as well as raising the level of growing medium.

Once the imported soil is installed and levelled the next steps will be to:

- Install drainage mainlines, piped drainage laterals, and collectors;
- Install specified irrigation system;
- Install new synthetic cricket wickets;
- Screed to ensure final surfaces levels, consolidation, and surface smoothness; and
- Supply and lay couch turf grass.

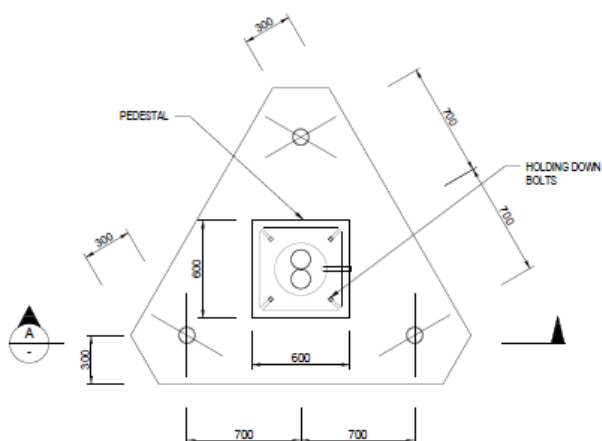
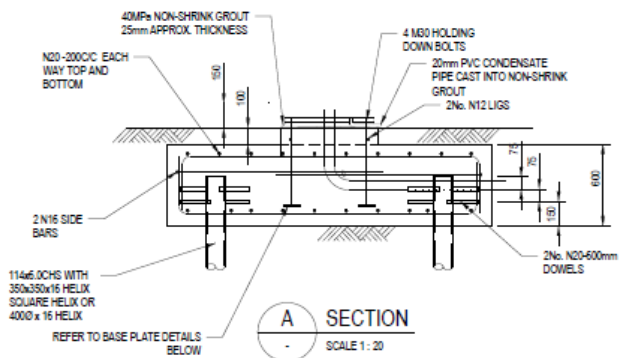
A25-20-100-89 - POLE PAD
SCALE 1:20

A Geotech investigation had to be undertaken to determine ground conditions and location of bed rock to finalise the footing designs for the new lights. Rock was found at random depths across the field up to 12.8 meters in one point. The diagram below shows the design of the new pole foundations and pads.

DESIGN LOADS:

M* = 67kNm
V* = 8.0kN

Pile Depth Requirements				
	BH01	BH02	BH03	BH04
Depth to rock from ground level	12.8	3.4	10.7	4.0
Depth of profiled excavation	0.7	0.7	0.7	0.7
Strength on first contact	Low	Medium	Medium	Medium
Required rock socket	0.3	0.6	0.3	0.6
Pile embedment depth	12.4	3.3	10.3	3.9

The next steps will be to:

- Trenching and installing conduits;
- Installation of footings;
- Installation of new switchboards;
- Mount floodlights; and
- Stand new poles.
