3.1. Hunts Lookout Footbridge Replacement

The purpose of this report is to inform Councillors and the community about plans to replace a pedestrian footbridge in Cremorne Reserve (Hunts Lookout) that was destroyed by a fallen tree in December 2022.

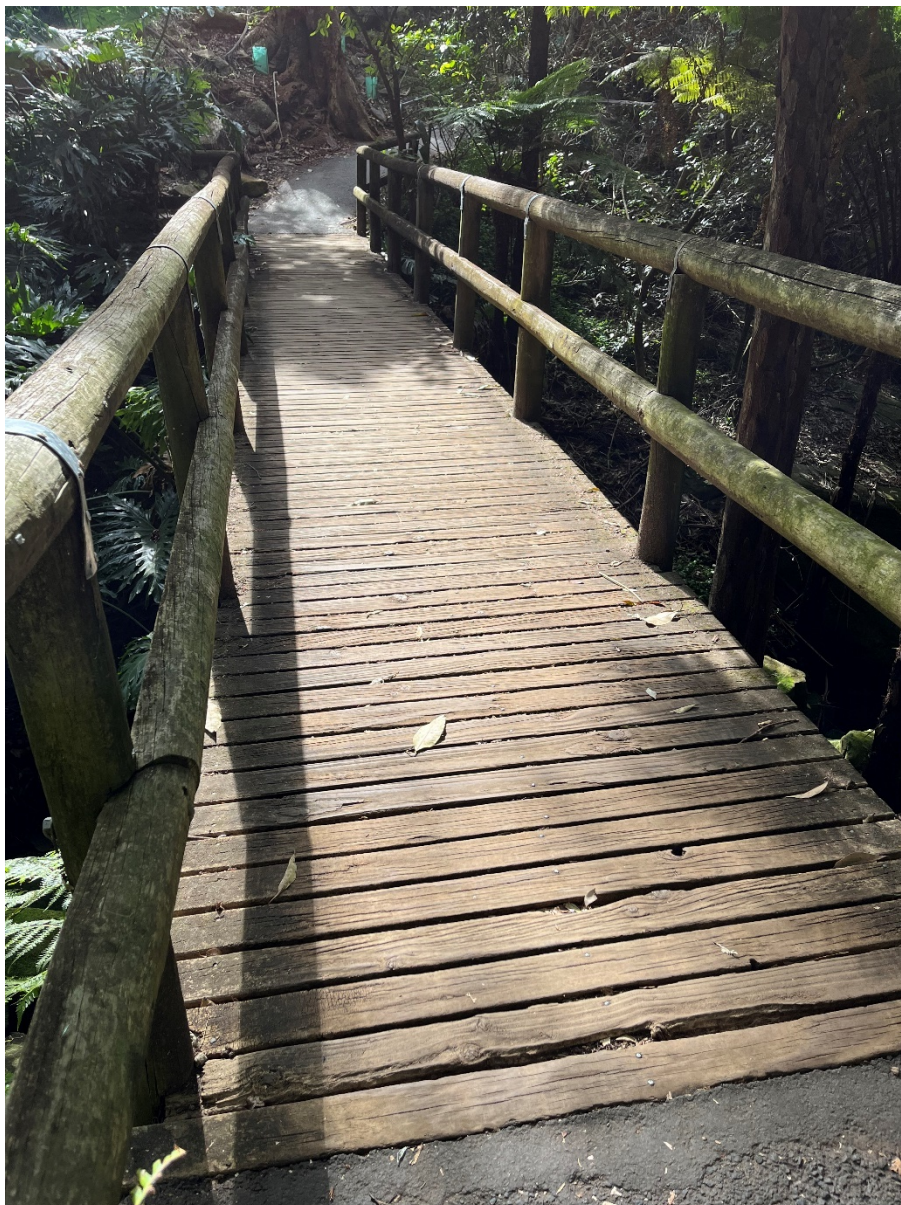
The Hunts Lookout footbridge (pictured below) located in Cremorne Reserve (Cremorne Point) provides an important pedestrian link between Cremorne Reserve in North Sydney LGA and Harnett Park in Mosman LGA.

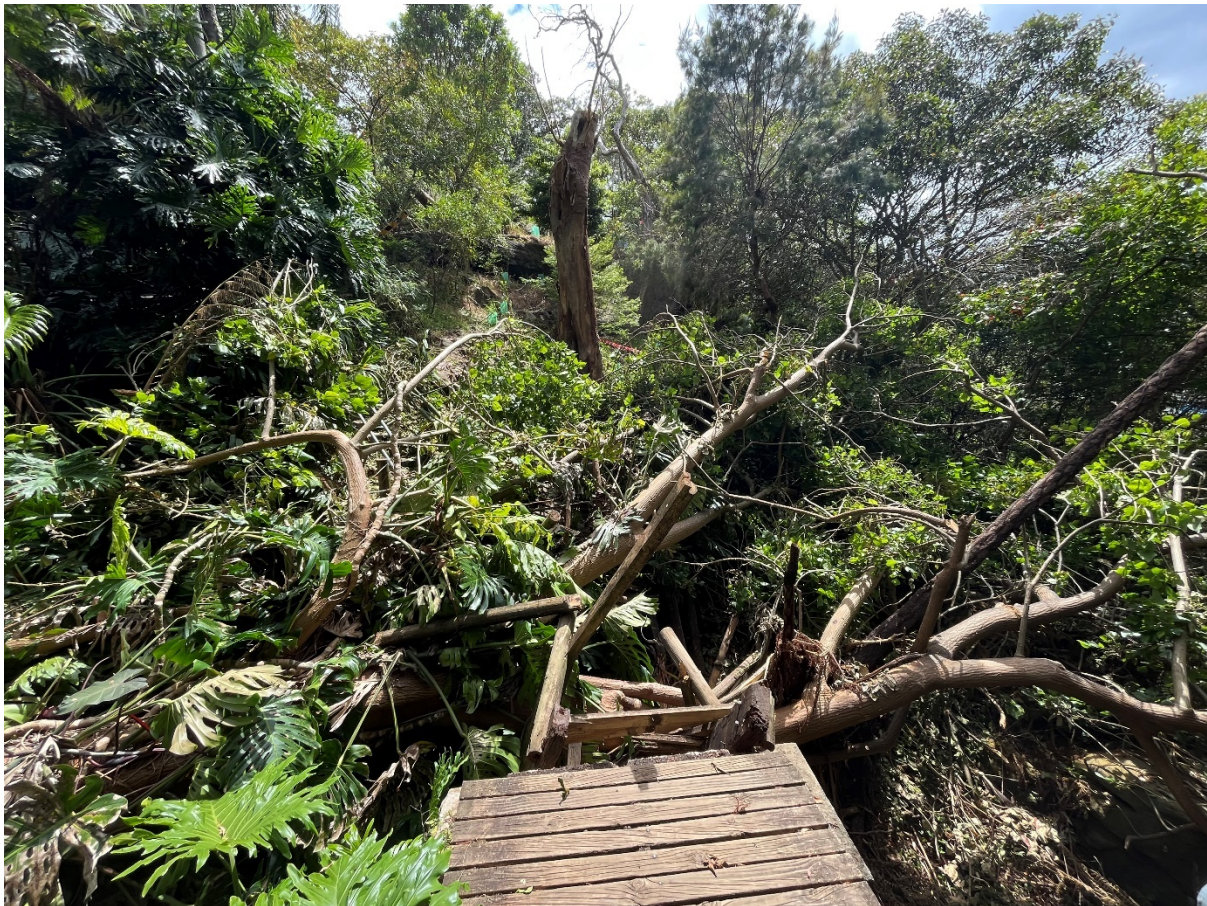
The original ~12m-long timber footbridge was partially destroyed by a large Coral Tree, which failed around the middle of December 2022, smashing through a 5m-long section of the raised footbridge on the Mosman Council side of the LGA boundary (see image below). As the tree fell from privately owned land into both Harnett Park and Cremorne Reserve, Mosman Council facilitated the landowner's cooperation in arranging removal of the failed tree.

With several branches of the failed Coral Tree also 'hung up' in adjacent canopy and an unknown extent of damage caused to close-by standing trees, assessment and removal of this material by arborists was necessary in order to provide safe access for Council staff to evaluate the extent of the damage and determine options going forward.

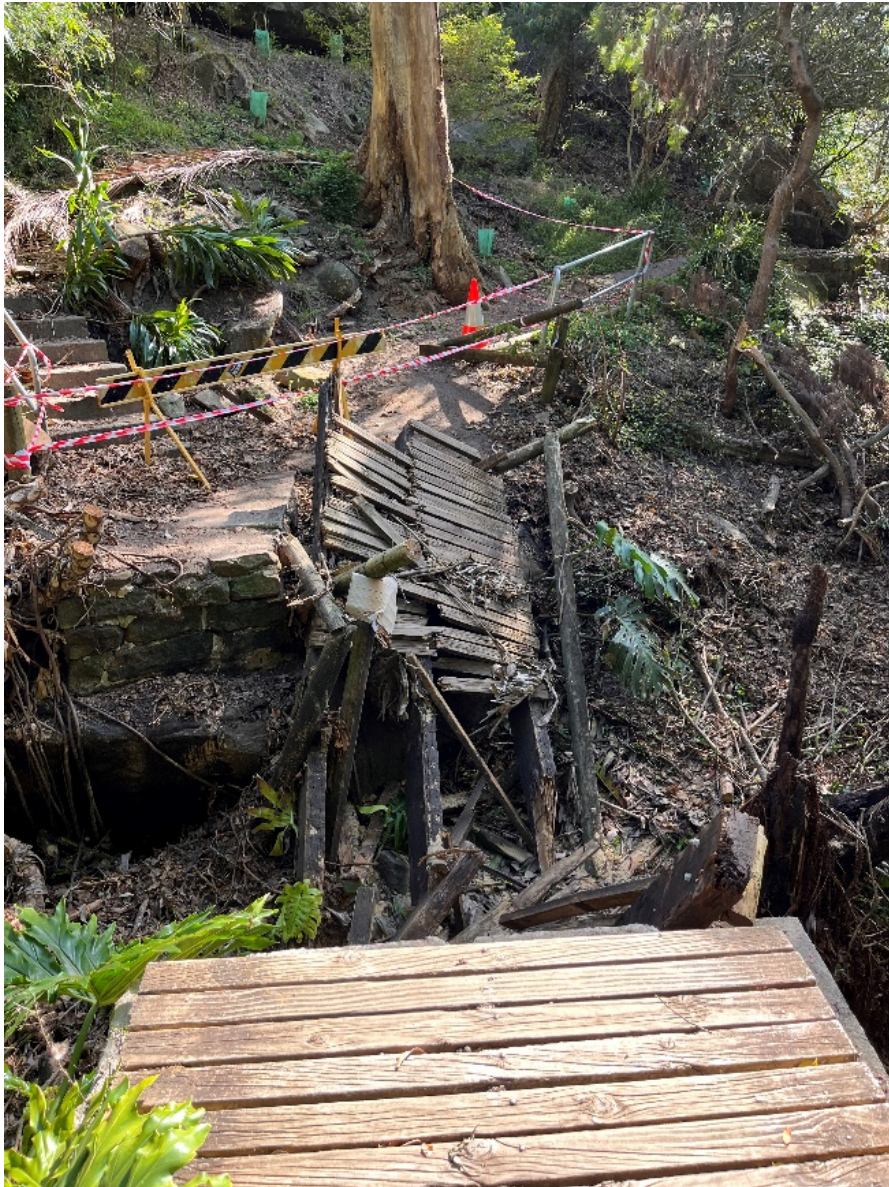
Full removal of the fallen tree and associated debris was completed in late January 2023 (see below), at which point North Sydney Council arranged for a structural engineer to assess the remaining in-tact section of footbridge to determine whether repair was an option or full replacement would be required. Based on the aged condition of the existing structure and level of decay evident in the old hardwood timber subframe, it was determined that full replacement was the only viable option.

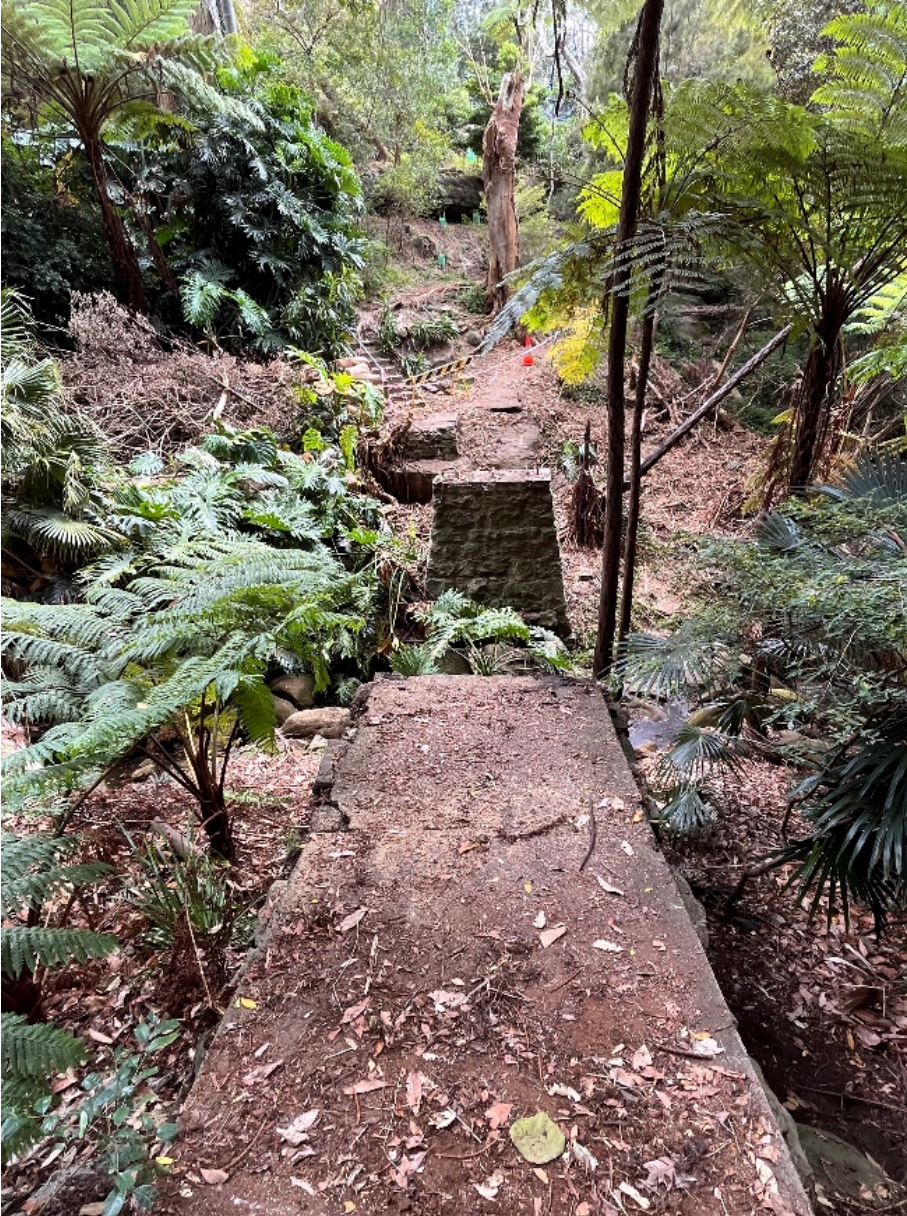
Due to the steep-sided gully environment and distance from near-by streets, access to the footbridge location for construction purposes is exceedingly difficult and for the most part, only possible on-foot. This being the case, North Sydney Council arranged for the demolition and removal of the remaining footbridge (see below) structure by a specialist bushland track construction contractor, experienced in removing track infrastructure in especially difficult-to-access areas. Removal of the old, damaged footbridge was completed by the beginning of February 2023.

The new footbridge will feature a (black-painted) galvanised steel sub-frame instead of the hardwood timber used in the original structure. This change provides greater longevity and shortens the construction timeframes, as hardwood beams of the size required to span such lengths need to be specially milled and dried for a lengthy period before they can be used. Similarly, the treated pine timber deck has been replaced with grippy fibre-reinforced-plastic mesh panels commonly used in bushland track construction. These panels provide a long service life and high grip levels suited to the moist, creekline environment of Hunts Lookout. A reference to the previous timber footbridge has been integrated into the contemporary design with the retention of timber for the posts and handrails – albeit with stainless-steel mesh inserts (similar to the Coal Loader’s handrails) to comply with non-climbable fall prevention requirements.
