Report on Geotechnical Investigation

Proposed Residential Development

1 Warung Street, McMahons Point NSW

Project 203182.01

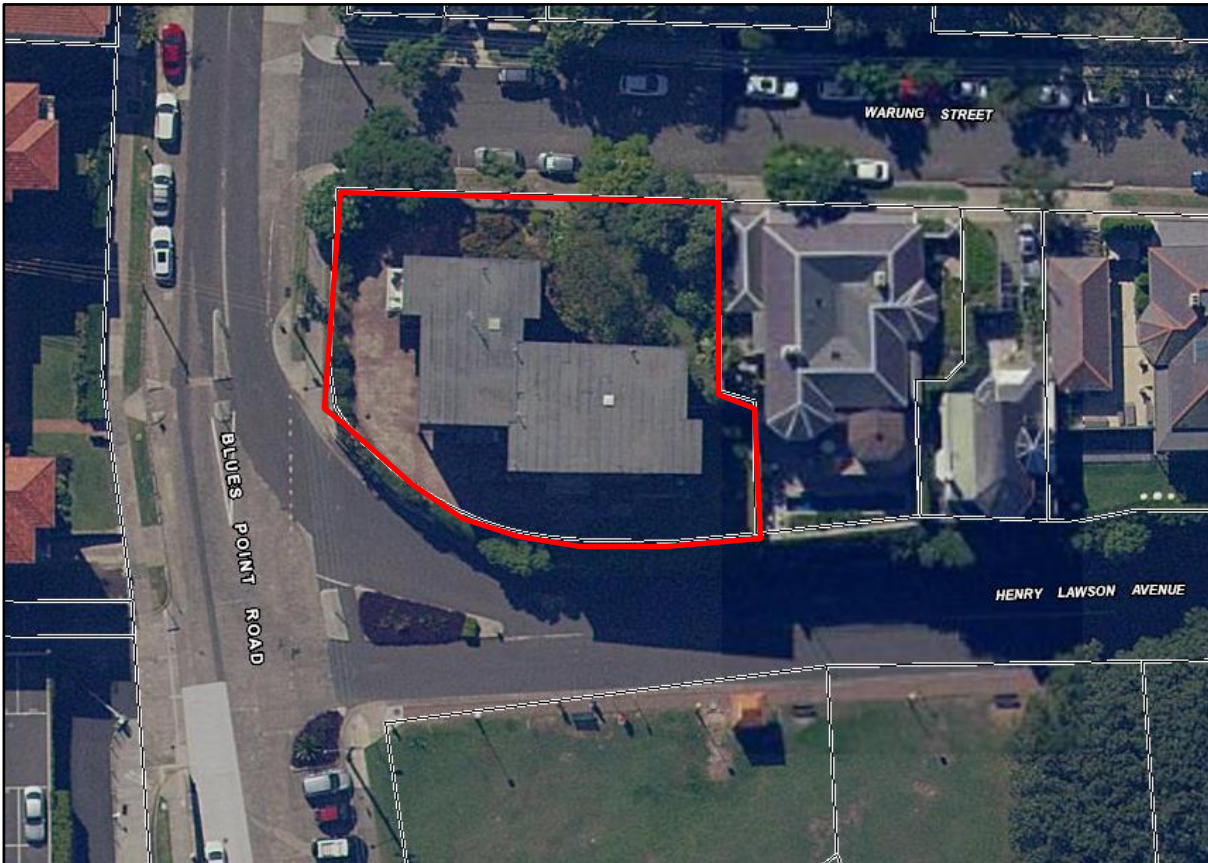
Figure 1: Site Location and Site Boundary

The surface level varies across the site, sloping from the north east to the south west, with a 4 m fall across the site, dropping abruptly at the retaining, located just to the northwest of the building, then sloping gently down across the building footprint and carpark towards the south west corner.

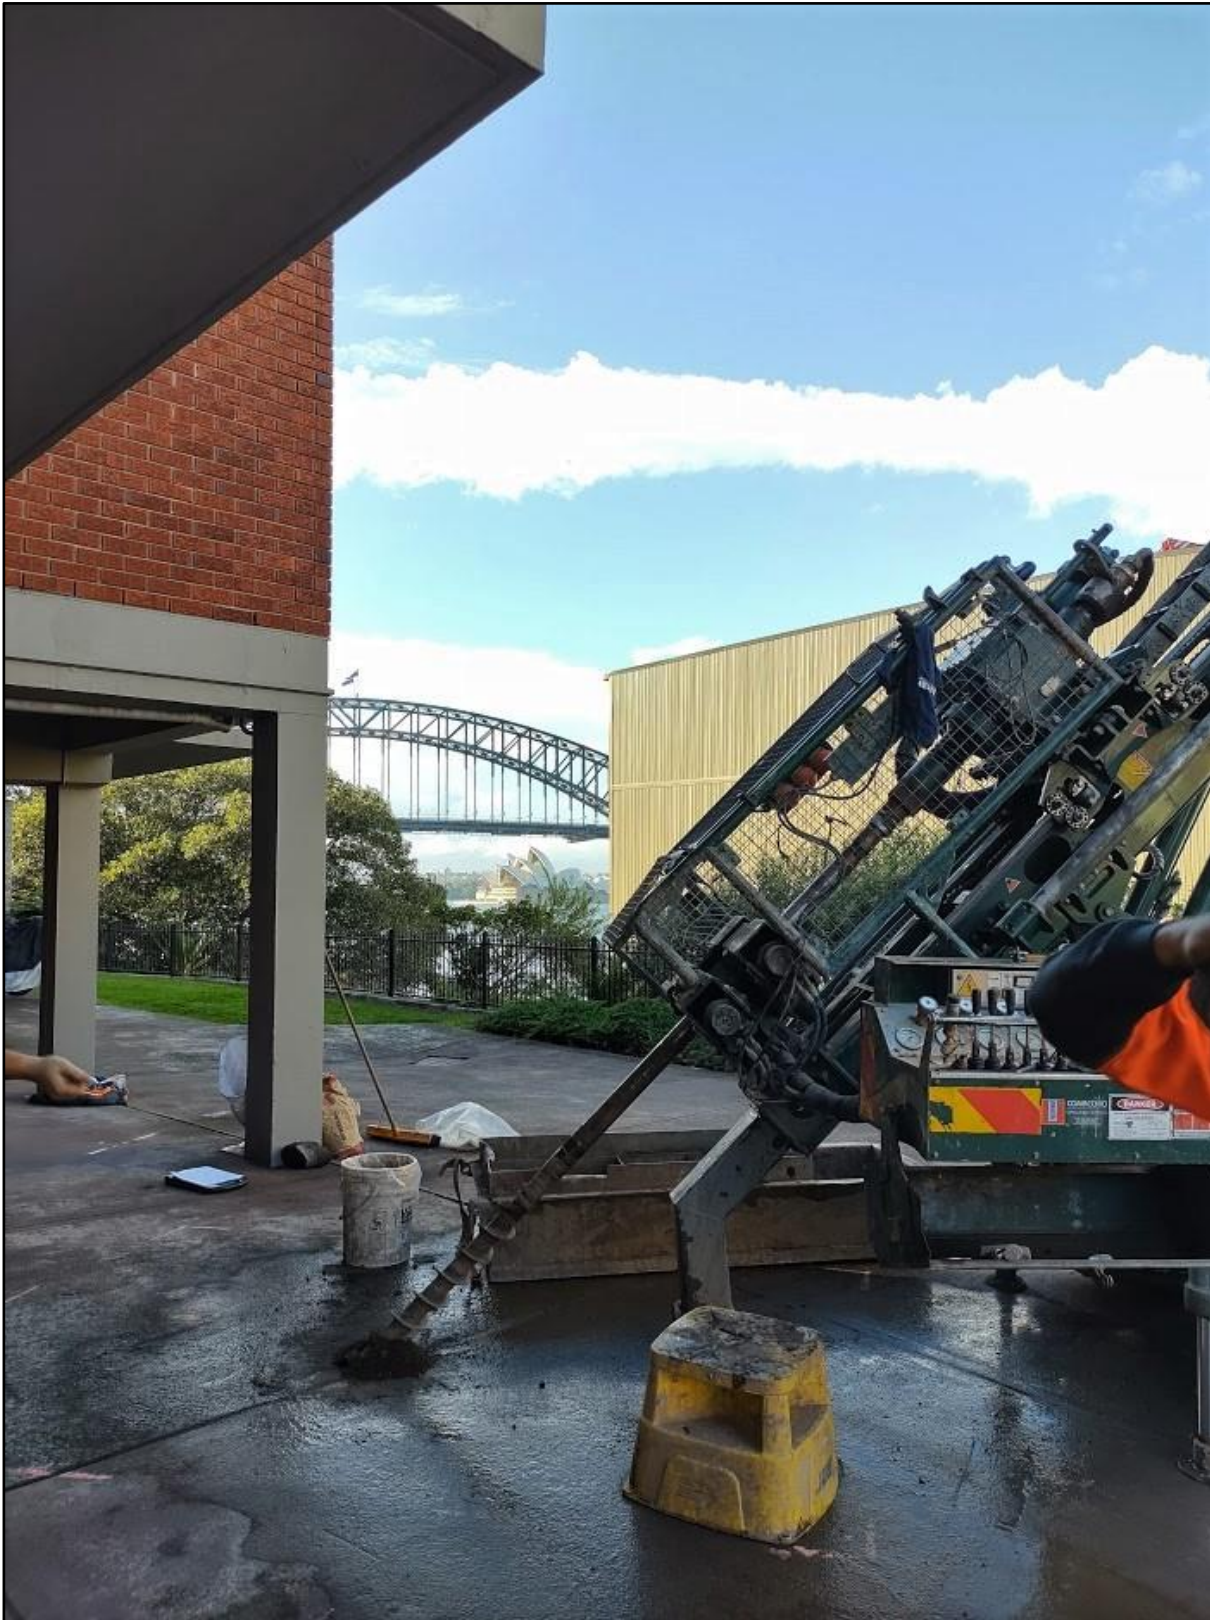
Photograph 1: Track-mounted drilling rig on 45° angled borehole (BH03)

The rock cores recovered from the boreholes were logged on site before being returned to DP's workshop where they were photographed and Point Load Strength Index ($I_{s(50)}$) tests carried out on selected samples of the rock core, in accordance with AS4133.4.1.
