*Arboricultural Assessment  
and Tree Protection Plan  
Panel Determination – Council correspondence  
D418/21JD(CIS)*

Commissioned by: T + P Dugal

Site: 37 Bay View Street, Lavender Bay 2060

Date of Inspection: 22 August & 5 November 2022

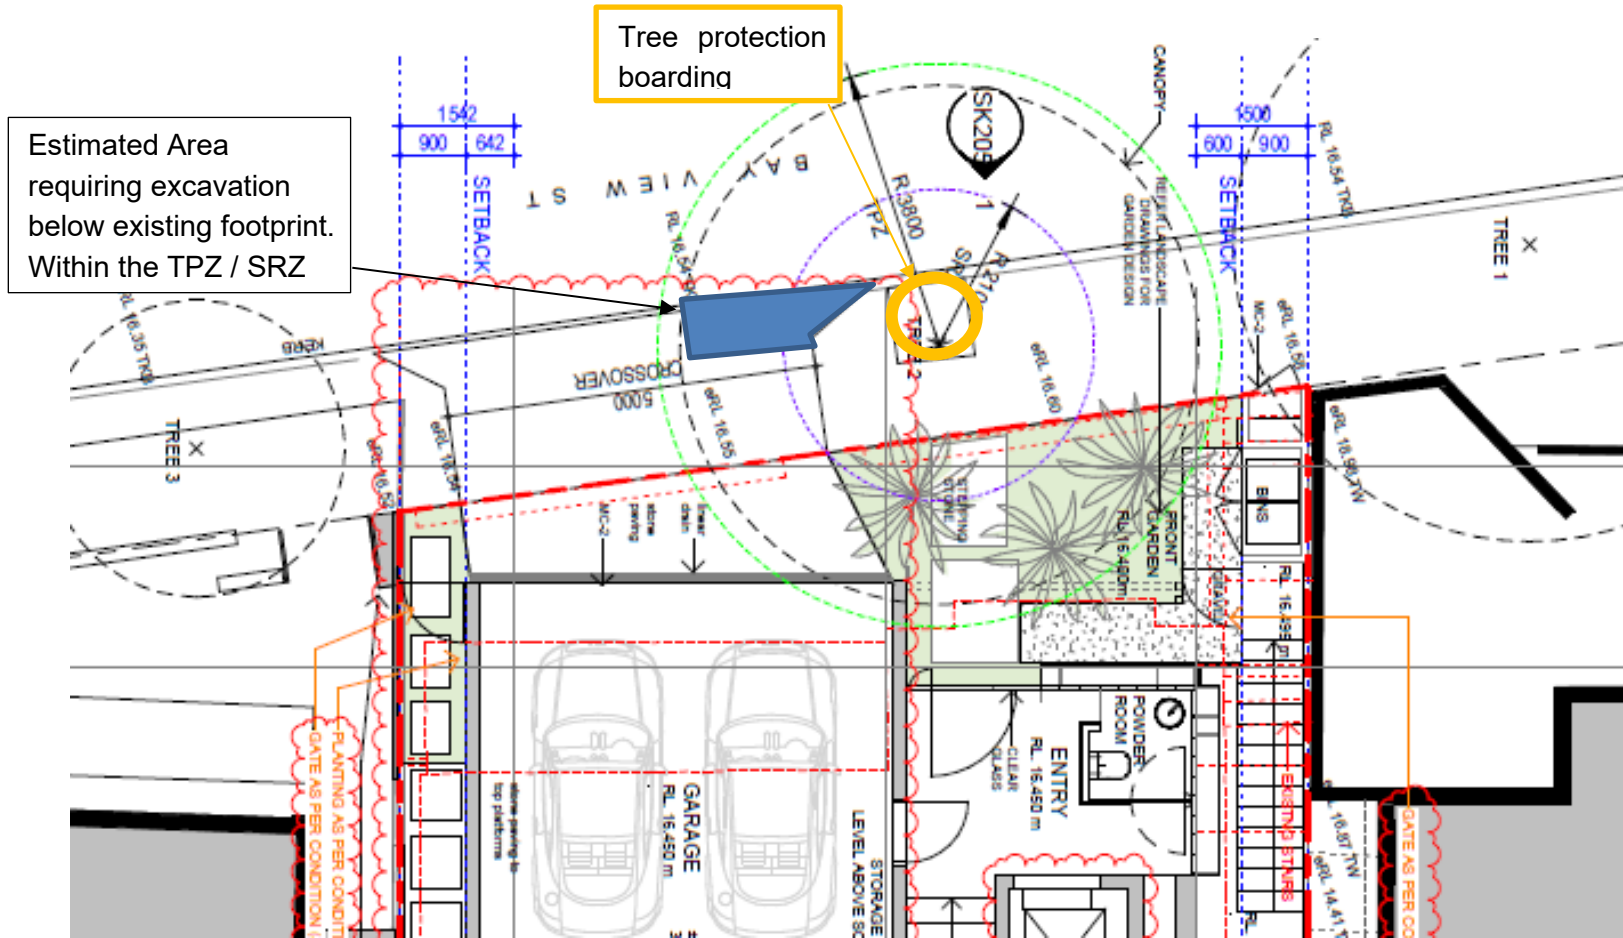
# Appendix A - Tree Assessment data 37 Bay View St, Lavender Bay, NSW 2060

Number	Botanic/Common name	Height	Width	DBH	DGL	TPZ	SRZ	Age Class	Health	Condition	Amenity	Retention Value	Notes
1	<i>Lagerstroemia indica</i> crepe myrtle	6	10	23/21	33	3.8	2.1	Mature	Good	Good	High	High	Located in the street verge adjacent to the site (centre). An assessment of the impact of the proposed works on the tree has been provided in the Observation & Discussion section 5 of this report.
2	<i>Lagerstroemia indica</i> crepe myrtle	~6	~7	~20/18	~28	~3.2	~2	Mature	Good	Good	High	High	Located adjacent to the left neighbouring property within the street verge. The tree is in good health and condition with no impact anticipated.
3	<i>Lagerstroemia indica</i> crepe myrtle	~4	~5	~18	~23	~2.2	~1.8	Mature	Good	Good	High	High	Located adjacent to the right neighbouring property within the street verge. The tree is in good health and condition with no impact anticipated.
