**Don Bank Museum  
6 Napier Street, North Sydney**

**Conservation Management Plan**

Date:  
Final: 6<sup>th</sup> March 2023

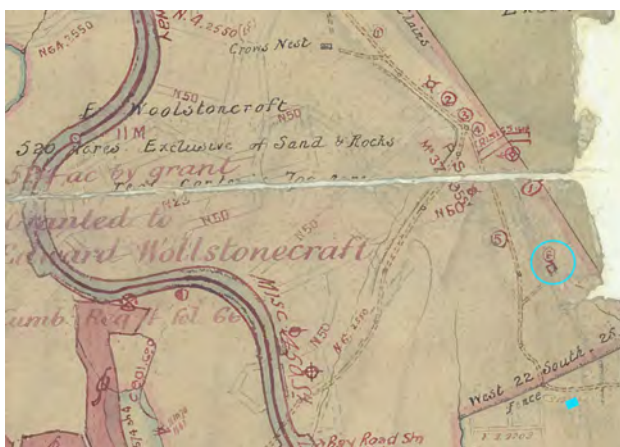
Figure 2. 10: Detail of the government survey of Wollstonecraft’s grant dated 1833, with later, twentieth century annotations (red text). It recorded a number of notations on the east side of the road that became Lane Cove Road and later the Pacific Highway. The notation 6 (circled in blue) refers to a Lands Department plan (7418.3000) dated 1928 prepared for the resumption of land between the Pacific Highway and Angelo Street. This notation was mistaken in the 1970s for a dwelling. The approximate location of Don Bank is indicated with a blue square located south of a fence line to the south of later annotation. Source: NSW Land Registry Services (Crown Plan S.437b)

The government survey of Crow’s Nest Farm undertaken in 1833 (see Figure 2.10) showing what appears to be a dwelling in the vicinity of present-day Don Bank. Further analysis of this survey concludes this “dwelling” was a later notation for a plan reference number made by the Lands Department in 1928 for the widening of the highway in the vicinity of Angelo Street, located to the north of Napier Street and Don Bank.

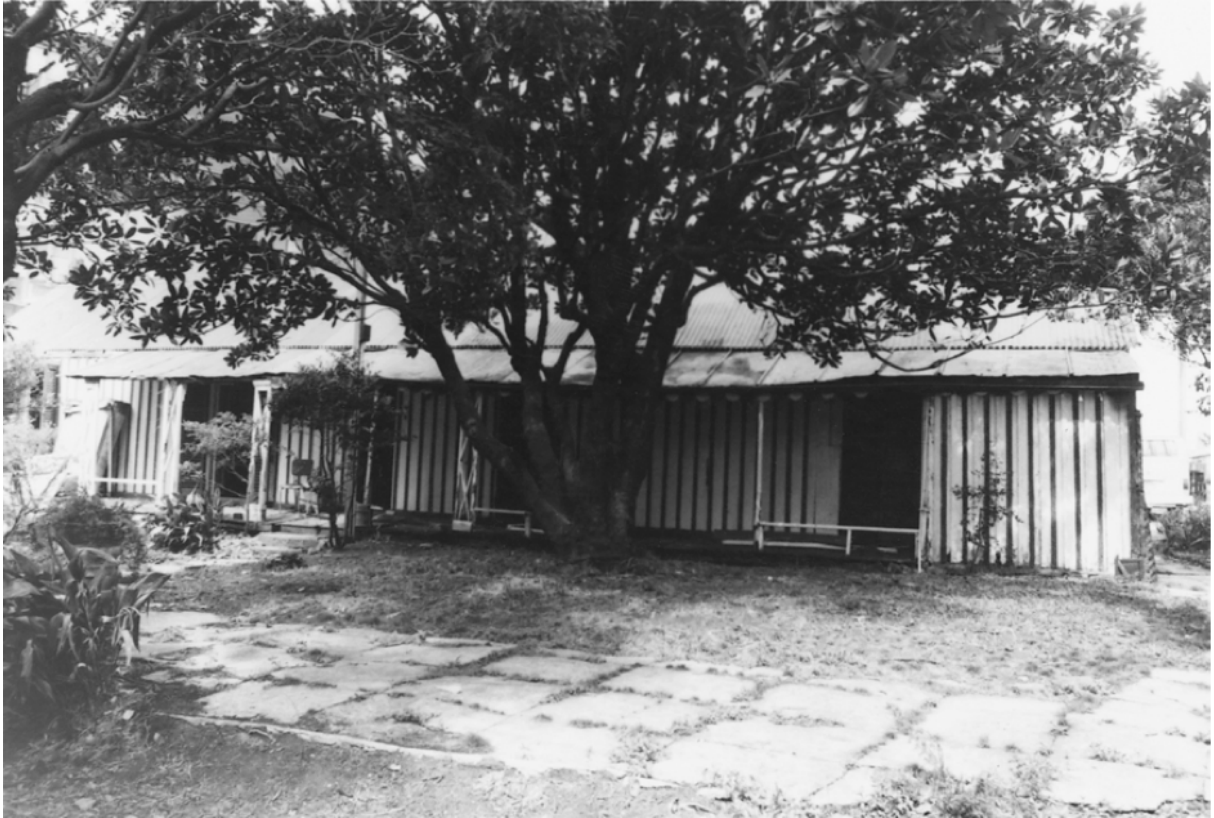
Figure 2. 37: Front elevation of Don Bank prior to restoration works in c.1975. Courtesy: G. Britton

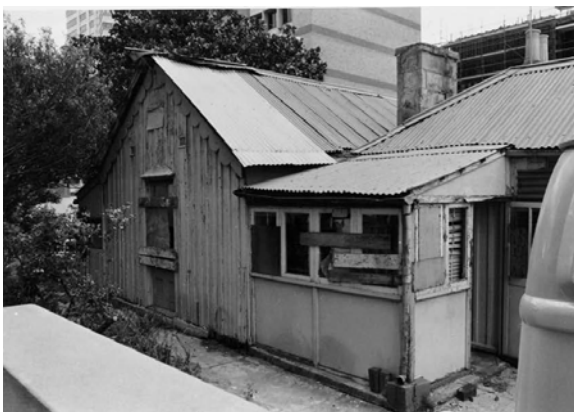
Figure 2. 38: View of the north elevation of the house and entry porch leading into the rear kitchen wing of Don Bank prior to restoration. Source: Stanton Library

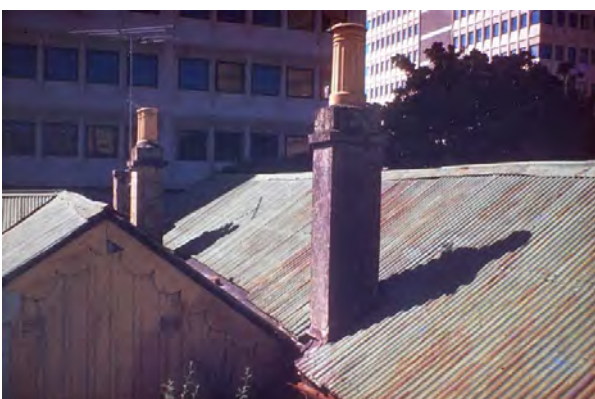
Figure 2. 42: A photograph by Beryl Graham of the roof materials of Don Bank in February 1974. Source: Stanton Library (CT11/34)

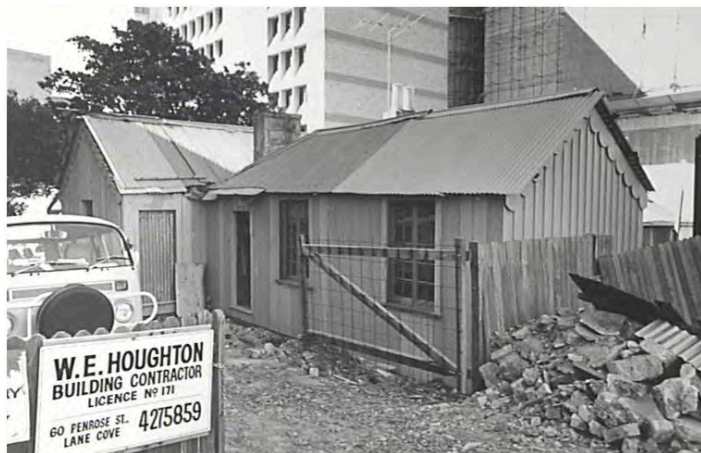
Figure 2. 46: The rear wing of Don Bank during restoration works c.1980. Source: Stanton Library (PF 2420)

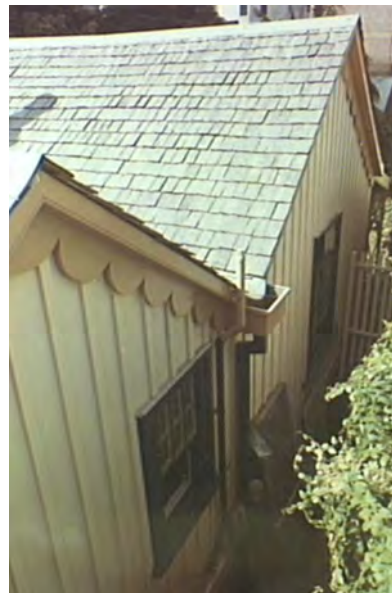
Figure 2. 49: The restored roofing of shingles. Source: Stanton Library (CPF 324)

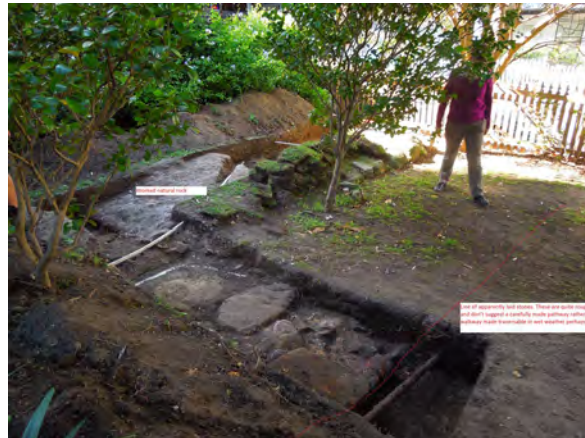
Figure 3.22: Photograph of the worked stone revealed by the test excavations. Source: G. Britton

Three trenches were excavated (see Figure 3.21) which revealed that a driveway was never located in the north-east corner of the site and that a stone paved walkway was once located in that area, leading from the house down to Napier Street (see Figure 3.22).

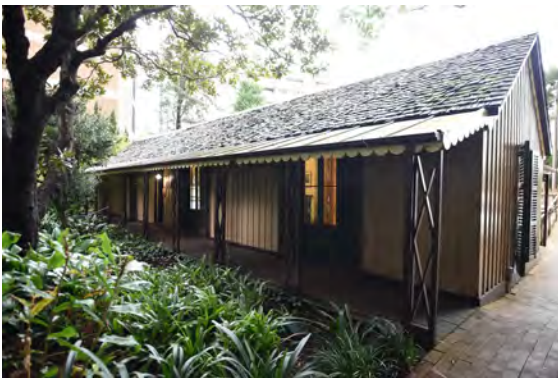
Figure 3. 24: Front (east) elevation

It is a long, low, cottage with a timber shingled roof and walls of vertical timber boards with battened joints. It has a continuous galvanised iron-roofed verandah supported on light latticed timber columns and the front elevation is symmetrical about the central front door with two sets of French doors to both sides.

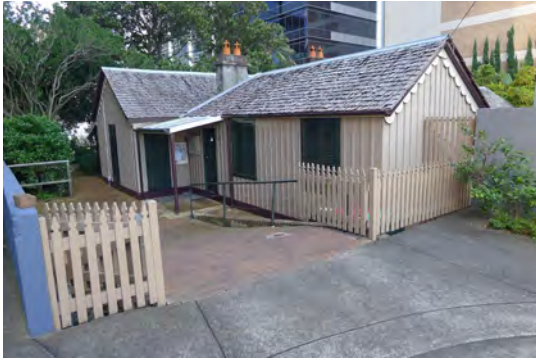
Figure 3. 26: North and west elevations of kitchen wing attached to rear elevation of main body of the cottage.

Although a kitchen wing would have originally been separate to the main body of the house, since the mid-19<sup>th</sup> century, the kitchen wing (Space 08 and 09) intersects at right angles at the rear northern end of the building. This too is clad in vertical boards with battening, a timber shingle roof, four panel doors and sash windows, with timber louvred shutters.

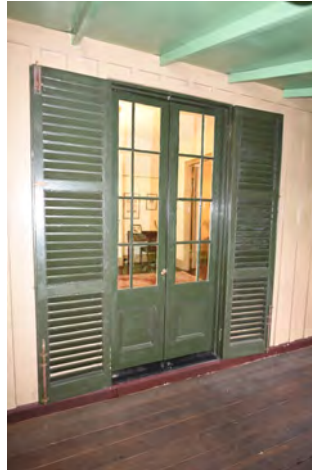
Figure 3. 27: Example of an original French door.

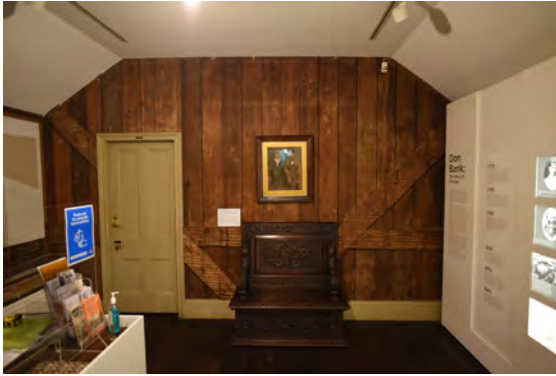
Figure 3. 30: Space 03, the main reception room with display showcases and wall and ceiling cladding.

The right-hand front room (Space 03) is displayed with some of its vertical wall boards revealed inside. Here they have a rougher, sawn surface and butt joints. In this room the internal linings are thought to have been calico fabric, remnants of which were found tacked to the perimeter. The calico was (originally or later) lined with newspaper and finished with decorative wallpaper. Later on (date unknown), the room was lined out with lath and plaster, the markings of which remain highly visible.

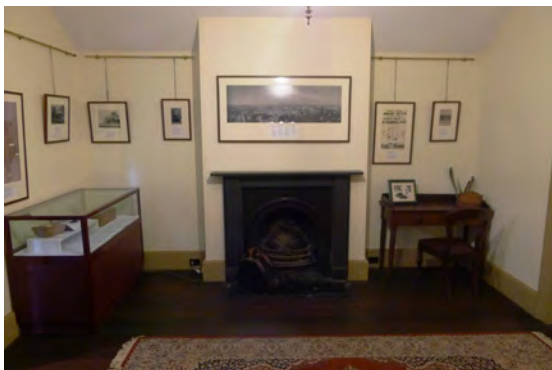
Figure 3. 38: Fireplace in Space 06

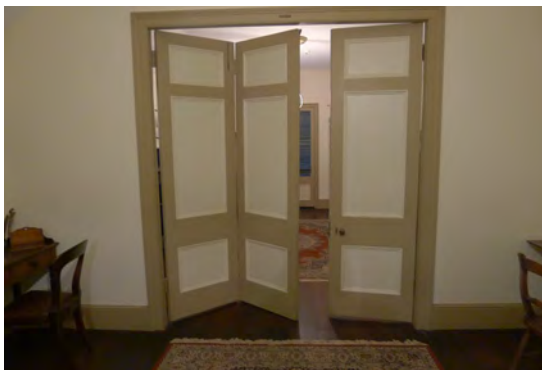
Figure 3. 39: Folding doors between Spaces 06 and 07

<sup>4</sup> Byrne, 1982, p.26. Byrne does not state under which architrave the newspaper was found, but we assume it was the triple leaf door D19 between Spaces 06 & 07. This door is assumed to date from c1856 when space 07 was added. If that is the case, it would seem natural that the earlier wallpaper was covered by the new door architrave, whereas the finish was stripped and replaced in the rest of the room.

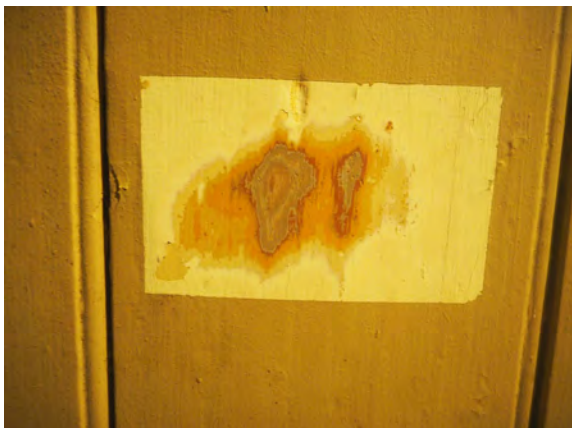
Figure 3. 64: Retained area in Space 02 showing results of paint scrapes.

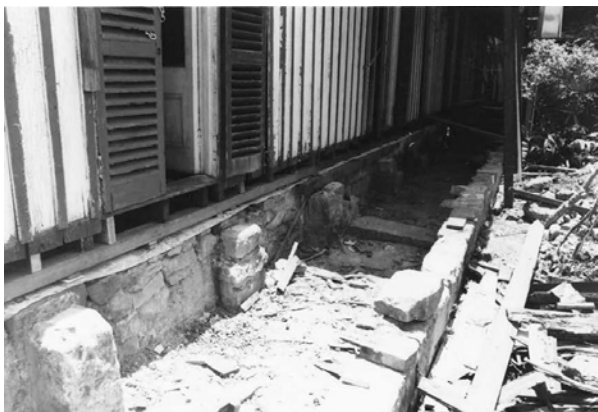
Figure 3. 68: Front verandah during conversion, c1979

Interior wall and ceiling linings were all removed to inspect the construction and efforts made to clean off the plaster markings. The floor was taken up in the southern room Space 10. The front verandah was completely rebuilt with the boards running parallel to the building front (previously they had been perpendicular to the front). According to an architect's progress report 70% of the frame and flooring was replaced, all architraves and skirtings were replaced along with scalloped barge boards.

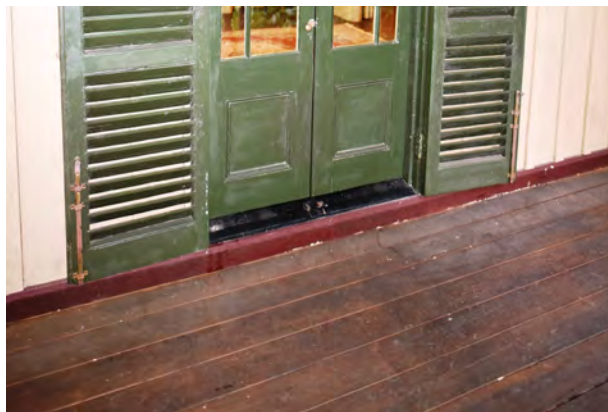
Figure 3. 69: Front verandah, 2022

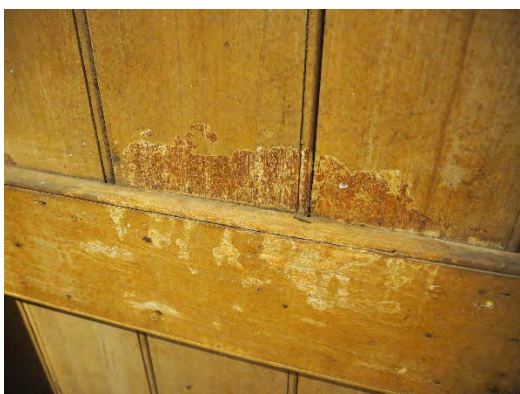
Figure 3. 70: Rail and boards in Space 05 with shiplap joints and a shaped beaded profile.

In the smaller two rooms at the rear of the original cottage (Spaces 04 & 05) the boards and rails have smoothly planed internal surfaces, shiplap joints and a shaped 'beaded' profile along one or both edges. They were painted internally. Clearly these boards were meant to be seen inside and in the absence of internal linings the shiplap joint was employed to provide some added protection.

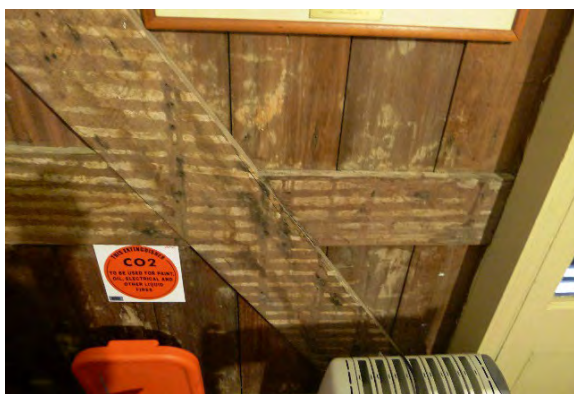
Figure 3. 71: Rails and boards in Space 03 with butt joints and evidence of lath and plaster.

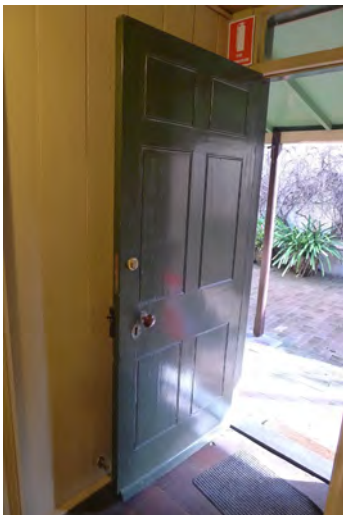
Figure 3. 72: Front door D01

The style of window and external door joinery of the original four-roomed cottage (Spaces 01-06 incl.) is consistent with our assumed date range of 1835-46. The front and rear door leaves have six panels, French doors have margin glazing bars and early moulding profiles are used on both French doors and sash windows. The four-panel internal doors, however, are thought to be of a later date, as one would expect to see six-panel doors used internally to match the external doors.

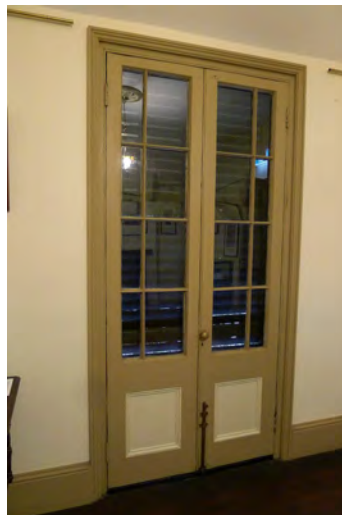
Figure 3. 73: French door D11

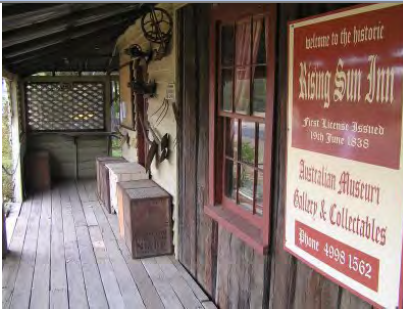
Item	Description	Image
<p><b>Rising Sun Inn (former), Millfield, NSW</b></p> <p>State Heritage Register (No. 00529)</p>	<p>A rare example of a vernacular slab-built inn, part of which dates from the early nineteenth century, which served travellers on the Great North Road from Wollombi to Maitland. Consisting of a vertical split hardwood slab building with double gabled roof, the house dates from c1838 and retains fabric from that date, and from all of its later additions reflecting its varied history as an inn, general store, post office and residence.</p>

<p>Figure 4. 1: Front elevation of the Rising Sun Inn. Source: Wikipedia</p>
<p><b>Durham Hall, Jembaicumbe, Bateman’s Bay</b></p> <p>Local heritage item (No. I294)</p>	<p>Pre-1841 - an outstanding example of rural farm complex. Some 10 metres south of the 1889 addition is a vertical slab cottage possibly dating from the mid to late 1820s. The slab cottage's original windows, doors, framing and shingled roof under a later corrugated iron roof remain intact and it is known once to have housed and been adapted for a meat store</p>

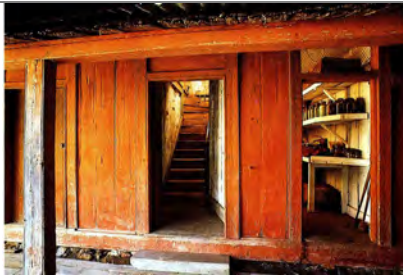
<p>Figure 4. 2: Entry to slab cottage. Source: Braidwoodgardens.com</p>

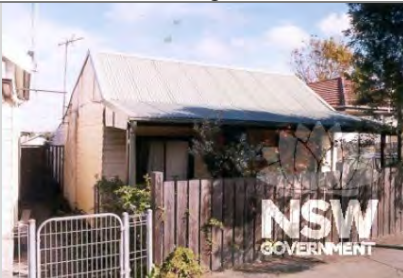
<p><b>Timber Slab Cottage, Tempe, NSW</b></p> <p>State Heritage Register (No. 01412)</p>	<p>A timber slab cottage at 44 Barden Street Tempe dating from c1840. It is a rare surviving example of the type of vernacular rudimentary timber building built in early Sydney. The house is one of the oldest houses in Tempe and is on land which was part of an original land grant dating back to 1799. It would have been a worker's cottage on land owned by A.B. Sparke, the man who built Tempe House in the mid-1830s.</p> <p>The walls are made up of vertical timber slabs which have been split and painted with limewash. The gaps between the timber slabs have been caulked with a lime putty.</p>

<p>Figure 4. 3: Timber slab cottage, Tempe. Source: NSW Heritage</p>

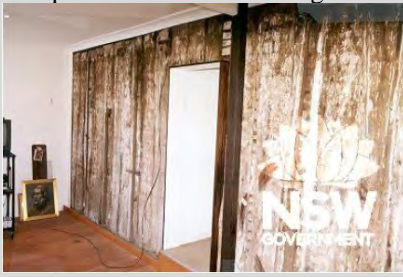
<p>Figure 4. 4: Interior wall of cottage. Source: NSW Heritage</p>

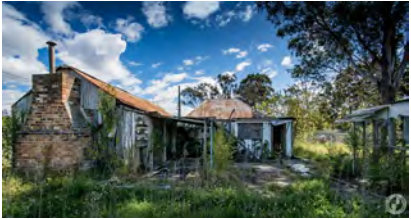
Item	Description	Image
<p><b>Rose Cottage, cnr. Water Street and Tennant Road, Werrington, NSW</b></p> <p>Local heritage item (No. I318)</p>	<p>Rose Cottage 1869 and slab hut are highly significant for their association with early settlement of the Werrington district. The early two roomed slab hut, located at the rear of the house, is most likely the original house. Although most of its early fabric has been removed, its slab kitchen, overall form, roof structure and remnant outbuildings demonstrate the building style and techniques of local handymen of the period. The timber slab hut is of very high significance as one of few surviving examples of Old Colonial Rustic Vernacular Architecture in the Sydney Metropolitan Region.</p>

<p>Figure 4. 9: Rose Cottage, Werrington. Source: Historical encounters.org</p>
<p><b>Gracemere Homestead, Gracemere, Rockhampton region, Queensland</b></p> <p>Queensland State Heritage Register (No. 600508)</p>	<p>Constructed in c1858/59 by Colin Archer as a two-room house clad in split vertical ironbark slabs, lined internally with vertical cedar boards. In about 1869 a wing was added constructed of vertical sawn beaded boards of Burdekin Plum.</p>

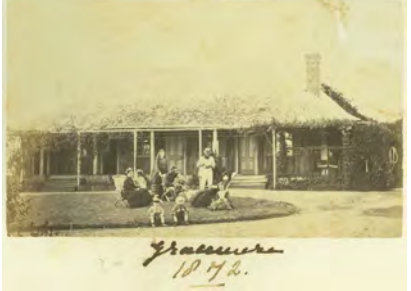
<p>Figure 4. 10: Gracemere homestead in 1872. Source: Wikipedia</p>

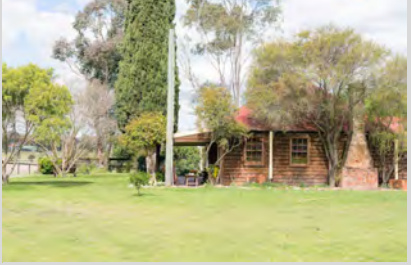
<p><b>Samuel Cox's House, 16 Lagoon Road, Pitt Town NSW</b></p> <p>Local heritage item (No. I278)</p>	<p>Constructed in 1870 Samuel Cox's Cottage is a simple hipped roof slab cottage and a rare example of a slab cottage in a rural setting remaining in the Hawkesbury area. It has a steeply pitched hipped roof, framed with timber poles. The internal walls and the original external walls are of hardwood slabs. The north wall has been replaced with weatherboards.</p>

<p>Figure 4. 11: Samuel Cox's House. Source: Wikipedia</p>
<p><b>Mascot Cottage, 56 North Street Ulladulla NSW</b></p> <p>Local heritage item (No. I486)</p>	<p>A mid-nineteenth century vernacular slab cottage which has been progressively modified but which clearly maintains its external form. The joints between the slabs are covered by narrow battens.</p>

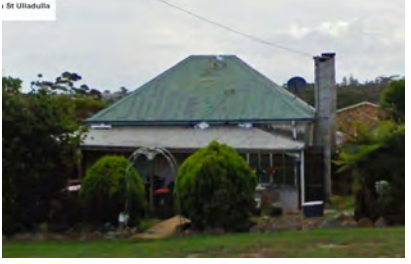
<p>Figure 4. 12: Mascot Cottage. Source: Domain.com</p>

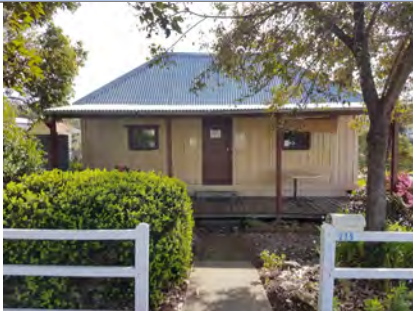
Item	Description	Image
<p><b>275 Green Street, Ulladulla, NSW</b></p> <p>Local heritage item (No. I485)</p>	<p>A mid-nineteenth century tannery worker's vertical slab cottage relocated to this site from nearby and restored as a community work project in 1994. The joints between the slabs are covered by narrow battens.</p>

<p>Figure 4.13: Street frontage. Source: Shoalhaven tourism</p>

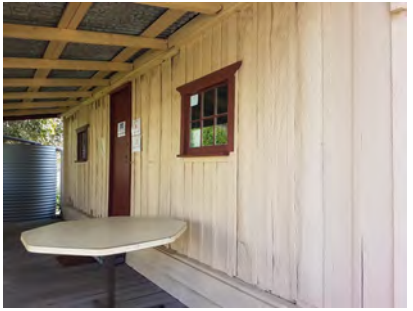
<p>Figure 4.14: Detail of vertical slab front elevation. Source: Shoalhaven tourism</p>
<p><b>Sharman's Slab Cottage, Harrington Park, NSW</b></p> <p>Local heritage item (No. I121)</p>	<p>A late 19<sup>th</sup> century slab cottage, a rare example of a worker's cottage of the time.</p> <p>The one family lived in this cottage continually for over 70 years, with boxing promoter Jimmy Sharman being born there in 1887. The cottage is clad in vertical timber slabs, with a corrugated metal gabled roof.</p>

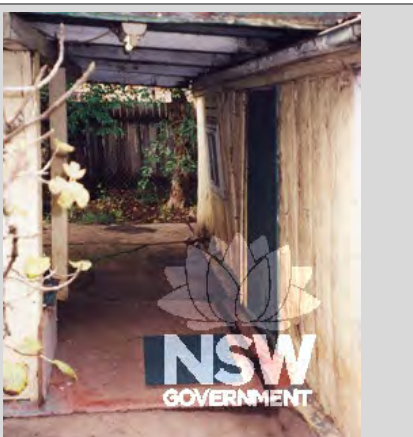
<p>Figure 4.15: Detail of front elevation. Source: NSW Heritage</p>
