10.5. Don Bank Museum - Conservation Management Plan 2023

**Don Bank Museum
6 Napier Street, North Sydney**

Conservation Management Plan

Prepared by:
Lucas Stapleton Johnson & Partners Pty. Ltd.
The Trust Building, Suite 303, 155 King Street
Sydney NSW 2000
Telephone: (02) 9357 4811
Email: mailbox@lsjarchitects.com

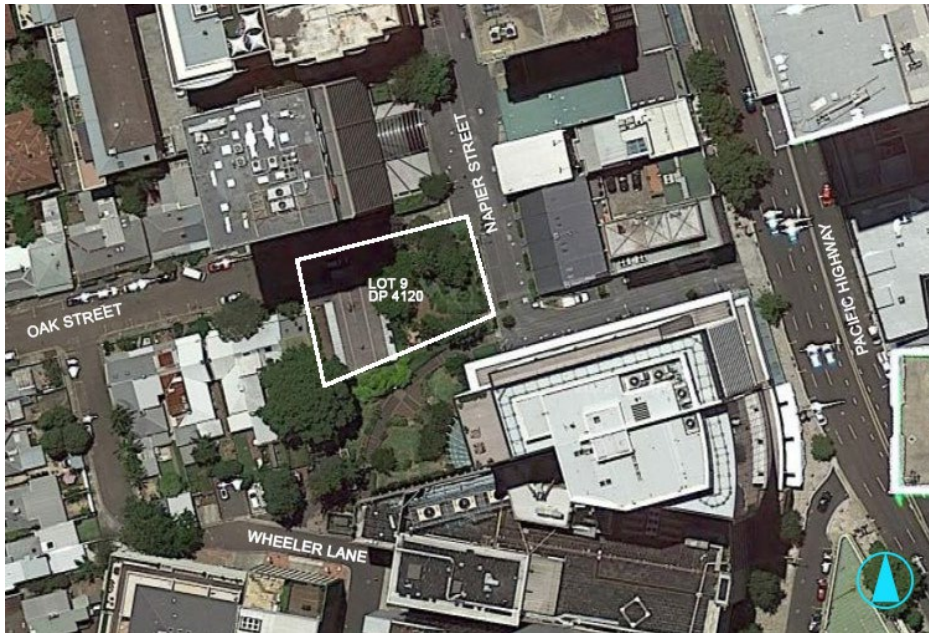
Figure 1. 2: Aerial photograph of Don Bank Museum showing the allotment boundaries of the place. The real property definition is Lot 9 of DP 4120 Source: LRS, SixMaps

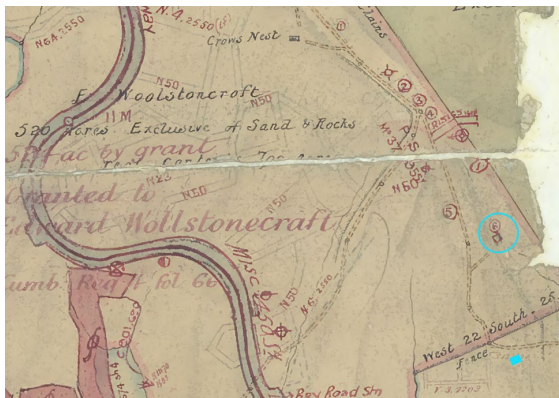
Figure 2. 10: Detail of the government survey of Wollstonecraft’s grant dated 1833, with later, twentieth century annotations (red text). It recorded a number of notations on the east side of the road that became Lane Cove Road and later the Pacific Highway. The notation 6 (circled in blue) refers to a Lands Department plan (7418.3000) dated 1928 prepared for the resumption of land between the Pacific Highway and Angelo Street. This notation was mistaken in the 1970s for a dwelling. The approximate location of Don Bank is indicated with a blue square located south of a fence line to the south of later annotation. Source: NSW Land Registry Services (Crown Plan S.437b)

The government survey of Crow’s Nest Farm undertaken in 1833 (see Figure 2.10) showing what appears to be a dwelling in the vicinity of present-day Don Bank. Further analysis of this survey concludes this “dwelling” was a later notation for a plan reference number made by the Lands Department in 1928 for the widening of the highway in the vicinity of Angelo Street, located to the north of Napier Street and Don Bank.

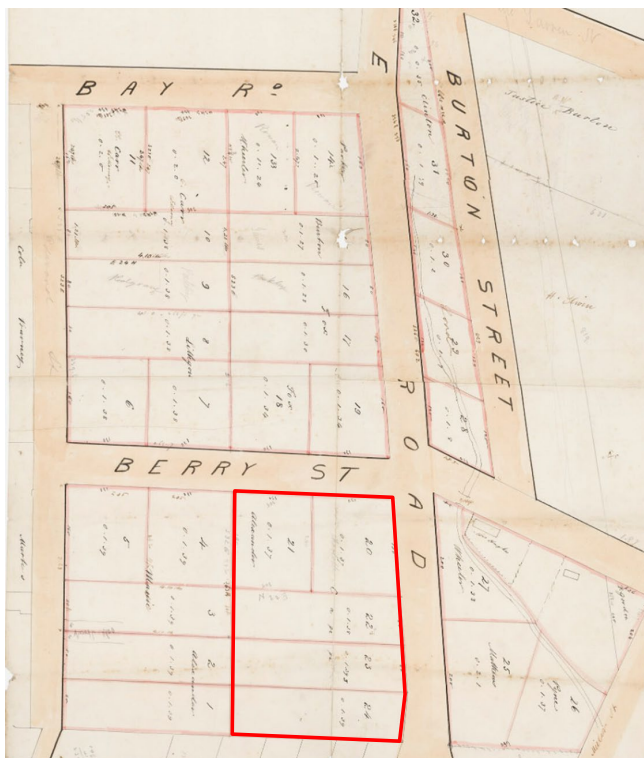
Figure 2.17: Detail of the plan of Alexander Berry's land release of 1853 forming 41 allotments. The area outlined in red for this report comprised Lots 20-24 purchased by William Carr. The plan did not record any built development within the vicinity of present-day Don Bank, although other buildings were recorded. The area to the east of these allotments was the government township of St Leonard's (across Lane Cove Road). Source: State Library of NSW (North Sydney subdivision plan no. 185)

The subdivision undertaken by Berry in 1853 included allotments later associated with St Leonard's Cottage, these being Lots 20 to 24, which collectively comprised an area of around 2&1/4 acres, with the location of the cottage being within Lot 23 (see Figure 2.17).¹⁴ Berry's subdivision comprised a total of 41 allotments that was advertised in 1853 as 'forming an extension of the township of St Leonard's' and they were bounded in part by the east side of Lane Cove Road (Pacific Highway), and from Bay Street to across Berry Street (see Figure 2.17).¹⁵ The average area of the allotments was 1/4 acre.¹⁶

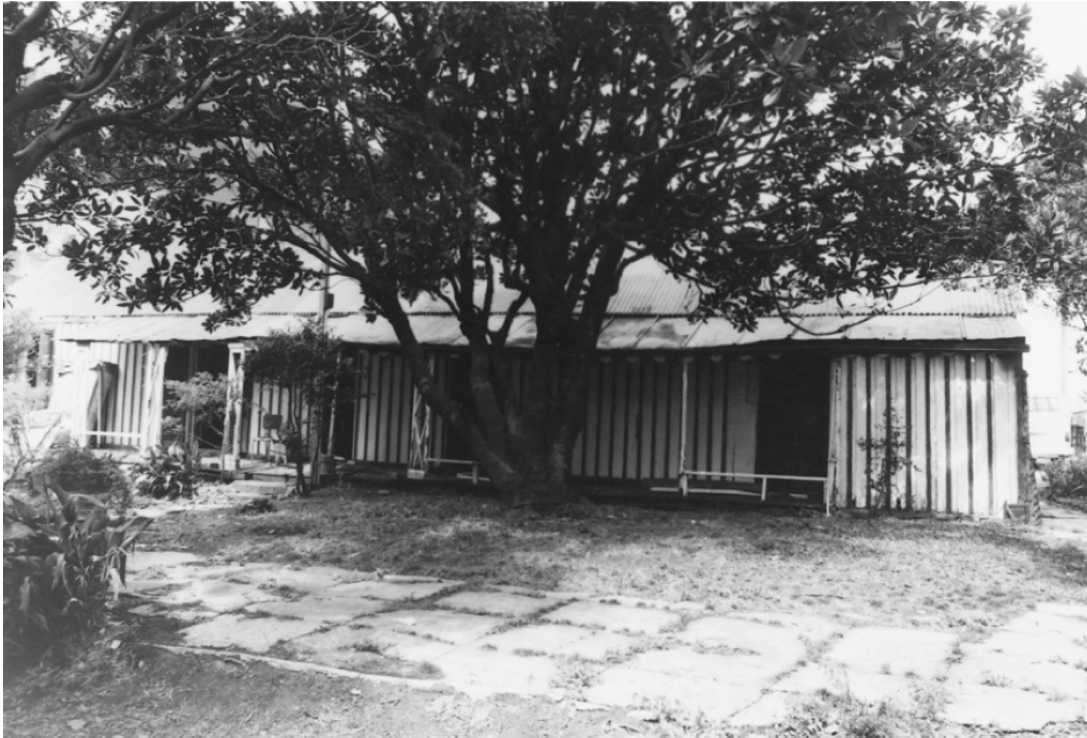
Figure 2. 37: Front elevation of Don Bank prior to restoration works in c.1975. Courtesy: G. Britton

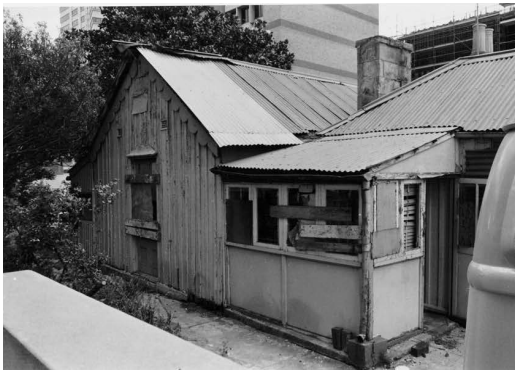
Figure 2. 38: View of the north elevation of the house and entry porch leading into the rear kitchen wing of Don Bank prior to restoration. Source: Stanton Library

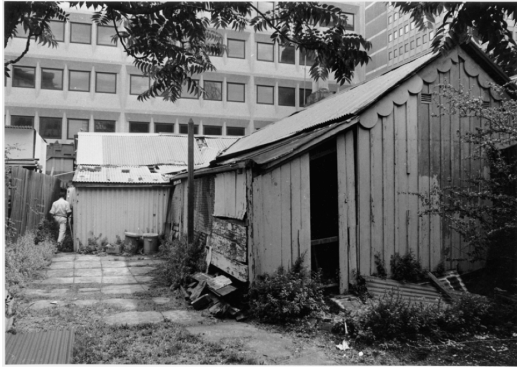
Figure 2. 40: Rear elevation of Don Bank prior to restoration works in c.1975. Courtesy: G. Britton

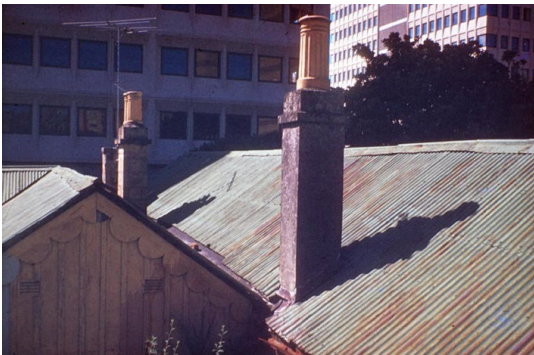
Figure 2. 42: A photograph by Beryl Graham of the roof materials of Don Bank in February 1974. Source: Stanton Library (CT11/34)

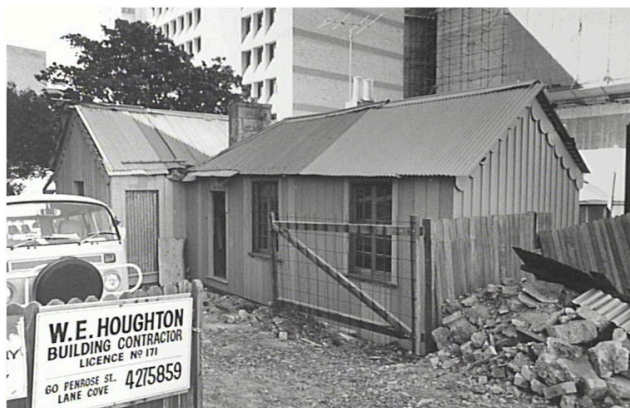
Figure 2.46: The rear wing of Don Bank during restoration works c.1980. Source: Stanton Library (PF 2420)

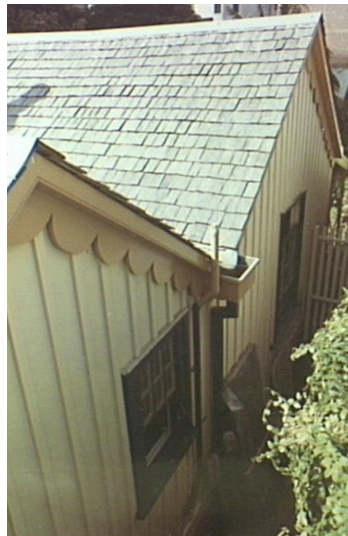
Figure 2. 49: The restored roofing of shingles. Source: Stanton Library (CPF 324)

Implementing Earle's proposal necessitated laying a new shingle roof of forest oak (*Casuarina*) tiles sourced from Wauchope.⁵² The exterior paint scheme of green and cream indicative of the Federation period was implemented.

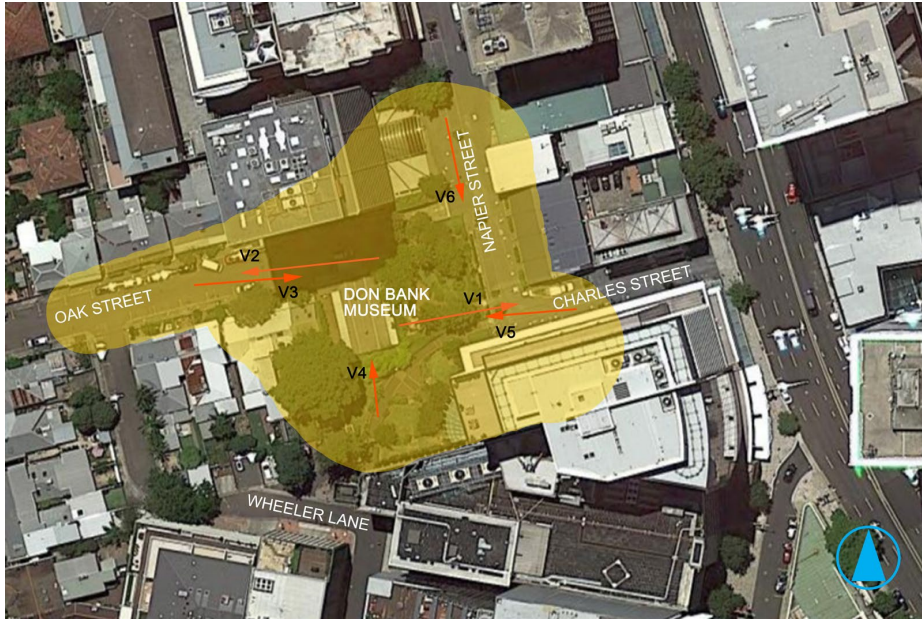
Figure 3. 2: Aerial view of Don Bank Museum locality showing principal views to and from the place and the visual setting of the place (shaded yellow). Source: GoogleMaps.

Views looking down onto the site would also be available from within the commercial and educational tower buildings located immediately to the north and southeast. Refer to Table 3.1 and Figure 3.2 below for identification of principal views.

Table 3. 1: Key views to and from Don Bank Museum. Refer to Figure 3.2 below.

View No.	Description
V1	Limited views looking east from the front verandah and front garden of Don Bank to Napier and Charles streets.
V2	Views from the driveway located on the north side of the allotment looking west down Oak Street.
V3	Views looking east down Oak Street to rear of Don Bank.
V4	Limited views through landscaping of southern elevation and garden setting from adjacent park.
V5	Views from Charles Street looking west to front garden and entry gate of Don Bank.
V6	Views from Napier Street looking west and south to front garden of Don Bank.

Policy 4: The setting of the place should be defined as shown the visual curtilage for the place, as shown in Figure 3.2 and any new development within the visual setting should be controlled in consideration of the significance of the place.

Policy 5: Views to and from the place as identified in Figure 3.2 should be retained.

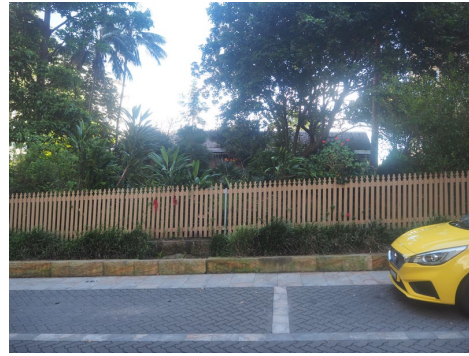
Figure 3. 10: Front timber paling fence with sandstone garden bed running along the length of the Napier Street frontage.

The site is fenced with timber paling fencing on a sandstone base with sandstone garden bed running along the eastern boundary, rendered masonry wall on the northern boundary, metal palisade fencing along the southern boundary and the western boundary is defined by the eastern wall of the adjacent property at No. 15 Oak Street. The southern and northern boundaries of the allotment are planted out with trees to provide a sense of enclosure within the site and obscure views of the adjacent commercial development. A small, brick paved yard is located at the rear of the house, which holds the storage shed.

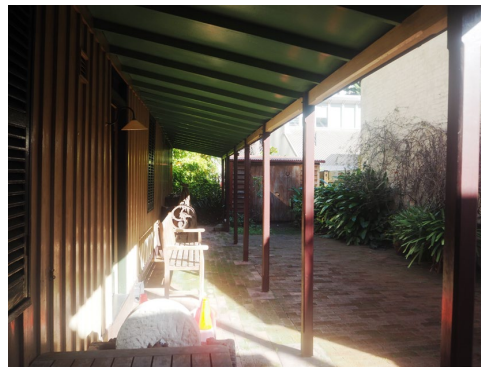
Figure 3.20: Rear yard looking south with storage shed.

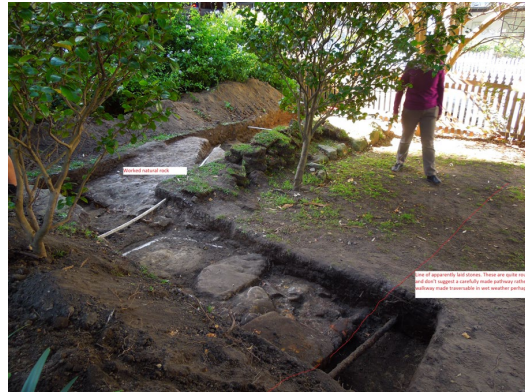
Figure 3.22: Photograph of the worked stone revealed by the test excavations. Source: G. Britton

Three trenches were excavated (see Figure 3.21) which revealed that a driveway was never located in the north-east corner of the site and that a stone paved walkway was once located in that area, leading from the house down to Napier Street (see Figure 3.22).

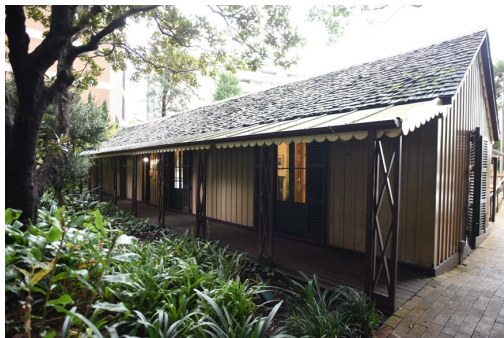
Figure 3. 24: Front (east) elevation

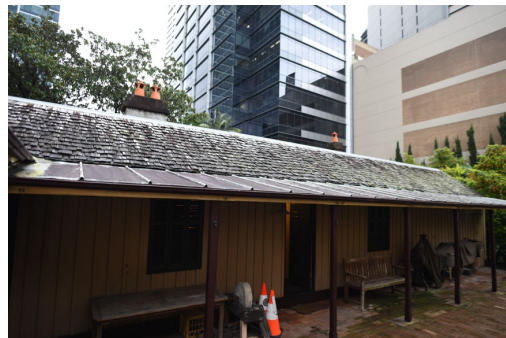
Figure 3. 25: Rear (west) elevation

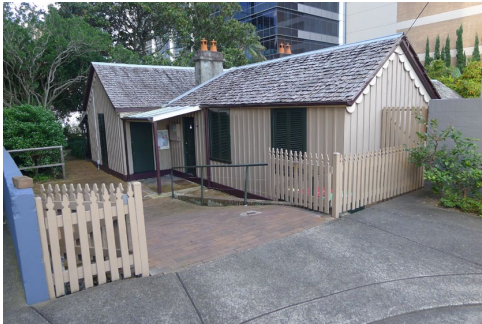
Figure 3. 26: North and west elevations of kitchen wing attached to rear elevation of main body of the cottage.

Although a kitchen wing would have originally been separate to the main body of the house, since the mid-19th century, the kitchen wing (Space 08 and 09) intersects at right angles at the rear northern end of the building. This too is clad in vertical boards with battening, a timber shingle roof, four panel doors and sash windows, with timber louvred shutters.

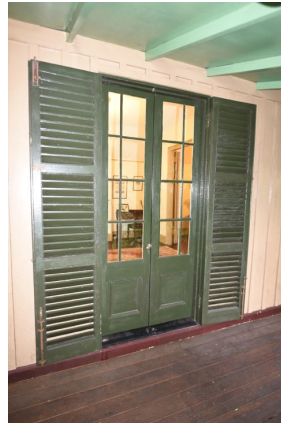
Figure 3. 27: Example of an original French door.

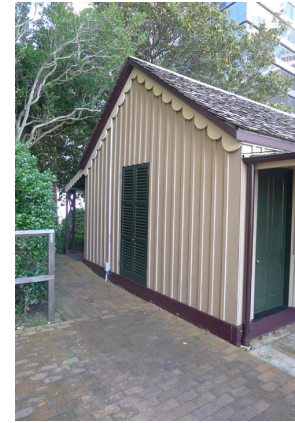
Figure 3. 28: North elevation of cottage.

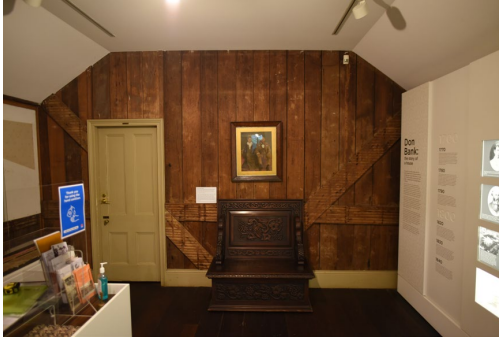
Figure 3. 30: Space 03, the main reception room with display showcases and wall and ceiling cladding.

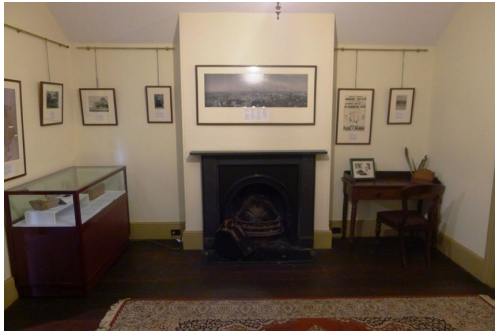
Figure 3.38: Fireplace in Space 06

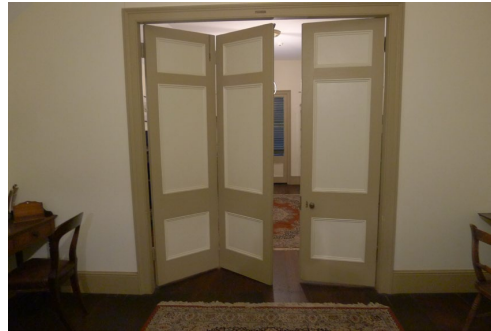
Figure 3.39: Folding doors between Spaces 06 and 07

⁴ Byrne, 1982, p.26. Byrne does not state under which architrave the newspaper was found, but we assume it was the triple leaf door D19 between Spaces 06 & 07. This door is assumed to date from c1856 when space 07 was added. If that is the case, it would seem natural that the earlier wallpaper was covered by the new door architrave, whereas the finish was stripped and replaced in the rest of the room.

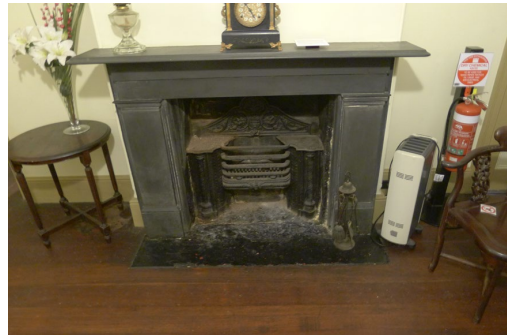
Figure 3.41: Fireplace in Space 06

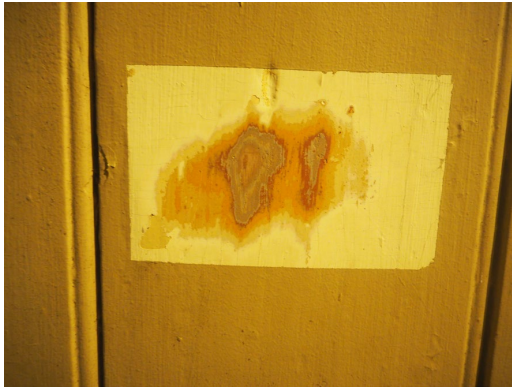
Figure 3. 64: Retained area in Space 02 showing results of paint scrapes.

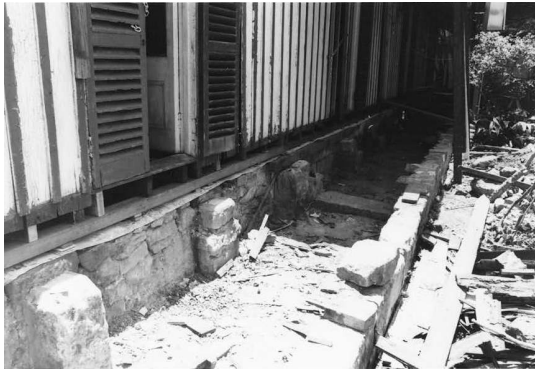
Figure 3. 68: Front verandah during conversion, c1979

Interior wall and ceiling linings were all removed to inspect the construction and efforts made to clean off the plaster markings. The floor was taken up in the southern room Space 10. The front verandah was completely rebuilt with the boards running parallel to the building front (previously they had been perpendicular to the front). According to an architect's progress report 70% of the frame and flooring was replaced, all architraves and skirtings were replaced along with scalloped barge boards.

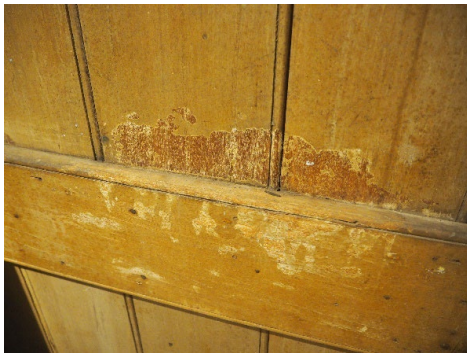
In the smaller two rooms at the rear of the original cottage (Spaces 04 & 05) the boards and rails have smoothly planed internal surfaces, shiplap joints and a shaped 'beaded' profile along one or both edges. They were painted internally. Clearly these boards were meant to be seen inside and in the absence of internal linings the shiplap joint was employed to provide some added protection.

Figure 3. 70: Rail and boards in Space 05 with shiplap joints and a shaped beaded profile.

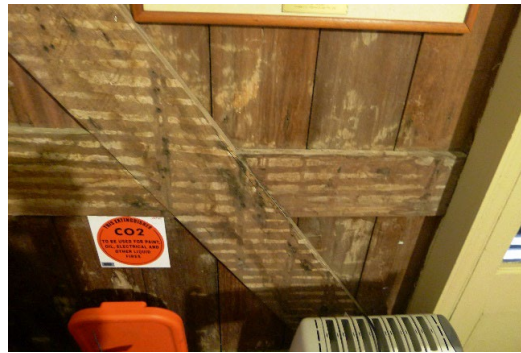
Figure 3. 71: Rails and boards in Space 03 with butt joints and evidence of lath and plaster.

The right-hand front room (Space 03) is displayed with some of its vertical wall boards revealed inside. Here they have a rougher, sawn surface and butt joints. In this room the internal linings are thought to have been calico fabric, remnants of which were found tacked to the perimeter. The calico was (originally or later) lined with newspaper and finished with decorative wallpaper. Later on (date unknown), the room was lined out with lath and plaster, the markings of which remain highly visible.

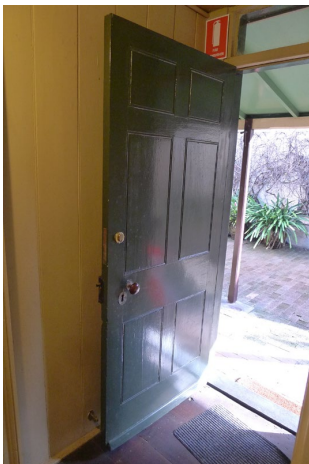
The style of window and external door joinery of the original four-roomed cottage (Spaces 01-06 incl.) is consistent with our assumed date range of 1835-46. The front and rear door leaves have six panels, French doors have margin glazing bars and early moulding profiles are used on both French doors and sash windows. The four-panel internal doors, however, are thought to be of a later date, as one would expect to see six-panel doors used internally to match the external doors.

Figure 3. 72: Front door D01

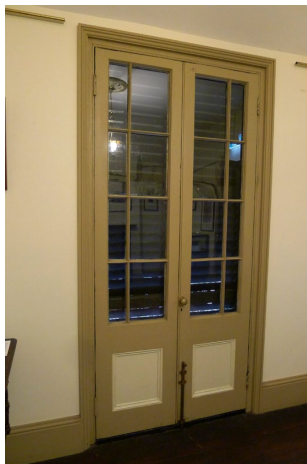
Figure 3. 73: French door D11

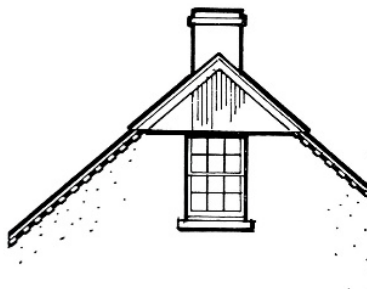
Figure 3. 75 (above): Diagram of a Jerkin head roof form.
Source: Stapleton, I., *How to Restore the Old Aussie House*, The Flannel Flower Press, 1983; p. 33

It is assumed that as originally constructed, St Leonard’s Cottage (Don Bank) had a timber shingled roof of M-shaped profile with a central valley like the present cottage. Timber shingles were found under the corrugated iron when the place was renovated in 1979-81 and some shingles (assumed to be early) were salvaged and remain on site in storage and on display.¹³ We do not know whether the roof had gables at the northern and southern ends like the present cottage. It is considered possible that it instead had hipped roofs or ‘jerkin-head’ ends to the roofs, as those were more common roof forms on colonial cottages.¹⁴

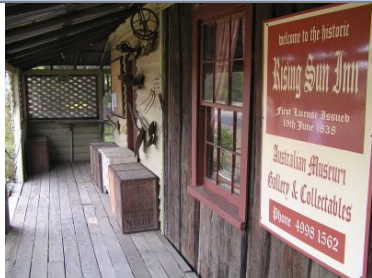
Item	Description	Image
<p>Rising Sun Inn (former), Millfield, NSW</p> <p>State Heritage Register (No. 00529)</p>	<p>A rare example of a vernacular slab-built inn, part of which dates from the early nineteenth century, which served travellers on the Great North Road from Wollombi to Maitland. Consisting of a vertical split hardwood slab building with double gabled roof, the house dates from c1838 and retains fabric from that date, and from all of its later additions reflecting its varied history as an inn, general store, post office and residence.</p>

<p>Figure 4. 1: Front elevation of the Rising Sun Inn. Source: Wikipedia</p>
<p>Durham Hall, Jembaicumbe, Bateman's Bay</p> <p>Local heritage item (No. 1294)</p>	<p>Pre-1841 - an outstanding example of rural farm complex. Some 10 metres south of the 1889 addition is a vertical slab cottage possibly dating from the mid to late 1820s. The slab cottage's original windows, doors, framing and shingled roof under a later corrugated iron roof remain intact and it is known once to have housed and been adapted for a meat store</p>

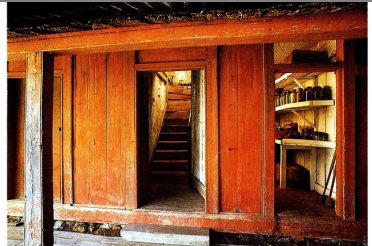
<p>Figure 4. 2: Entry to slab cottage. Source: Braidwoodgardens.com</p>

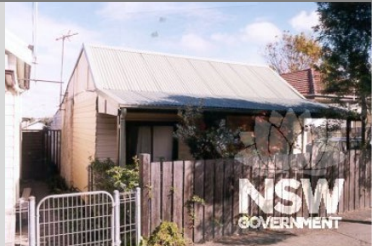
<p>Timber Slab Cottage, Tempe, NSW</p> <p>State Heritage Register (No. 01412)</p>	<p>A timber slab cottage at 44 Barden Street Tempe dating from c1840. It is a rare surviving example of the type of vernacular rudimentary timber building built in early Sydney. The house is one of the oldest houses in Tempe and is on land which was part of an original land grant dating back to 1799. It would have been a worker's cottage on land owned by A.B. Sparke, the man who built Tempe House in the mid-1830s.</p> <p>The walls are made up of vertical timber slabs which have been split and painted with limewash. The gaps between the timber slabs have been caulked with a lime putty.</p>

<p>Figure 4. 3: Timber slab cottage, Tempe. Source: NSW Heritage</p>

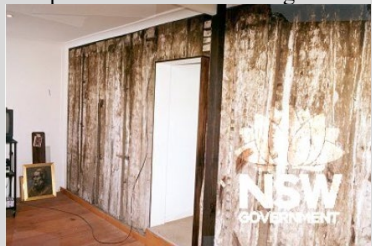
<p>Figure 4. 4: Interior wall of cottage. Source: NSW Heritage</p>

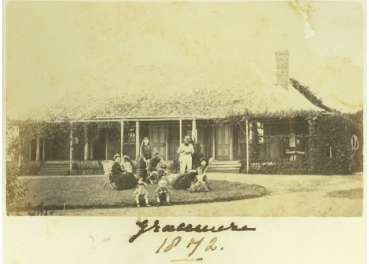
<p>Figure 4. 9: Rose Cottage, Werrington. Source: Historical encounters.org</p>
<p>Gracemere Homestead, Gracemere, Rockhampton region, Queensland</p> <p>Queensland State Heritage Register (No. 600508)</p>	<p>Constructed in c1858/59 by Colin Archer as a two-room house clad in split vertical ironbark slabs, lined internally with vertical cedar boards. In about 1869 a wing was added constructed of vertical sawn beaded boards of Burdekin Plum.</p>

<p>Figure 4. 10: Gracemere homestead in 1872. Source: Wikipedia</p>

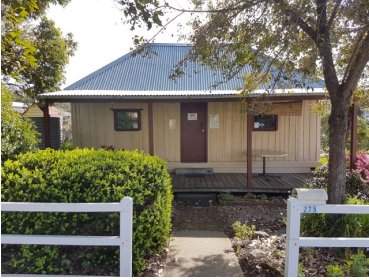
Item	Description	Image
<p>275 Green Street, Ulladulla, NSW</p> <p>Local heritage item (No. I485)</p>	<p>A mid-nineteenth century tannery worker's vertical slab cottage relocated to this site from nearby and restored as a community work project in 1994. The joints between the slabs are covered by narrow battens.</p>

<p>Figure 4. 13: Street frontage. Source: Shoalhaven tourism</p>

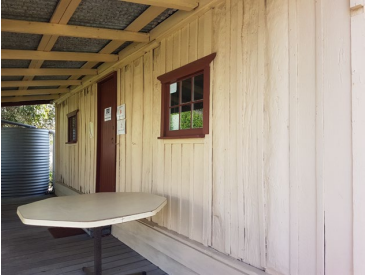
<p>Figure 4. 14: Detail of vertical slab front elevation. Source: Shoalhaven tourism</p>
<p>Sharman's Slab Cottage, Harrington Park, NSW</p> <p>Local heritage item (No. I121)</p>	<p>A late 19th century slab cottage, a rare example of a worker's cottage of the time. The one family lived in this cottage continually for over 70 years, with boxing promoter Jimmy Sharman being born there in 1887. The cottage is clad in vertical timber slabs, with a corrugated metal gabled roof.</p>

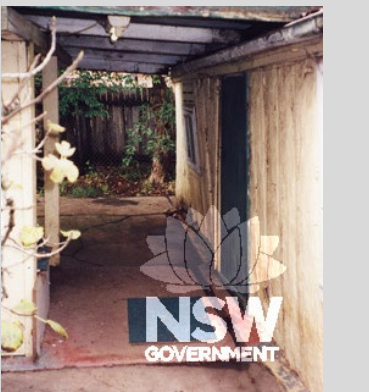
<p>Figure 4. 15: Detail of front elevation. Source: NSW Heritage</p>
