3.3. Balls Head Reserve Vehicle Access Management

AUTHOR: Gareth Debney, Bushland Management Co-ordinator

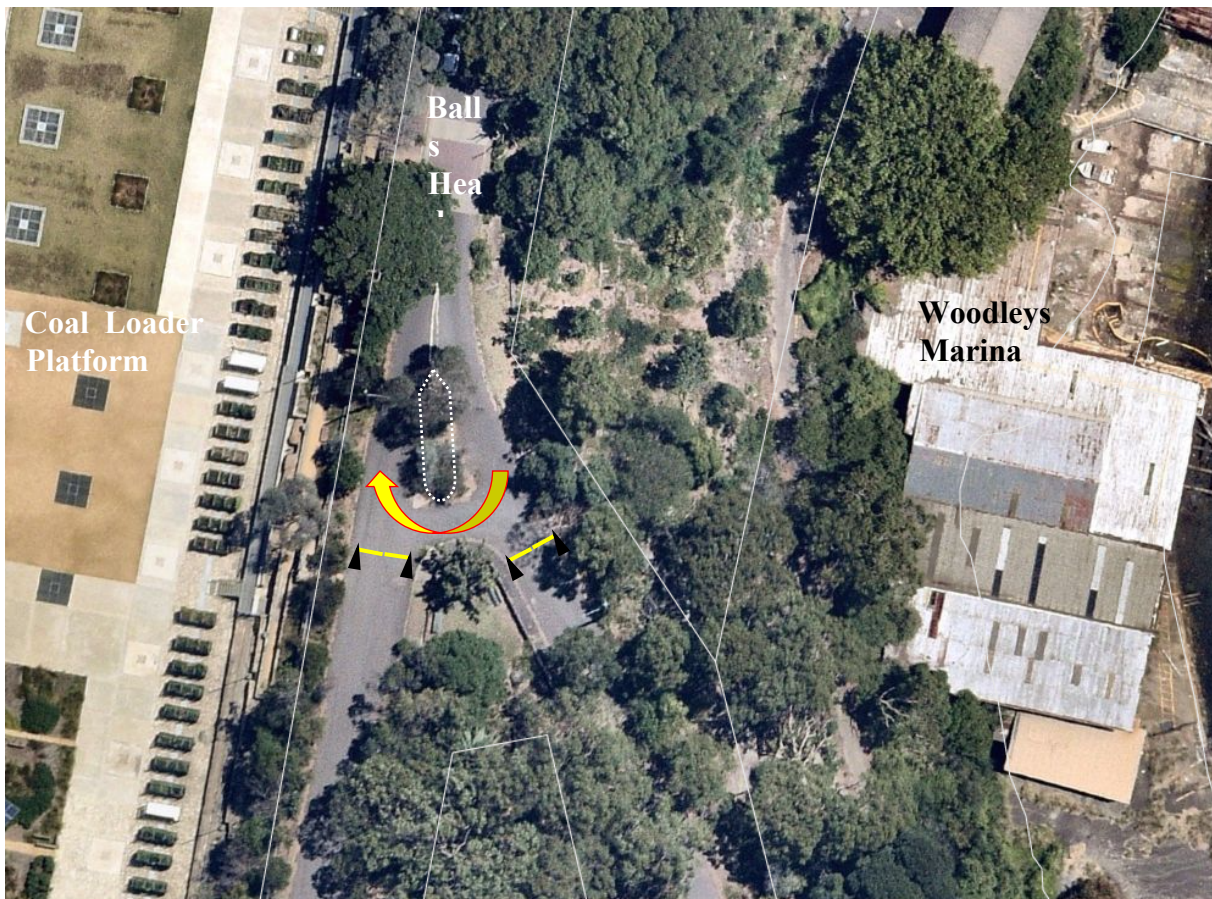
Above: draft schematic of proposed boom gate location and re-shaped road-island Council's Ranger Services have been consulted regarding the proposed installation of boom gates in Balls Head Reserve and are supportive of the initiative. Duty Rangers could perform the opening and closing of the boom gates, as the times correspond with shift rotation and existing duties such as opening/closing public amenities in the Coal Loader Parklands. In the event that vehicles are locked inside Balls Head Reserve, Council's security services provider could potentially provide out-of-hours boom gate opening on a user-pays basis, similar to the model used in other Local Council-operated bushland reserves such as Manly-Warringah War Memorial Park (Manly Dam Reserve).

To assist with managing these ongoing impacts on the reserve, it is proposed to install boom-gates on the entry and exit sides of the Balls Head loop road, incorporating minor modification of the road island to facilitate light vehicle U-turns when the gates are closed. These gates would subsequently be used to manage night-time vehicle access to the reserve in line with the existing parking restrictions (i.e. closed at 10pm and opened at 6am).

Funding for the proposed boom gate installation and minor road augmentation works is available under the existing 2021/22 Bushland Management budget allocation. Installation of the boom gates has been costed at between \$12,000-16,000 whilst modification to the existing road island near the entrance to Balls Head Reserve, where the roadway divides and becomes a one-way loop through the reserve, would require approximately \$14,000-18,000 including new signage and replacement plantings.
