## **Sport and Recreation Reference Group**

**Report SR05 - 15 March 2021**

**SUBJECT:** Tunks Park Eastern Amenities Block

# North Sydney Council Amenities Condition Report

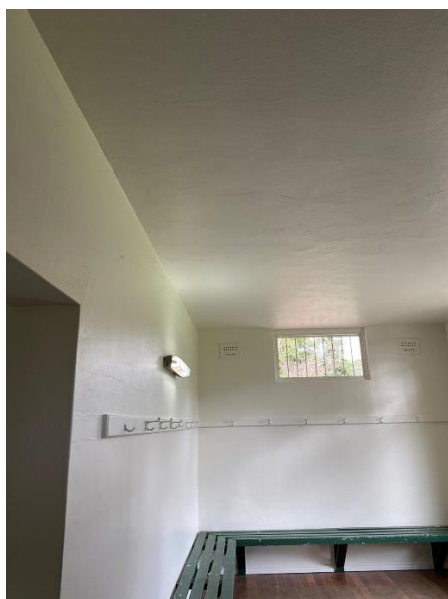
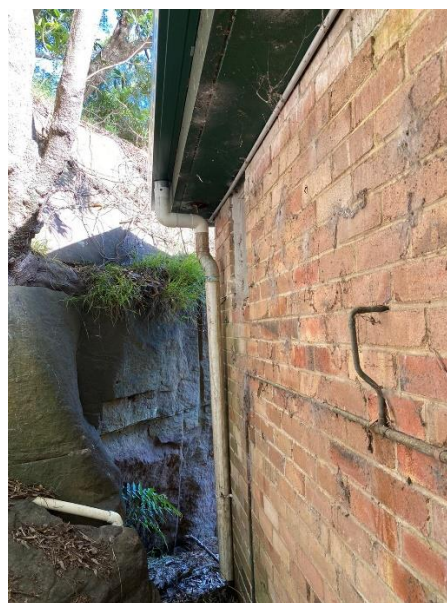
The only change made to the above recommendations was that instead of the 300mm extension past the southern lip the roof was installed with gutters attached the existing downpipes. Some photos below of the completed works

It is important to note that the repairs are of a short term solution and will extend the useful life of the buiding by approximately 10 years. Beyond that time frame Council should be considering the full repalcement of the building.

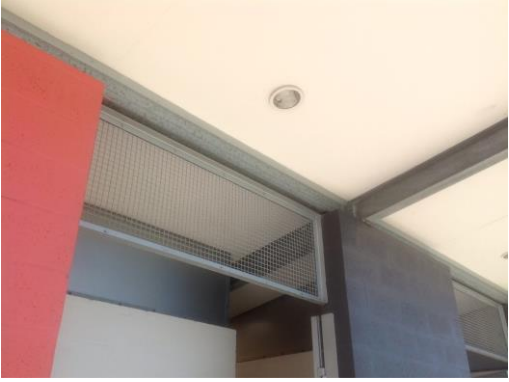
<p>Unisex/Accessible amenities require some permanent ventilation. Upon entering this area it was evident there was a lack of continuous ventilation as the mechanical fan only activates by sensor upon entry. Consider modifying the front high panels above entry door with mesh panels to match the remaining building.</p>

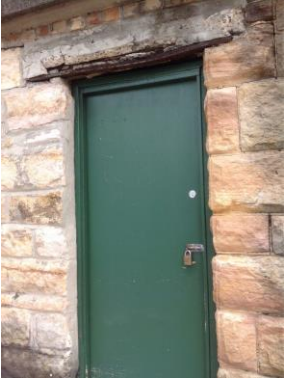
<p>Renew arch bars above openings and repair lintels.</p>
---	---

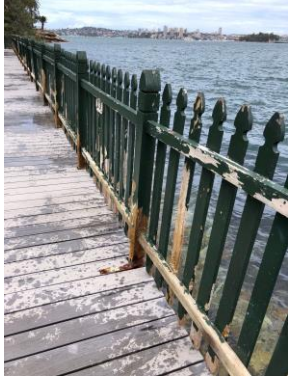
Paint handrails harbour side of pool including minor repairs.

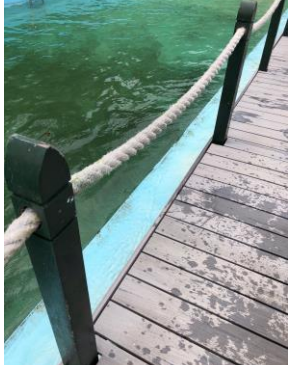
Annual allowance to maintain rope and bollards.

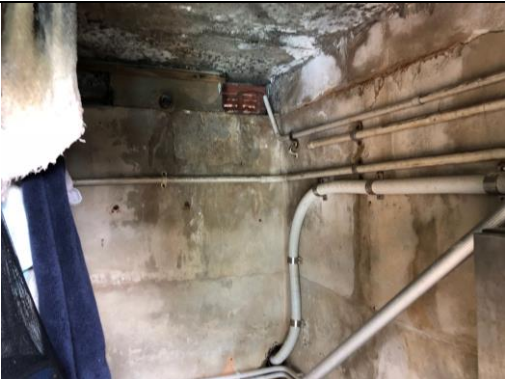
Consider providing additional ventilation or enlarging existing wall vents due to chemicals stored in shed.

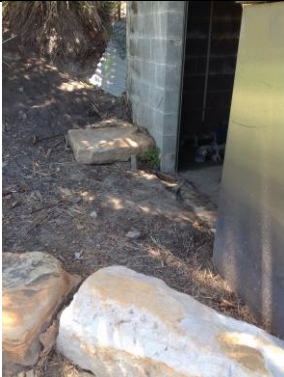
The structure is in good condition and no major lifecycle works are anticipated within the next ten years. There is evidence of rainwater entering the building and works to divert the water away is recommended.

Excavate and form a concrete pad at entrance of pump house to divert stormwater away to prevent flooding.

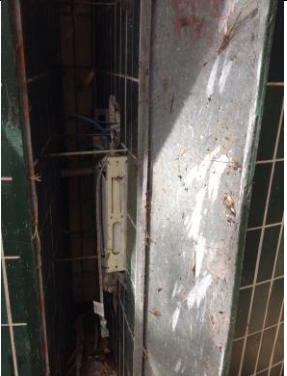
<p>Treat rusted surfaces such as doors and jambs to service rooms, structural steelwork.</p>

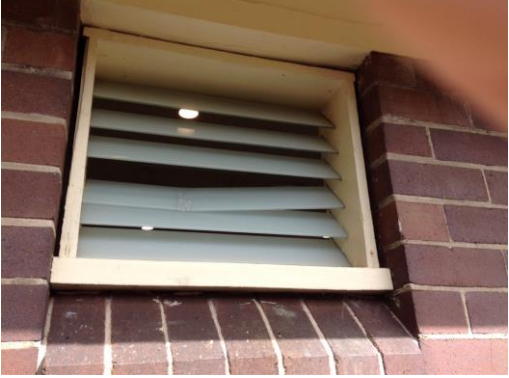
<p>Consider replacing timber window louvres with aluminium due to ongoing breakage.</p>

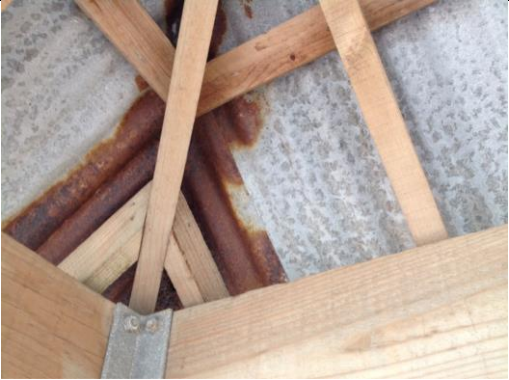
<p>Re-roof complete building.</p>

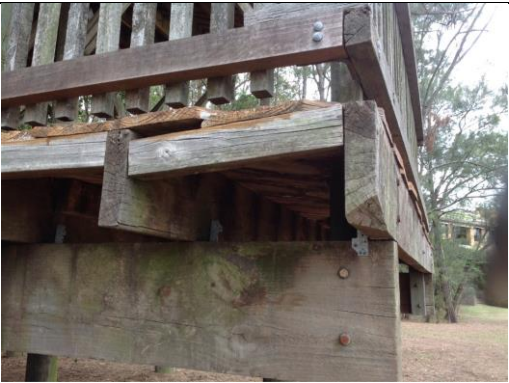
<p>Annual allowance to maintain timber.</p>

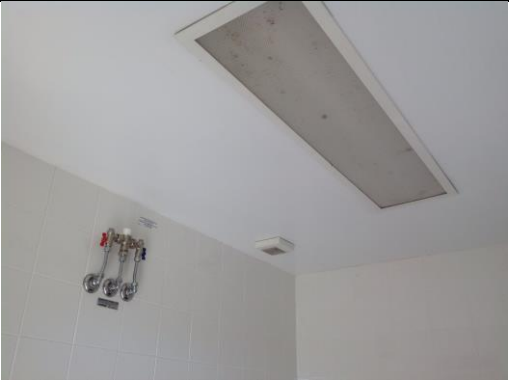
<p>Toilet in canteen, additional air turnover required.</p> <p>Upon entering this area it was evident there was a lack of ventilation. Consider increasing the capacity of the existing mechanical ventilation. Note there is a small fixed panel in the window that provides some natural ventilation.</p>
---	---

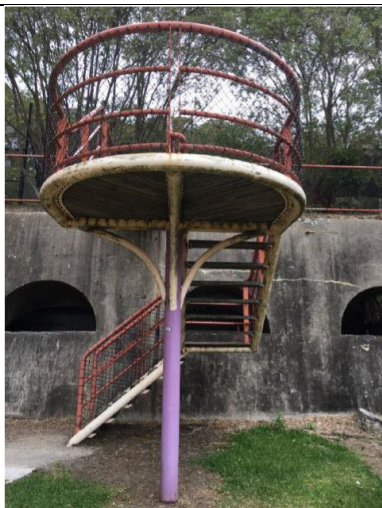
<p>Stair</p>
---	--------------

The stair is in poor condition and a number of works have been identified in the lifecycle plan.

Photo	Issue
 	There is plywood on the top of the stair.
 	The ply is covering a missing decking timber.
 	Timber decking in poor condition.

Corroded timber beam fixings incl. stair stringer and support column.

It is recommended that all the timber treads and decking be replaced with 35 x 130 F27 kiln dried hardwood. The fixings should be grade 316 stainless steel bolts with neoprene washers to provide metal separation.

The corroded steel needs to be removed and where required to maintain original section capacity site weld new sections of steel into place.

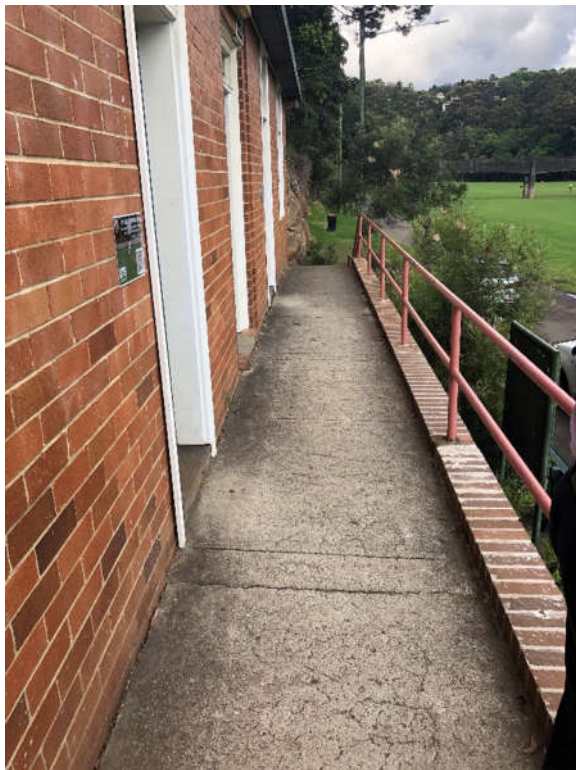
*Figure 1. Dry Northern Face*

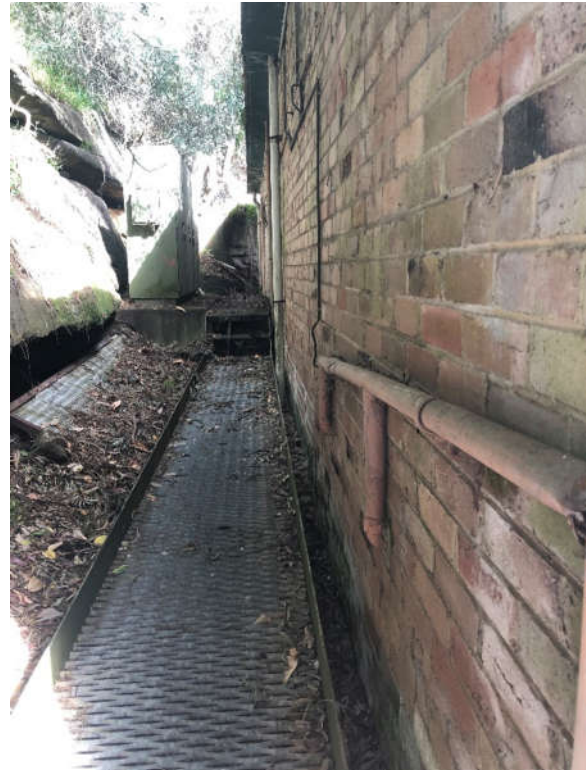
*Figure 2. Perpetually Wet Southern Face*
